Attn: Darin Gerow
Re: Structural Assessment & Life Cycle Assessment of the Memorial Arena – Interim Report
100 - 30th Street SE, Salmon Arm, BC

Structural Assessment and Lifecycle Analysis of the Memorial Arena

Interim Report

Project No. 24VR-600400

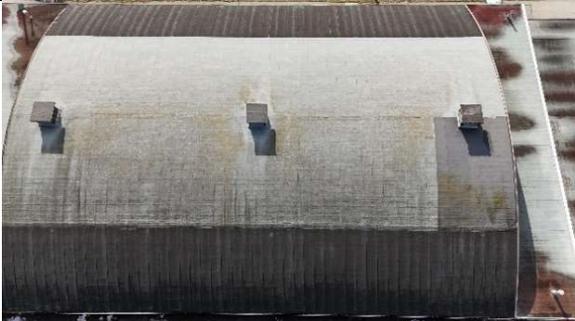
<p>Photo 1: Overview of arched roof area.</p>

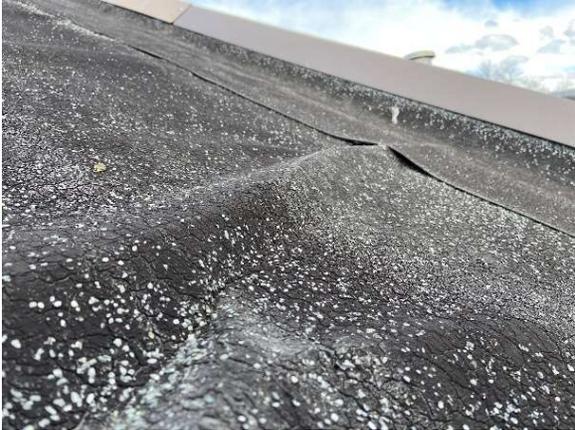
OBSERVATIONS	PHOTOS
<p>SBS Torch-on Roll Roofing – Arena</p> <ul style="list-style-type: none"> • Center third of arched roof area <ul style="list-style-type: none"> ○ Roofing appears to be in fair condition. Photo 1. ○ Sanded surface appears weathered but still intact. • Outer thirds of arched roof area (along eaves) <ul style="list-style-type: none"> ○ Roofing appears to be in poor condition. ○ Sanded surface has deteriorated and only the SBS membrane remains. Photo 2. ○ Large portions of the aggregate from the sanded surface have accumulated in the eavestroughs along the eaves of the arena. ○ Edge and end laps appear adequate, and the thermally welded edges are mainly intact. ○ Roofing terminates along eaves with a welded connection to the aluminum eave flashing. The eave flashing has a 3/4" vertical upturn such that debris and water remain trapped at the eave, restricting natural drainage into the eavestroughs. ○ The roofing at the southeast corner is folded and is susceptible to water ingress. Photo 2.

<p>Photo 2: Folded SBS at southwest corner. Note lack of sanded surface.</p>

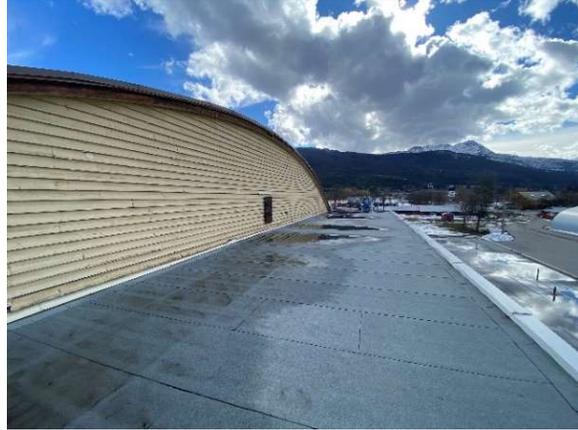
Photo 3: Flat roof at west end of arena. Ponding water observed.

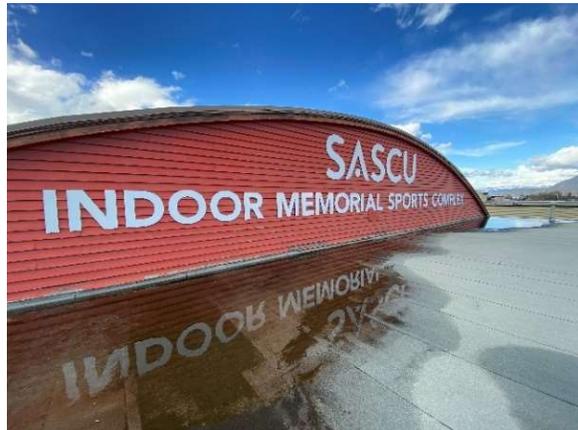
Photo 4: East arena flat roof.

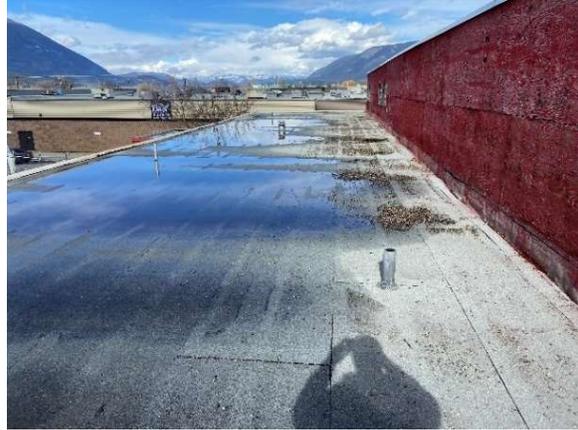
- Roofing appears to be in poor condition. Photo 6.
- Sanded surface is deteriorated and has micro cracking throughout. Photo 7.
- End and side laps of roll roofing are intact and watertight.
- Membrane extends vertically up rake wall and is thermally welded to the painted plywood gable end. Bond failure between the roofing and painted plywood was observed. Photo 7.
- Standing water observed in numerous locations as a result of inadequate roof slopes. Photo 6.
- The scuppers are clear of debris.
- Roof penetrations appear to be adequately sealed.
- Large membrane blisters observed along the rake wall. Photo 7.

Photo 6: West addition upper roof typical condition

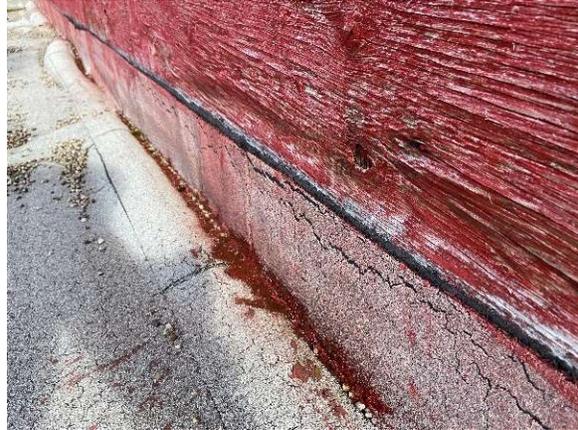
Photo 7: Microcracking, bond failure, and blistering observed.

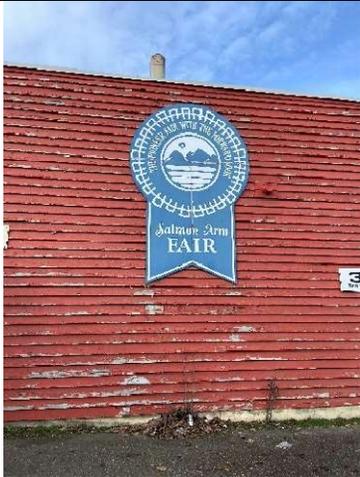
<p>Photo 8: Typical condition of cedar lap siding.</p>

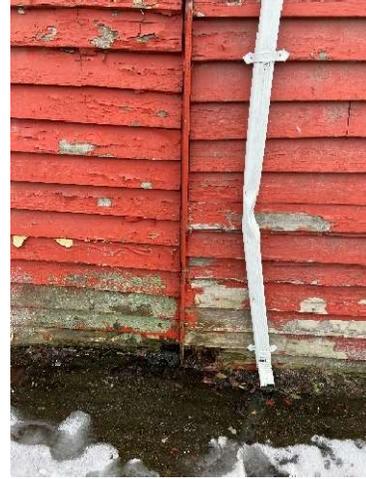
Photo 9: Cedar lap siding severely deteriorated within 48" of grade.

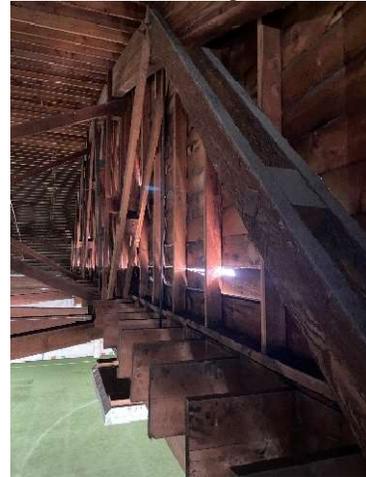
Photo 10: Light entering through cedar lap siding.

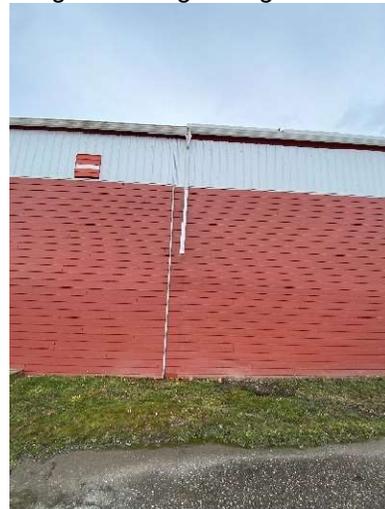
- The Hardi-plank lap siding is limited to the south wall of the arena and extends from grade to approximately within 5 feet of the eave. Photo 11.
- The siding is in fair condition throughout.
- The siding extends to grade along the east end of the arena. The manufacturer requires minimum 6-inch clearance from grade.
- The siding was installed over WRB and OSB sheathing.
- The bottom 6 inches of the OSB sheathing was saturated and has severe deterioration along the east half of the south wall.

Photo 11: Typical condition of Hardi-plank lap siding.

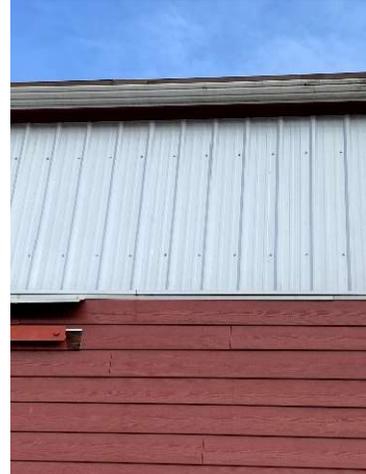
- The vertical metal cladding is limited to the upper 5 feet of the south wall of the arena.
- The metal cladding and associated trims and flashings are in good condition. Photo 12.
- The siding was installed over air barrier and OSB sheathing.

Photo 12: Vertical Metal Siding.

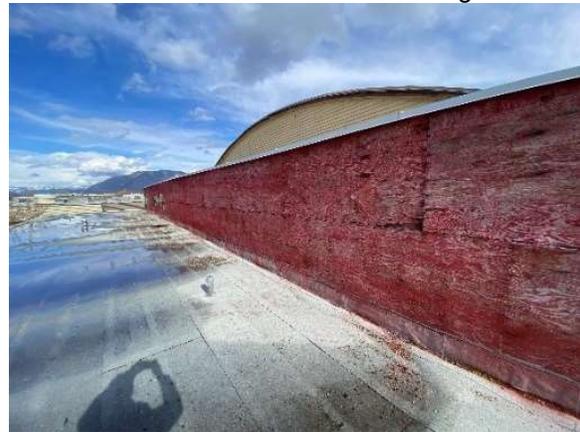
Photo 13: Typical condition of plywood sheathing.

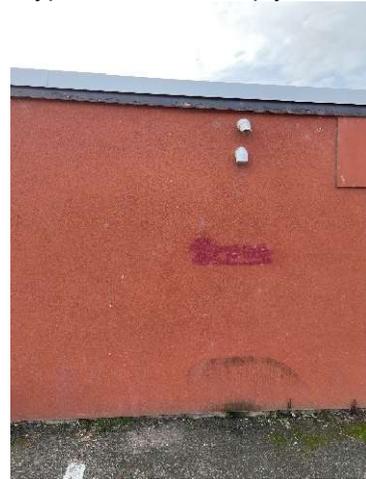
- The stucco siding is limited to the east addition of the building only.
- The stucco appears to be in fair condition with no significant cracking, delamination, or spalling. Photo 14.
- The stucco has a painted finish.

Photo 14: Typical condition of stucco siding.

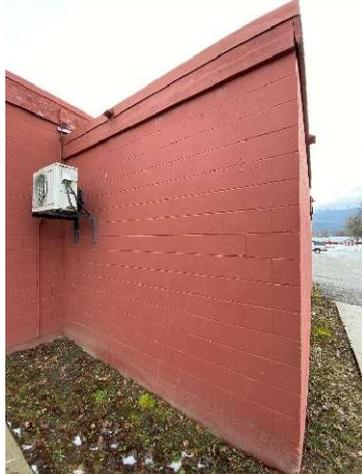
<p>Photo 15: Typical condition of painted CMU.</p>

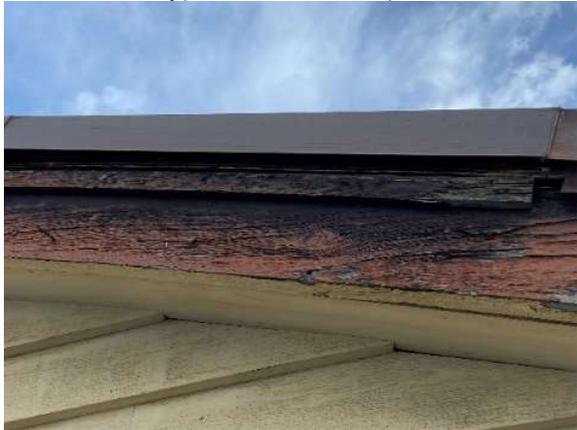
<p>Photo 16: Deterioration present on painted facia board.</p>
--	--

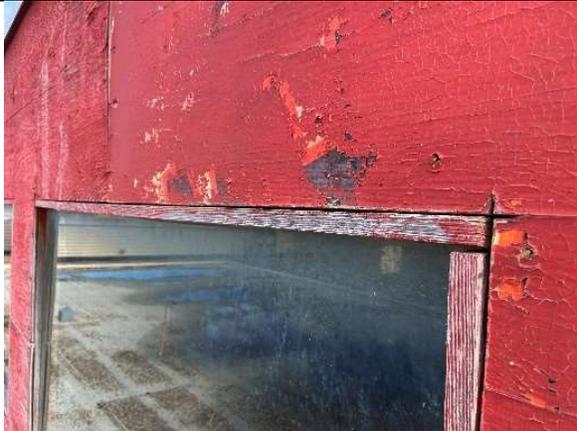
OBSERVATIONS	PHOTOS
<p>Wood Frames</p> <ul style="list-style-type: none"> • The exterior windows throughout the arena and the east side of the east addition are wood framed. • The wood frames are deteriorated and in poor condition. Photo 17. • Water staining on the interior side of the window frames suggests water ingress.

<p>Photo 17: Typical wood window frame condition</p>

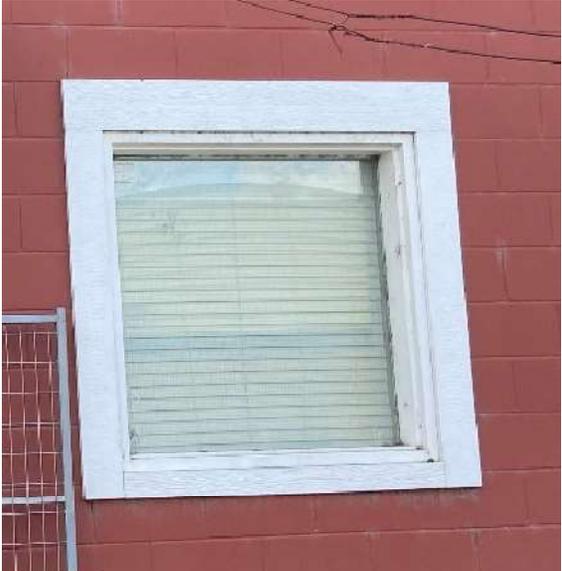
<p>PVC Frames</p> <ul style="list-style-type: none"> • The east and west addition windows are mainly PVC framed. Photo 18. • The frames are in fair condition with the exception of the south window in the east addition which is in poor condition. • The interior windows throughout the building are mainly PVC and are generally in fair condition. <p>Glazing</p> <ul style="list-style-type: none"> • The window glazing throughout the building are single pane and double pane sealed units. • The glazed units in PVC frames are generally in fair condition and well sealed. • The glazed units in wood frames are in poor condition and poorly sealed.

Photo 18: Typical PVC window frame condition

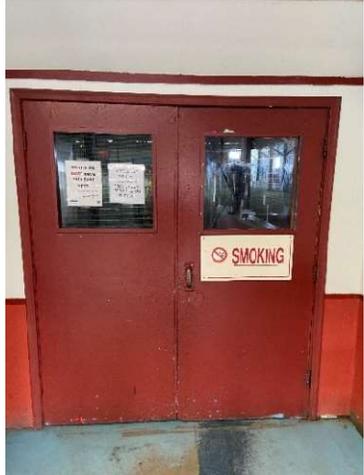
OBSERVATIONS	PHOTOS
<p>Solid Wood</p> <ul style="list-style-type: none"> • The solid wood doors are located sporadically throughout the building interior. The doors are generally in fair condition. Photo 19. • The southwest corner of the wood shop has a sliding wood door. The door is in poor condition and is difficult to operate. • The south wall of the arena has a large exterior barn style sliding door. The door is wood framed with a painted plywood exterior. The paint is peeling, and the wood is deteriorated. The door hardware appears to be in fair condition.

Photo 19: Solid wood door

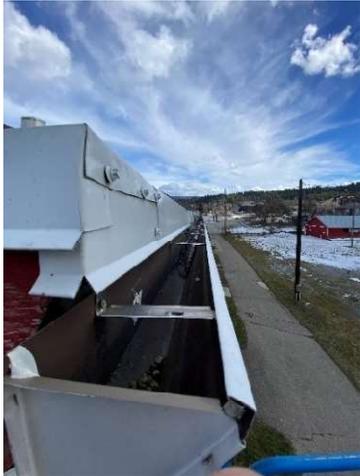
<p>Photo 24: Aluminium gutters and flashing along south arena wall.</p>

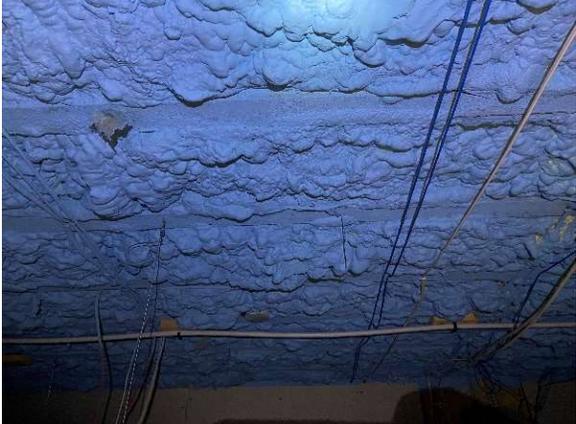
OBSERVATIONS	PHOTOS
<p>Vermiculite</p> <ul style="list-style-type: none"> Based on the background data reviewed the west addition CMU walls are filled with vermiculite insulation. The insulation could not be visually assessed. <p>Fibreglass Batt</p> <ul style="list-style-type: none"> Fibreglass insulation in the rafter bays of the west addition was confirmed, but its condition could not be assessed due to ceiling finishes. The east addition is assumed to have insulation between the roofing membrane and wood decking. Its condition could not be confirmed. The east addition exterior walls are assumed to be insulated with fibreglass batt insulation. Its condition could not be confirmed. <p>Polyurethane Spray Foam</p> <ul style="list-style-type: none"> The rafters above the offices at the northwest corner of the west addition are insulated with polyurethane spray foam insulation. The insulation is in good condition. Photo 26.

<p>Photo 26: Polyurethane spray foam and TJI joists</p>

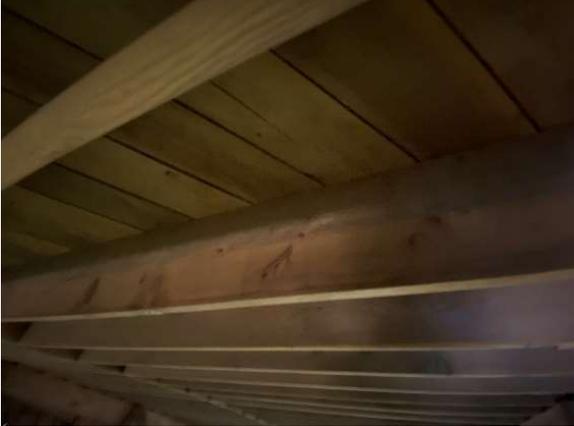
<p>Photo 27: Typical condition of arena roof planking</p>

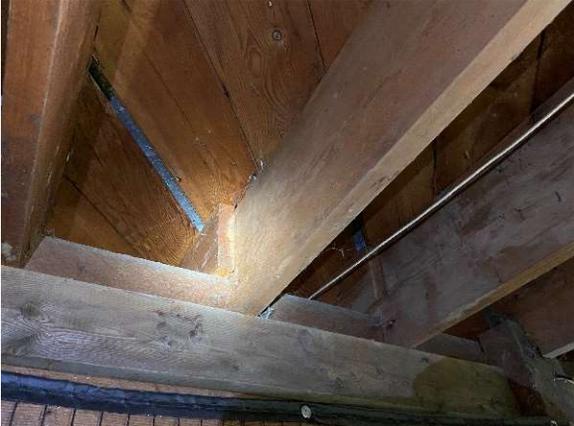
<p>Photo 28: Metal sheathing over gaps in planking.</p>

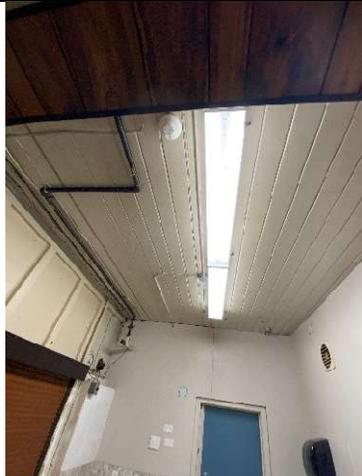
<p style="text-align: center;">Photo 29: T&G planking, east addition.</p>
---	--

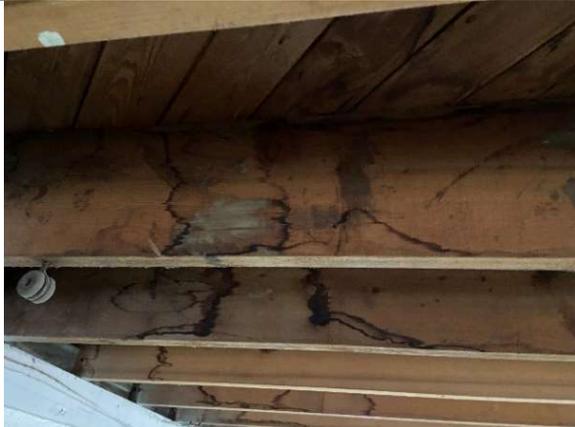
OBSERVATIONS	PHOTOS
<p>2x12 Douglas Fir Rafters</p> <ul style="list-style-type: none"> • The rafters are generally in good condition. • Water/moisture staining throughout. Photo 30. • The rafters are straight. • No excessive deflections were observed at the time of the assessment. Note that there was no snow accumulation on the roof at the time of the assessment. • Splitting of several rafters was observed. Refer to Appendix D which illustrates the approximate locations of rafters with observed splitting. Photo 31. • The bearing locations of the rafters on the top chord of the trusses are in good condition. No signs of bearing failure or lateral movement of the rafters were observed. • The rafters in the west addition were not visually assessed due to coverings. The rafters are assumed to be 2"x12" D. Fir members. <p>TJI Joists</p> <ul style="list-style-type: none"> • The rafters above the offices at the northwest corner of the west addition are TJI joists spaced at 16" on center. • The condition of the TJI joist could not be assessed as they are fully encapsulated by spray foam insulation with the exception of the bottom chords of the joists.

<p style="text-align: center;">Photo 30: Water staining observed on arena rafters.</p>

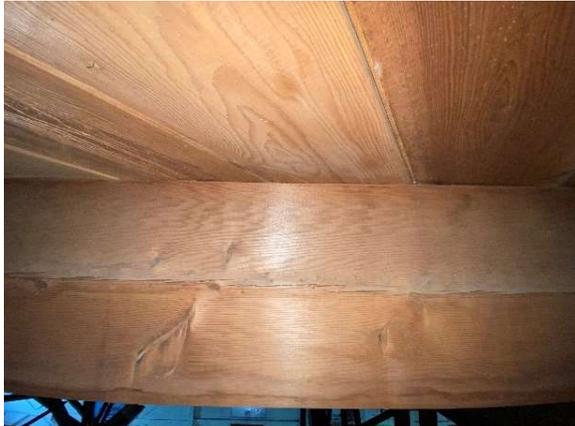
<p style="text-align: center;">Photo 31: Observed splitting in rafter</p>

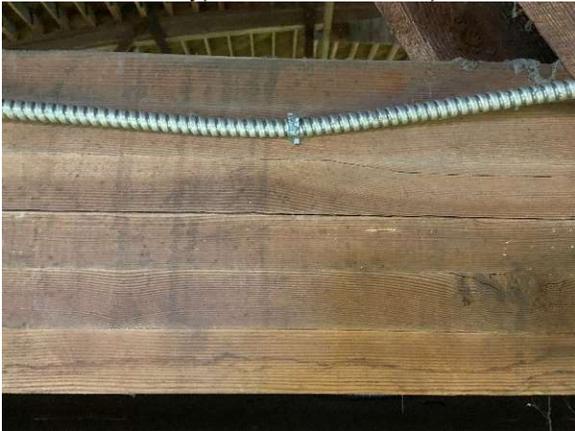
<p>Photo 33: Typical condition of bottom chord. Note minor checking in 3rd lamination.</p>

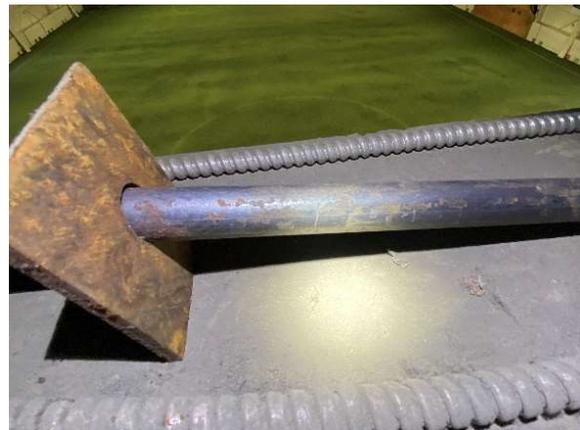
- Surface corrosion on the connection hardware was observed throughout. Photo 39.
- Random connection bolts were removed and assessed. The bolts reviewed are all in good condition. Photo 40.

Photo 40: Typical bolt surface corrosion.

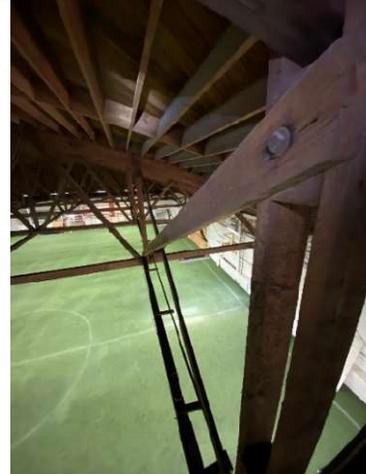
- The bottom chord bracing consists of cross-bracing in the east and west bays and strut braces in the remaining bays.
- The strut braces are in fair condition throughout.
- The cross-bracing in the end bays are in poor condition. Due to their long span, they have sagged 2-3 inches. Photo 42.
- Brace to truss connections are in fair condition with limited splitting.

Photo 41: Typical sway bracing.

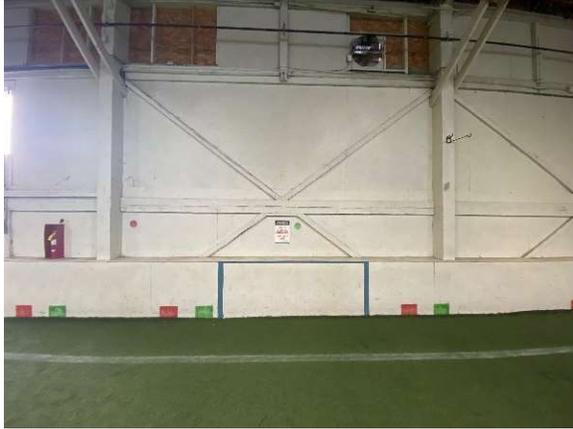
<p>Photo 43: Typical wall struts and bracing.</p>

- The walls of the arena have 4"x6" cross bracing. Photo 43.
- The braces are generally in fair condition.
- Checking was observed throughout.
- Several brace to column and brace to strut connections have failed due to building movement and member twisting and warping.

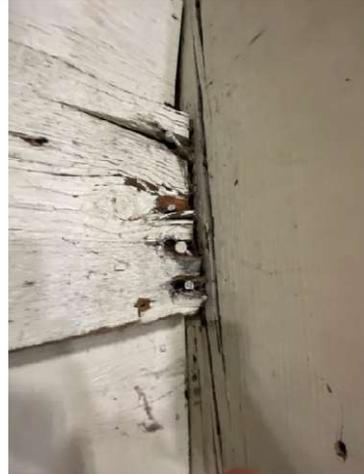
Photo 44: Strut to column connection.

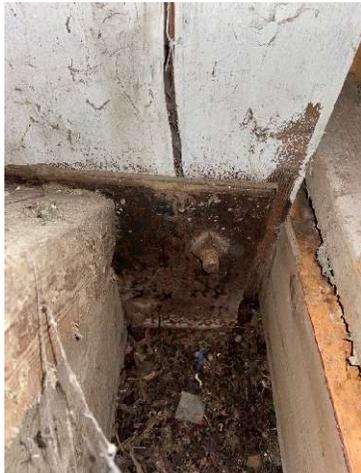
<p>Photo 45.2 Typical end split at base of column.</p>

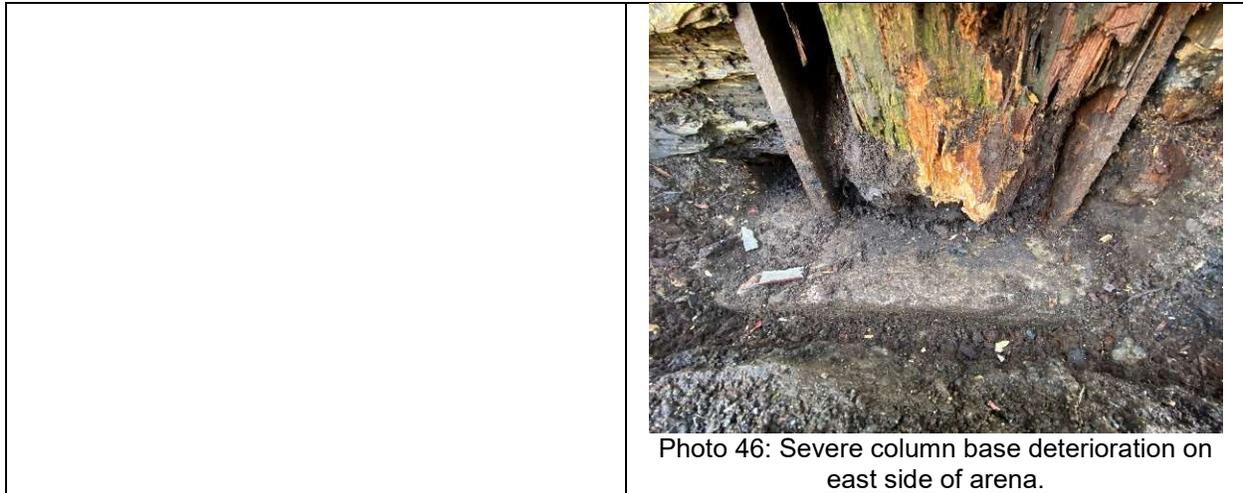
Photo 46: Severe column base deterioration on east side of arena.

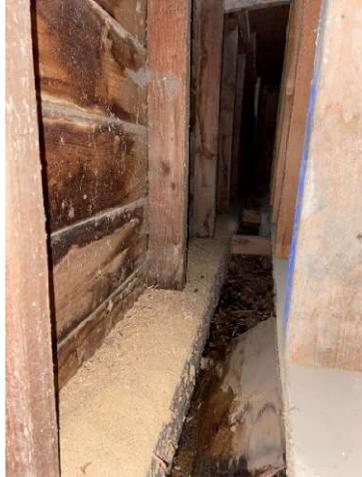
<p>Photo 48: Typical infill studwall framing seen on left, bearing on bottom strut, partially below grade. Studs clad with horizontal lap siding. No sill plate observed. Moisture staining throughout.</p>

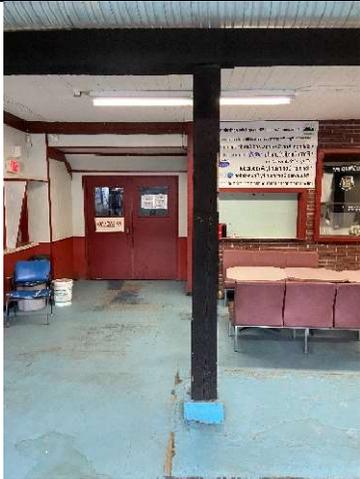
<p>Photo 49: East addition beam and column roof supports.</p>

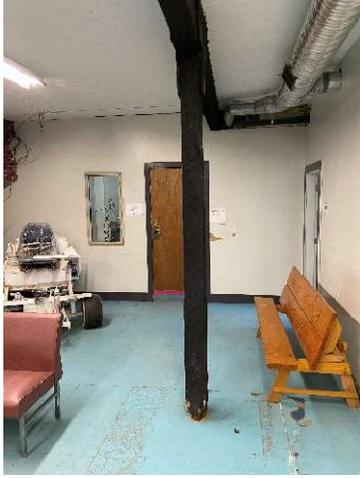
<p>Photo 50: East addition south column with mechanical damage at base.</p>

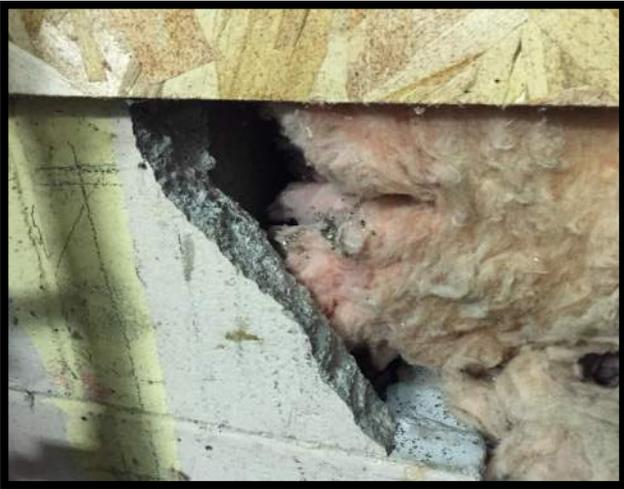
Damage to cinderblock walls allowing the accumulation of asbestos-containing vermiculite insulation debris in the Back Storage (Loc. 17).

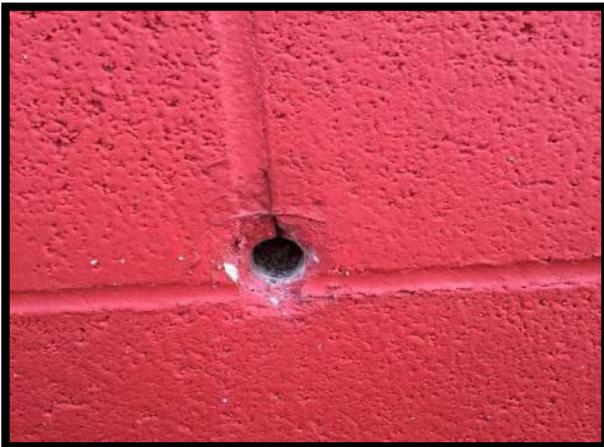
Damage to cinderblock walls allowing the accumulation of asbestos-containing vermiculite insulation debris on the Exterior of the Building.

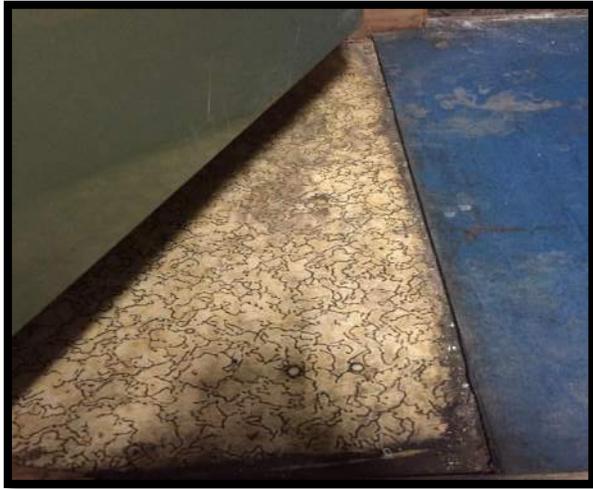
The paper backing applied to the yellow vinyl sheet flooring within the kitchen (Loc.7) is asbestos-containing

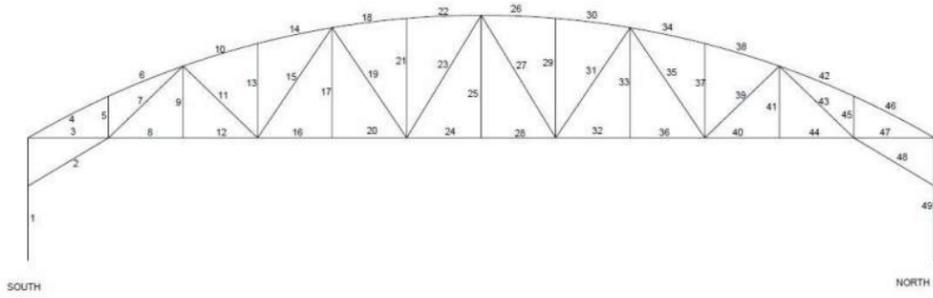
Truss:	A	Date: Feb 26	Inspector: CT / JF			
Member	Face (E/W)	Size (w"x d")	Splits	Checks	Delamination	Notes
1	East	10 x 16	Fail @ Bottom			
1	West	10 x 16	Fail @ Bottom	Checking (15mmx100mm)		
2	East	2 x 6				
2	West	2 x 6				
3	East	6-ply glulam, 5" x 9.75"		Lamination 6		
3	West	6-ply glulam, 5" x 9.75"		Lamination 6		
4	East	9-ply glulam, 5" x 14.625"				
4	West	9-ply glulam, 5" x 14.625"				
5	East	2 x 8	Fail @ bottom			
5	West	2 x 8		Checking		
6	East	9-ply glulam, 5" x 14.625"				
6	West	9-ply glulam, 5" x 14.625"				
7	East	2 x 6				
7	West	2 x 6				
8	East	6-ply glulam, 5" x 9.75"		Lamination 6		
8	West	6-ply glulam, 5" x 9.75"		Lamination 6		
9	East	Tension tie (gable) Null (non gable)				
9	West	Tension tie (gable) Null (non gable)				
10	East	9-ply glulam, 5" x 14.625"				
10	West	9-ply glulam, 5" x 14.625"				
11	East	2 x 6				water staining, no rot
11	West	2 x 6	Fail @ bottom			
12	East	6-ply glulam, 5" x 9.75"		Lamination 6

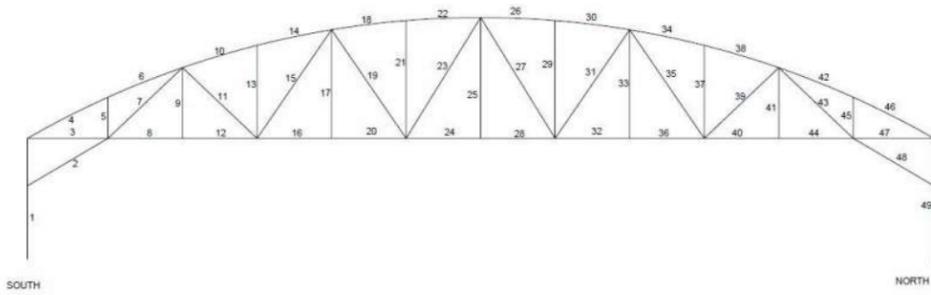
Truss:	B	Date: Feb 26	Inspector: CT / JF			
Member	East/West	Size (wxd)	Splits	Checks	Delamination	Notes
1	East	10 x 16 post	Fail @ bottom	Checking (8mmx75mm)		Top of post is 1" north of bottom
1	West	10 x 16 post	Fail @ bottom	Checking (8mmx75mm)		Top of post is 1" north of bottom
2	East	2 x 6				
2	West	2 x 6				
3	East	6ply 5x 10 glulam				
3	West	6ply 5x 10 glulam				
4	East	9ply 5 x 15 glulam				
4	West	9ply 5 x 15 glulam				
5	East	2 x 8				
5	West	2 x 8	Fail @ bottom			
6	East	9ply 5 x 15 glulam				
6	West	9ply 5 x 15 glulam				
7	East	2 x 6				
7	West	2 x 6				
8	East	6ply 5x 10 glulam				
8	West	6ply 5x 10 glulam				
9	East	Tension tie (gable) Null (non gable)				
9	West	Tension tie (gable) Null (non gable)				
10	East	9ply 5 x 15 glulam				
10	West	9ply 5 x 15 glulam				
11	East	2 x 6	Fail @ bottom			
11	West	2 x 6	Fail @ bottom			
12	East	6ply 5x 10 glulam				
12	West	6ply 5x 10 glulam				
13	East	2 x 6	Fail @ bottom

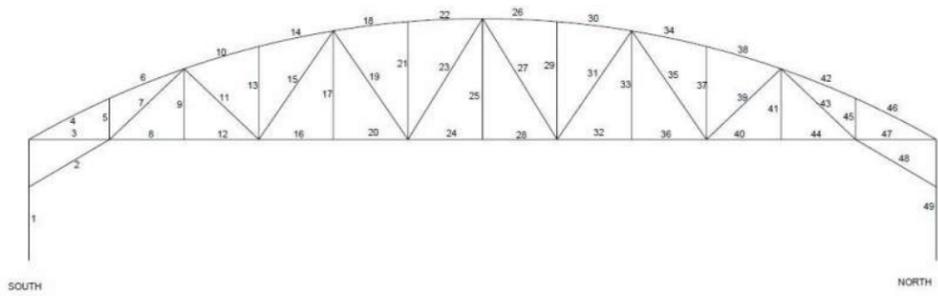
Truss:	C	Date: Feb 27	Inspector: CT / JF			
Member	East/West	Size (wxd)	Splits	Checks	Delamination	Notes
1	East	10 x 16 post	Fail @ bottom	Checking		Top of post is 1" north of bottom
1	West	10 x 16 post	Fail @ bottom			Top of post is 1" north of bottom
2	East	2 x 6				
2	West	2 x 6				
3	East	6ply 5x 10 glulam				
3	West	6ply 5x 10 glulam				
4	East	9ply 5 x 15 glulam				
4	West	9ply 5 x 15 glulam				
5	East	2 x 8	Fail @ bottom			
5	West	2 x 8	Fail @ bottom			
6	East	9ply 5 x 15 glulam				
6	West	9ply 5 x 15 glulam				
7	East	2 x 6	Fail @ bottom , Fail @ top			
7	West	2 x 6				
8	East	6ply 5x 10 glulam				
8	West	6ply 5x 10 glulam				
9	East	Tension tie (gable) Null (non gable)				
9	West	Tension tie (gable) Null (non gable)				
10	East	9ply 5 x 15 glulam				
10	West	9ply 5 x 15 glulam				
11	East	2 x 6	Fail @ top			
11	West	2 x 6	Fail @ bottom	Checking		
12	East	6ply 5x 10 glulam				
12	West	6ply 5x 10 glulam

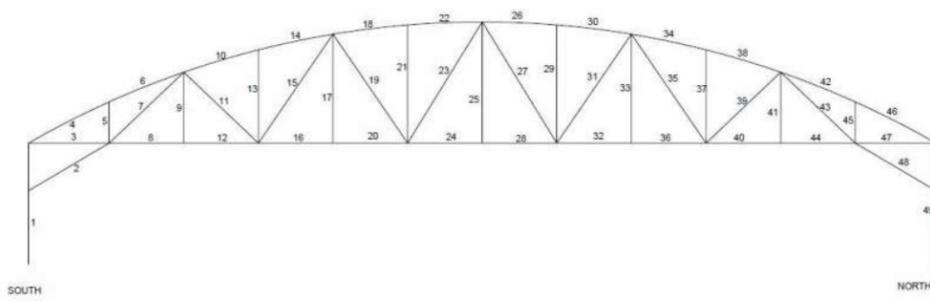
Truss:	D	Date: Feb 27	Inspector: CT / JF			
Member	East/West	Size (wxd)	Splits	Checks	Delamination	Notes
1	East	10 x 16 post				Top of post is 1" north of bottom
1	West	10 x 16 post		Checking (12mmx59mm)		
2	East	2 x 6				
2	West	2 x 6				
3	East	6ply 5x 10 glulam				
3	West	6ply 5x 10 glulam				
4	East	9ply 5 x 15 glulam	Fail @ top, Fail @ bottom			
4	West	9ply 5 x 15 glulam				
5	East	2 x 8				
5	West	2 x 8	Fail @ bottom			
6	East	9ply 5 x 15 glulam				
6	West	9ply 5 x 15 glulam				
7	East	2 x 6	Fail @ bottom			
7	West	2 x 6	Fail @ bottom			
8	East	6ply 5x 10 glulam				
8	West	6ply 5x 10 glulam				
9	East	Tension tie (gable) Null (non gable)				
9	West	Tension tie (gable) Null (non gable)				
10	East	9ply 5 x 15 glulam				
10	West	9ply 5 x 15 glulam		Lamination 8		
11	East	2 x 6	Fail @ bottom			
11	West	2 x 6	Fail @ bottom			
12	East	6ply 5x 10 glulam				
12	West	6ply 5x 10 glulam				
13	East	2 x 6	Fail @ bottom

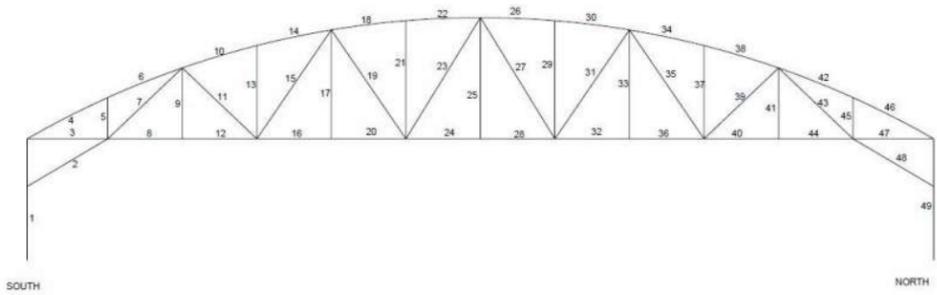
Truss:	E	Date: Feb 27	Inspector: CT / JF			
Member	East/West	Size (wxd)	Splits	Checks	Delamination	Notes
1	East	10 x 16 post				
1	West	10 x 16 post		Checking		
2	East	2 x 6				
2	West	2 x 6				
3	East	6ply 5x 10 glulam				
3	West	6ply 5x 10 glulam				
4	East	9ply 5 x 15 glulam				
4	West	9ply 5 x 15 glulam				
5	East	2 x 8	Fail @ bottom			
5	West	2 x 8	Fail @ bottom, Fail @ top	Checking		split ring exposed
6	East	9ply 5 x 15 glulam				split joist above
6	West	9ply 5 x 15 glulam				
7	East	2 x 6	Fail @ top			
7	West	2 x 6				
8	East	6ply 5x 10 glulam				
8	West	6ply 5x 10 glulam				
9	East	Tension tie (gable) Null (non gable)				
9	West	Tension tie (gable) Null (non gable)				split joist above
10	East	9ply 5 x 15 glulam				
10	West	9ply 5 x 15 glulam				
11	East	2 x 6				
11	West	2 x 6	Fail @ top, Fail @ bottom	Checking		
12	East	6ply 5x 10 glulam				
12	West	6ply 5x 10 glulam				
13	East	2 x 6	Fail @ bottom			
13	West	2 x 6	Fail @ bottom

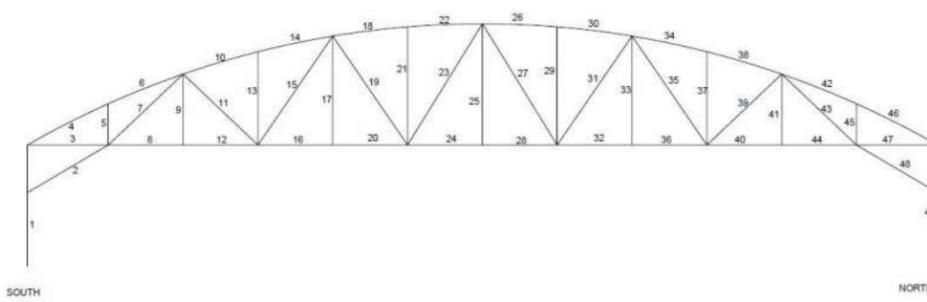
Truss:	F	Date: Feb 28	Inspector: CT / JF			
Member	East/West	Size (wxd)	Splits	Checks	Delamination	Notes
1	East	10 x 16 post		Checking		
1	West	10 x 16 post		Checking (10mmx85mm)		
2	East	2 x 6	Fail @ bottom			
2	West	2 x 6				
3	East	6ply 5x 10 glulam				
3	West	6ply 5x 10 glulam				
4	East	9ply 5 x 15 glulam				
4	West	9ply 5 x 15 glulam				
5	East	2 x 8	Fail @ bottom, Fail @ top			
5	West	2 x 8	Fail @ bottom, Fail @ top			
6	East	9ply 5 x 15 glulam				
6	West	9ply 5 x 15 glulam		Checking near joint w/ 5		split joist near joint w/ 7
7	East	2 x 6				
7	West	2 x 6				
8	East	6ply 5x 10 glulam				
8	West	6ply 5x 10 glulam				
9	East	Tension tie (gable) Null (non gable)				
9	West	Tension tie (gable) Null (non gable)				
10	East	9ply 5 x 15 glulam				
10	West	9ply 5 x 15 glulam				split joist above
11	East	2 x 6	Fail @ bottom, Fail @ top			
11	West	2 x 6				
12	East	6ply 5x 10 glulam		Lamination 6, Lamination 3		
12	West	6ply 5x 10 glulam		Lamination 6, Lamination 3

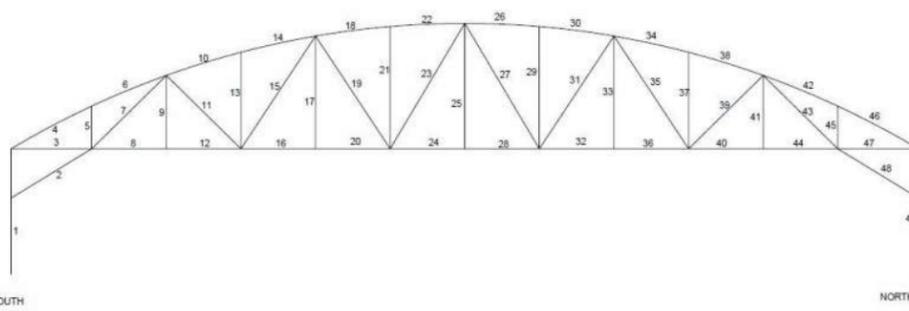
Truss:	G	Date: Feb 28	Inspector: CT / JF			
Member	East/West	Size (wxd)	Splits	Checks	Delamination	Notes
1	East	10 x 16 post	Fail @ bottom	Checking (10mmx75mm)		Top of post is 2" north of bottom
1	West	10 x 16 post	Fail @ bottom			Top of post is 2" north of bottom
2	East	2 x 6	Fail @ bottom			
2	West	2 x 6				
3	East	6ply 5x 10 glulam		Lamination 5, Lamination 2		
3	West	6ply 5x 10 glulam				
4	East	9ply 5 x 15 glulam				
4	West	9ply 5 x 15 glulam				
5	East	2 x 8	Fail @ bottom			
5	West	2 x 8	Fail @ bottom			
6	East	9ply 5 x 15 glulam				
6	West	9ply 5 x 15 glulam				
7	East	2 x 6				
7	West	2 x 6				
8	East	6ply 5x 10 glulam				
8	West	6ply 5x 10 glulam				
9	East	Tension tie (gable) Null (non gable)				
9	West	Tension tie (gable) Null (non gable)				
10	East	9ply 5 x 15 glulam				
10	West	9ply 5 x 15 glulam				
11	East	2 x 6	Fail @ bottom			
11	West	2 x 6	Fail @ top, Fail @ bottom			
12	East	6ply 5x 10 glulam

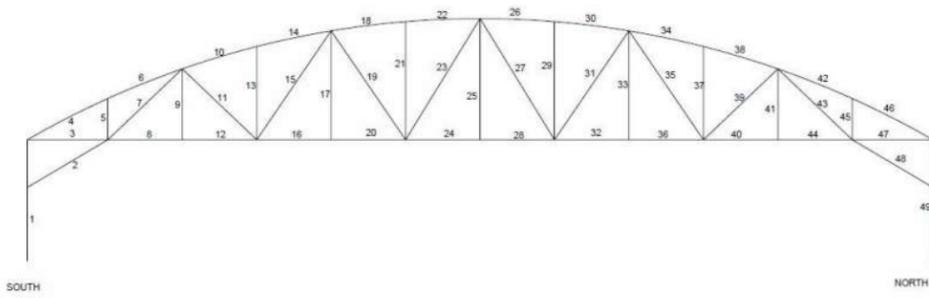
Truss:	H	Date: Feb 28	Inspector: CT / JF			
Member	East/West	Size (wxd)	Splits	Checks	Delamination	Notes
1	East	10 x 16 post	Fail @ bottom	Checking (15mmx100mm)		Top of post is 1" north of bottom
1	West	10 x 16 post	Fail @ bottom	Checking (12mmx50mm)		Top of post is 1" north of bottom
2	East	2 x 6				
2	West	2 x 6	Fail @ top			
3	East	6ply 5x 10 glulam				
3	West	6ply 5x 10 glulam				
4	East	9ply 5 x 15 glulam				
4	West	9ply 5 x 15 glulam				
5	East	2 x 8				
5	West	2 x 8	Fail @ top, Fail @ bottom			
6	East	9ply 5 x 15 glulam				
6	West	9ply 5 x 15 glulam				
7	East	2 x 6				
7	West	2 x 6				
8	East	6ply 5x 10 glulam				
8	West	6ply 5x 10 glulam		Lamination 5 (3mm wide x 40mm deep)		
9	East	Tension tie (gable) Null (non gable)				
9	West	Tension tie (gable) Null (non gable)				
10	East	9ply 5 x 15 glulam				
10	West	9ply 5 x 15 glulam				
11	East	2 x 6				
11	West	2 x 6				
12	East	6ply 5x 10 glulam		Lamination 5

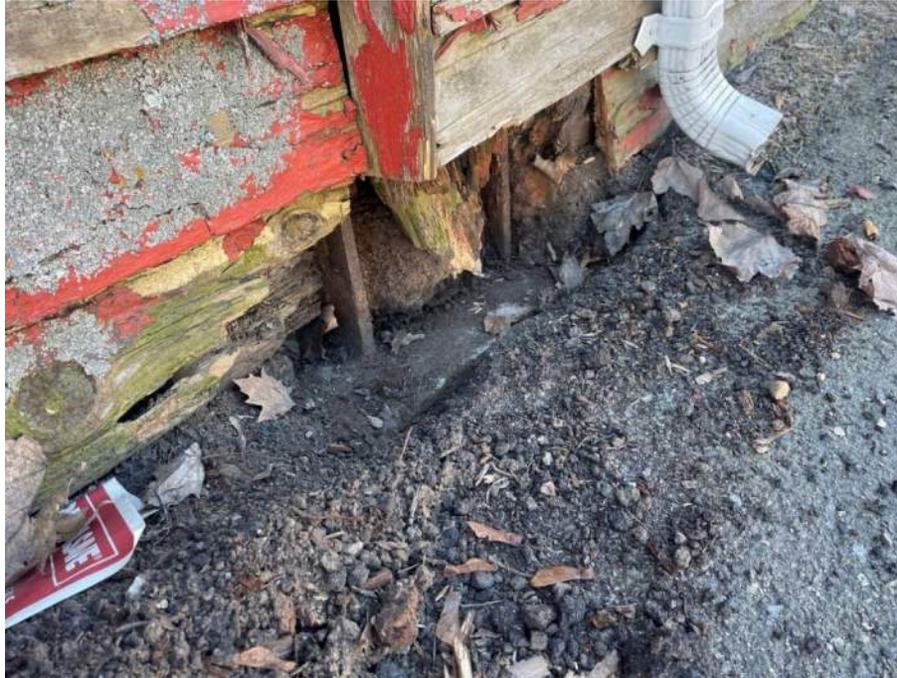
Photograph 9 – Condition of existing footing, column, north wall, closeup.
