**Attn: Darin Gerow**  
**Re: Structural Assessment & Life Cycle Assessment of the Memorial Arena – Final Report**  
**100 - 30th Street SE, Salmon Arm, BC**

# Structural Assessment and Lifecycle Analysis of the Memorial Arena

Final Report

Project No. 24VR-600400

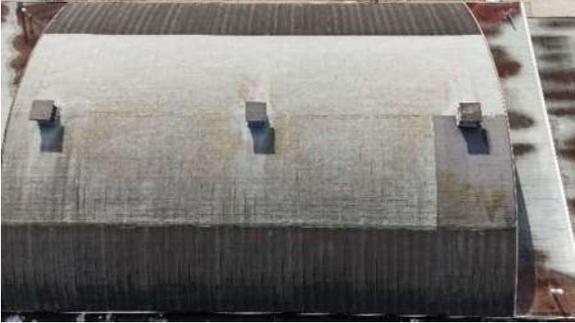
<p>Photo 1: Overview of arched roof area.</p>

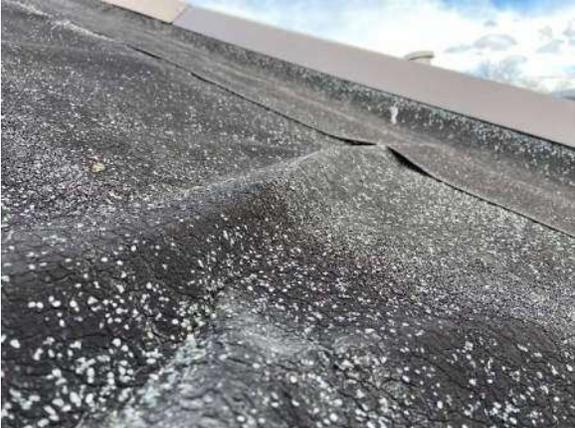
<p>Photo 2: Folded SBS at southwest corner. Note lack of sanded surface.</p> </div>

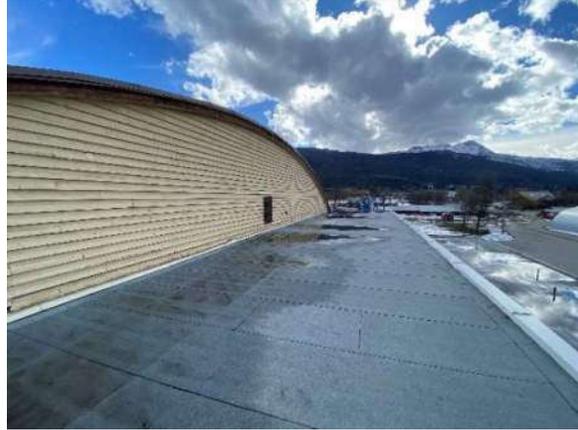
- East and west flat roof areas
  - Roofing appears to be in fair condition. Photo 3 and 4.
  - Sanded surface is intact.
  - End and side laps of roll roofing are intact and watertight.
  - Membrane extends vertically up rake walls, behind gable wall lap siding.
  - Standing water observed in numerous locations as a result of inadequate roof slopes. Photo 3 and 4.
  - 2-3 inches of standing water at the northwest corner of the roof
  - The scuppers are clear of debris.
  - Roof penetrations appear to be adequately sealed.

Photo 3: Flat roof at west end of arena. Ponding water observed.

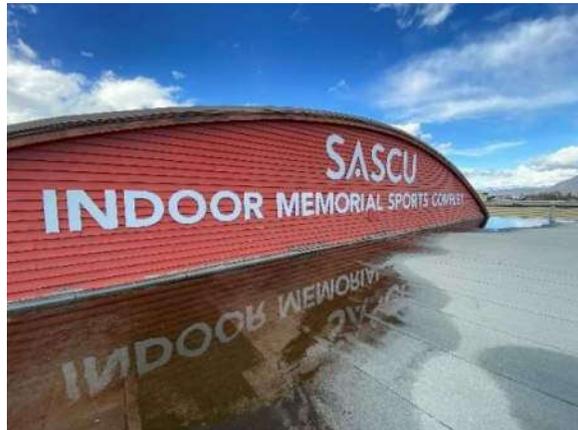
Photo 4: East arena flat roof.

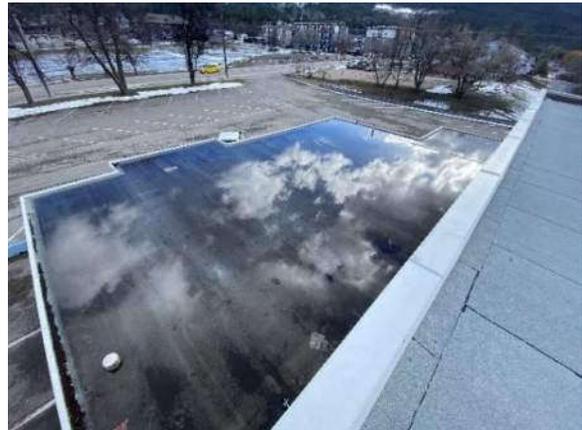
- Roofing is in fair condition.
- Entire lower roof area was flooded at time of review. No leaks apparent within building interior suggesting roofing is watertight. Photo 5.
- Significant staining observed throughout.
- Poor drainage.

Photo 5: East addition lower roof flooded.

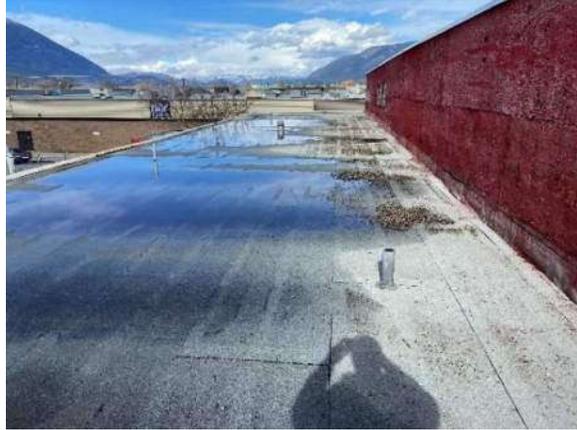
- Roofing appears to be in poor condition. Photo 6.
- Sanded surface is deteriorated and has micro cracking throughout. Photo 7.
- End and side laps of roll roofing are intact and watertight.
- Membrane extends vertically up rake wall and is thermally welded to the painted plywood gable end. Bond failure between the roofing and painted plywood was observed. Photo 7.
- Standing water observed in numerous locations as a result of inadequate roof slopes. Photo 6.
- The scuppers are clear of debris.
- Roof penetrations appear to be adequately sealed.
- Large membrane blisters observed along the rake wall. Photo 7.

Photo 6: West addition upper roof typical condition

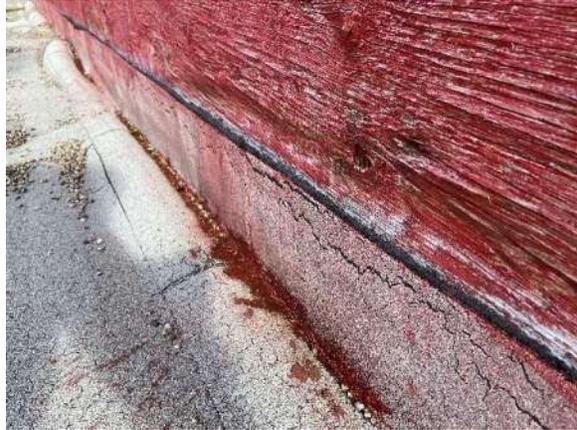
Photo 7: Microcracking, bond failure, and blistering observed.

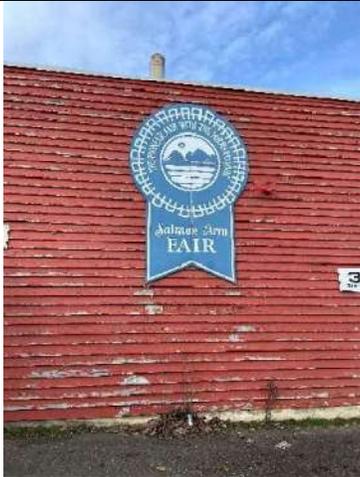
<p>Photo 8: Typical condition of cedar lap siding.</p>

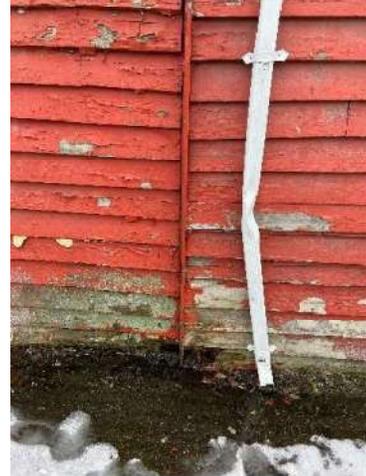
Photo 9: Cedar lap siding severely deteriorated within 48" of grade.

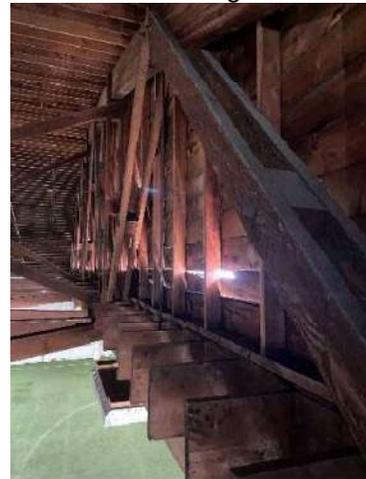
Photo 10: Light entering through cedar lap siding.

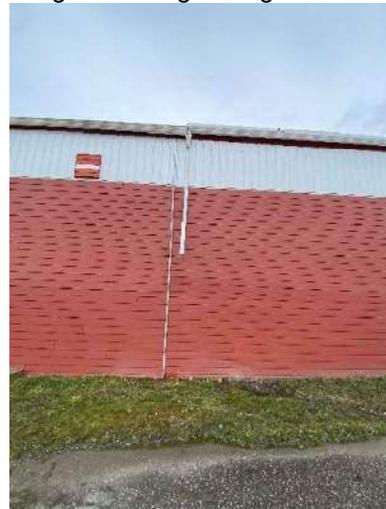
- The Hardi-plank lap siding is limited to the south wall of the arena and extends from grade to approximately within 5 feet of the eave. Photo 11.
- The siding is in fair condition throughout.
- The siding extends to grade along the east end of the arena. The manufacturer requires minimum 6-inch clearance from grade.
- The siding was installed over WRB and OSB sheathing.
- The bottom 6 inches of the OSB sheathing was saturated and has severe deterioration along the east half of the south wall.

Photo 11: Typical condition of Hardi-plank lap siding.

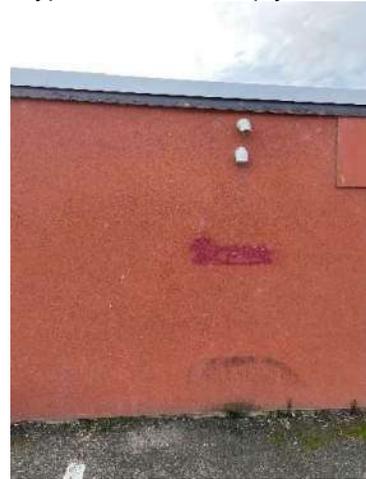
- The stucco siding is limited to the east addition of the building only.
- The stucco appears to be in fair condition with no significant cracking, delamination, or spalling. Photo 14.
- The stucco has a painted finish.

Photo 14: Typical condition of stucco siding.

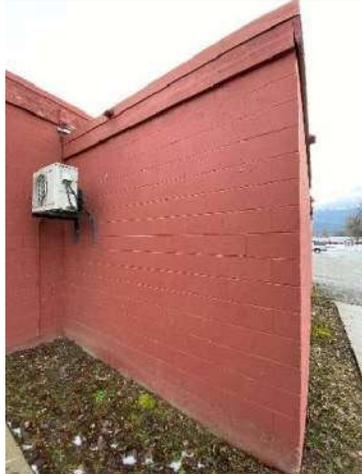
<p>Photo 15: Typical condition of painted CMU.</p>

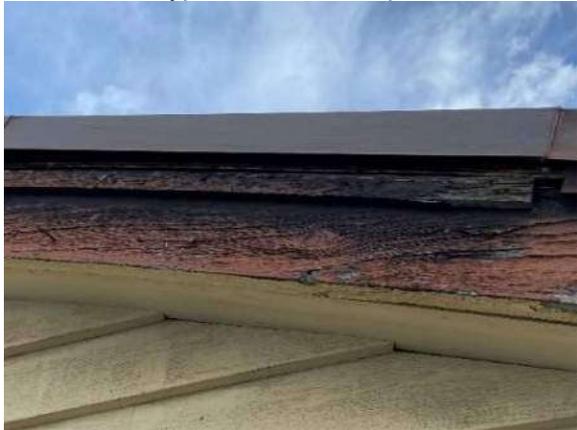
<p>Photo 16: Deterioration present on painted facia board.</p>
--	--

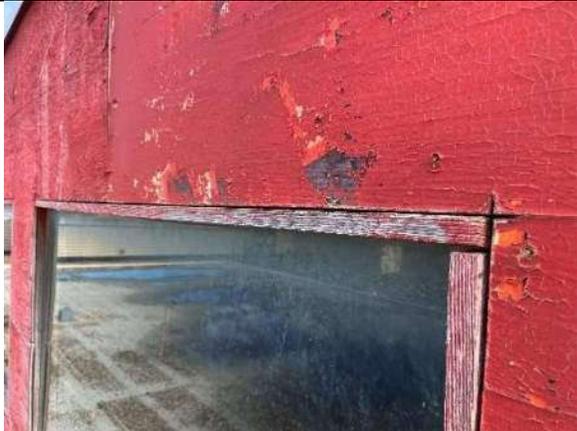
<p>Photo 17: Typical wood window frame condition</p>

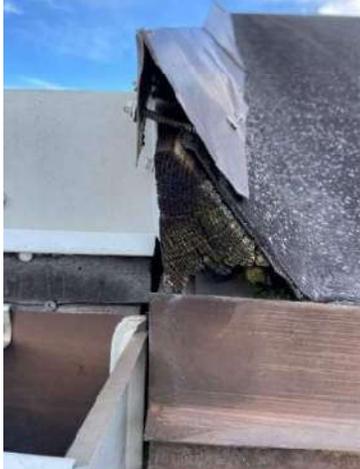
<p>Photo 23: Gable flashing with deteriorated substrate materials</p>

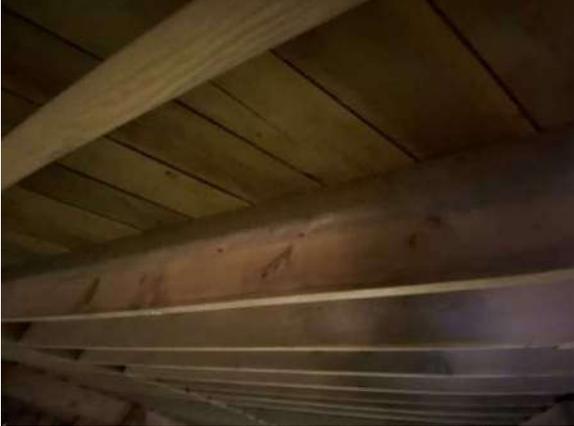
<p>Photo 27: Typical condition of arena roof planking</p>

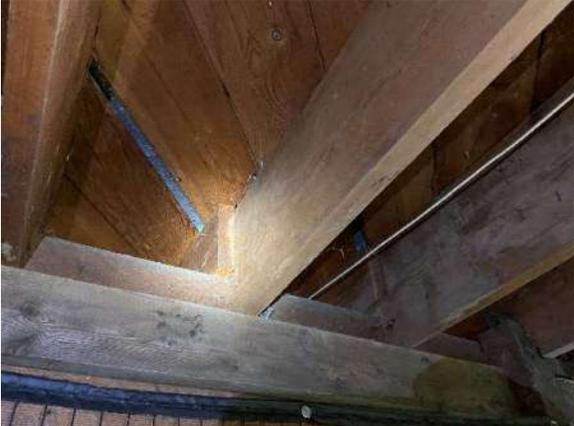
<p>Photo 28: Metal sheathing over gaps in planking.</p>

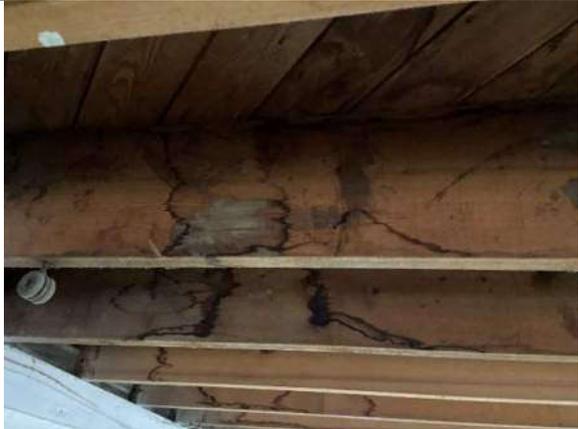
<p style="text-align: center;">Photo 30: Water staining observed on arena rafters.</p>

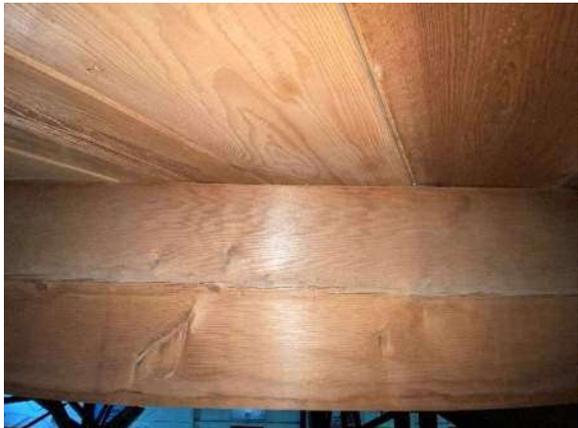
<p style="text-align: center;">Photo 31: Observed splitting in rafter</p>

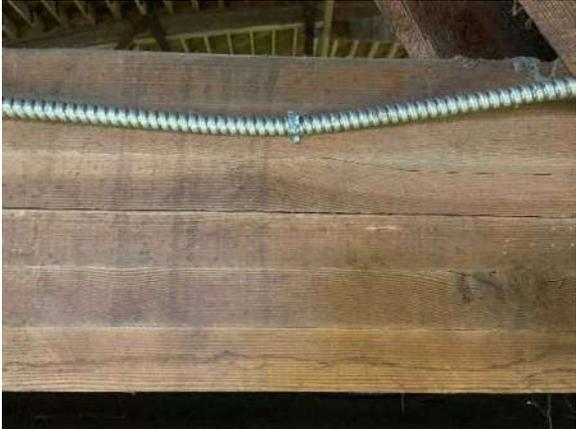
<p>Photo 33: Typical condition of bottom chord. Note minor checking in 3rd lamination.</p>

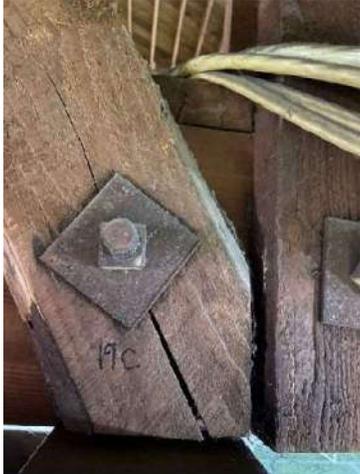
<p>Photo 34: Typical splitting at web to chord connection.</p>

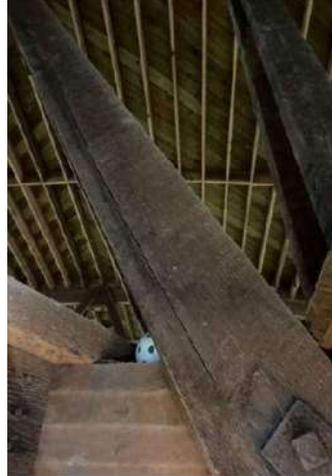
Photo 35: Web member with checking along entire length.

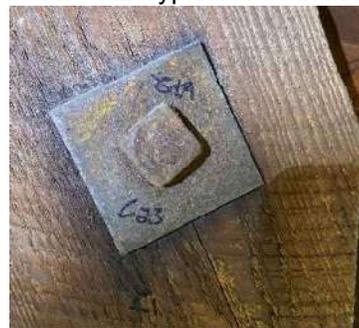
- Surface corrosion on the connection hardware was observed throughout. Photo 39.
- Random connection bolts were removed and assessed. The bolts reviewed are all in good condition. Photo 40.

Photo 39: Typical surface corrosion on connection hardware.

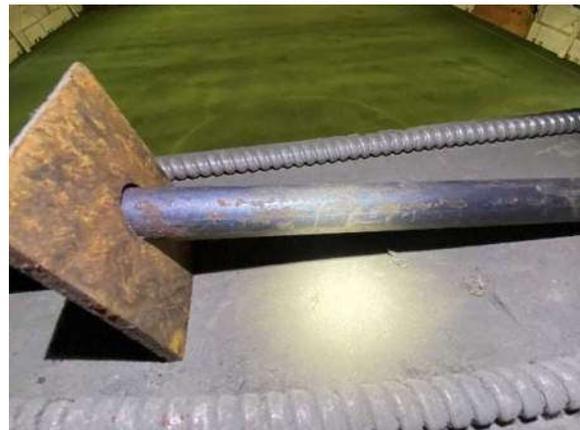
Photo 40: Typical bolt surface corrosion.

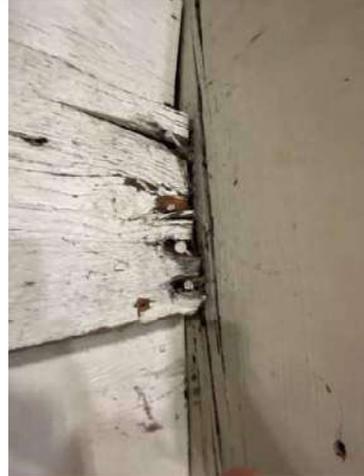
toenail locations and the members are disjointed from one another. Photo 44.

Photo 44: Strut to column connection.

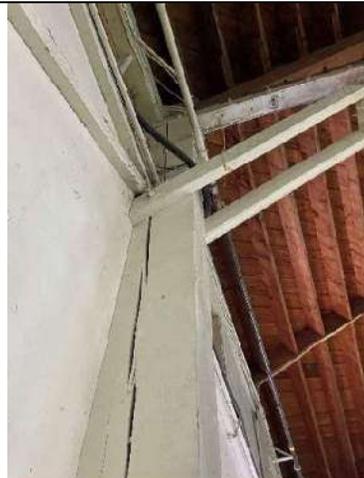
<p>Photo 45.1: Typical arena columns. Checking observed.</p>

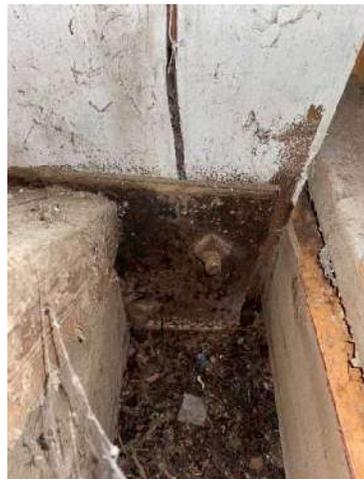
<p>Photo 45.2 Typical end split at base of column.</p>

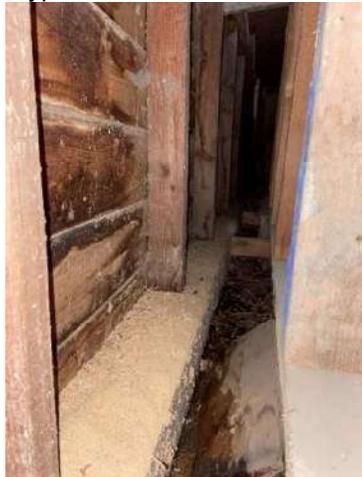
<p>Photo 48: Typical infill studwall framing seen on left, bearing on bottom strut, partially below grade. Studs clad with horizontal lap siding. No sill plate observed. Moisture staining throughout.</p> </div>

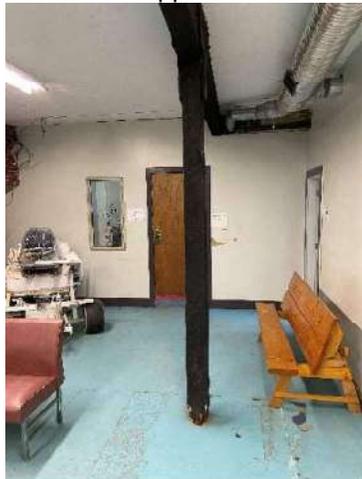
<p>Photo 50: East addition south column with mechanical damage at base.</p>

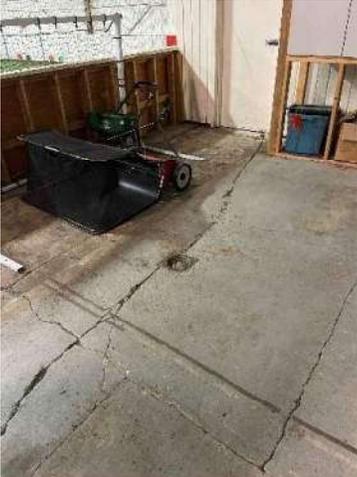
<p>Photo 52: East end of the arena typical slab cracking</p>

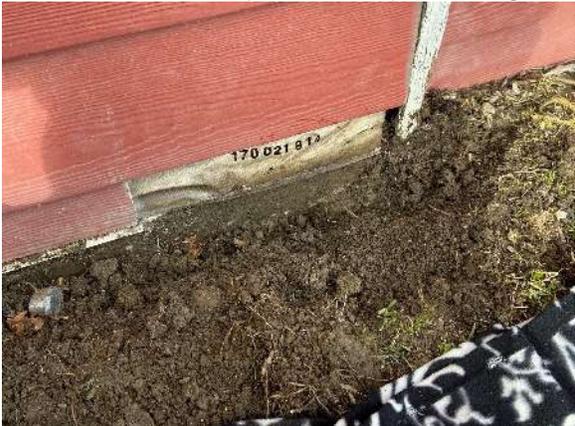
<p>Photo 55: Top of pilaster roughly 4" below grade.</p>
