Attn: Darin Gerow
Re: Structural Assessment & Life Cycle Assessment of the Memorial Arena – Interim Report
100 - 30th Street SE, Salmon Arm, BC

Structural Assessment and Lifecycle Analysis of the Memorial Arena

Interim Report

Project No. 24VR-600400

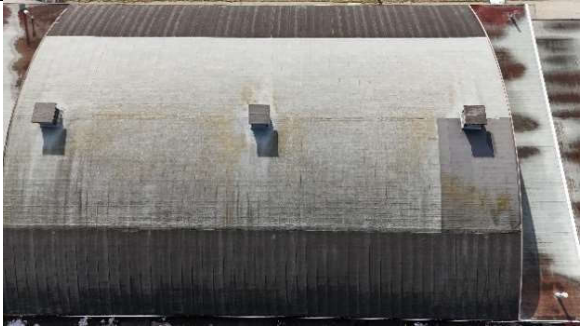
<p>Photo 1: Overview of arched roof area.</p>

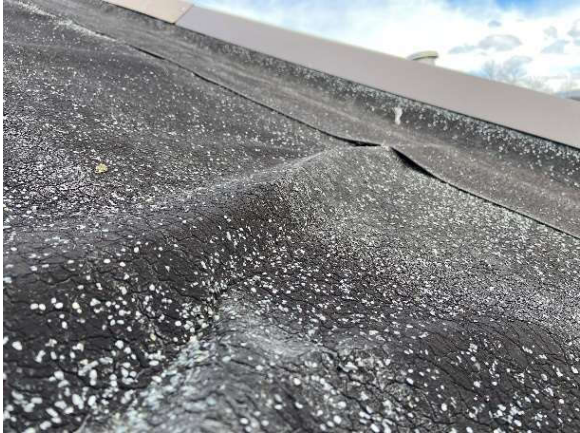
<p>Photo 2: Folded SBS at southwest corner. Note lack of sanded surface.</p> </div>

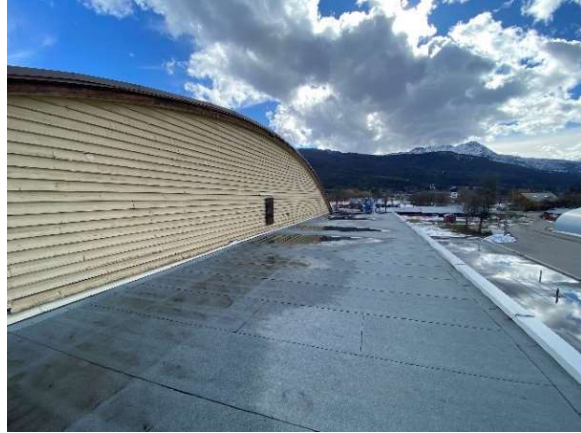
Photo 3: Flat roof at west end of arena. Ponding water observed.

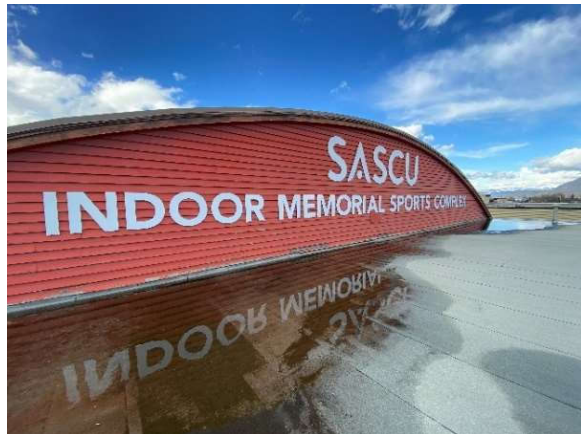
- East and west flat roof areas
 - Roofing appears to be in fair condition. Photo 3 and 4.
 - Sanded surface is intact.
 - End and side laps of roll roofing are intact and watertight.
 - Membrane extends vertically up rake walls, behind gable wall lap siding.
 - Standing water observed in numerous locations as a result of inadequate roof slopes. Photo 3 and 4.
 - 2-3 inches of standing water at the northwest corner of the roof
 - The scuppers are clear of debris.
 - Roof penetrations appear to be adequately sealed.

Photo 4: East arena flat roof.

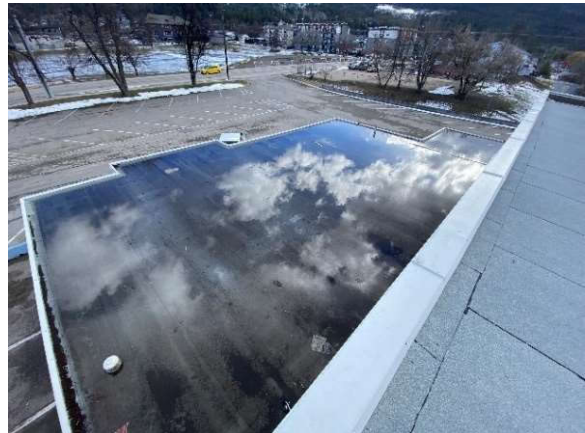
- Roofing is in fair condition.
- Entire lower roof area was flooded at time of review. No leaks apparent within building interior suggesting roofing is watertight. Photo 5.
- Significant staining observed throughout.
- Poor drainage.

Photo 5: East addition lower roof flooded.

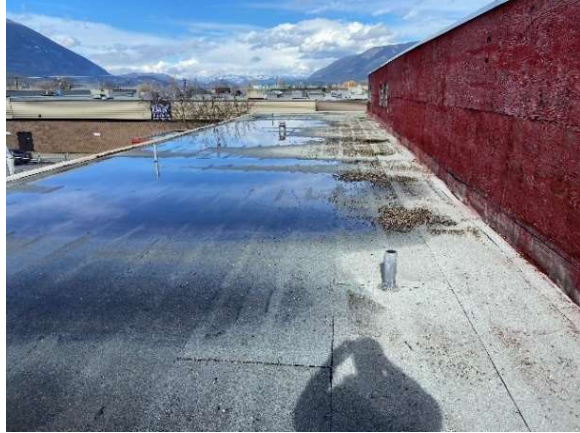
Photo 6: West addition upper roof typical condition

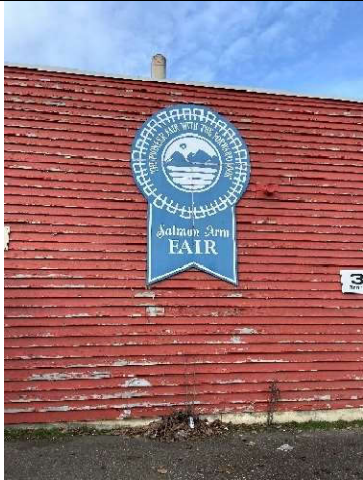
<p>Photo 8: Typical condition of cedar lap siding.</p>

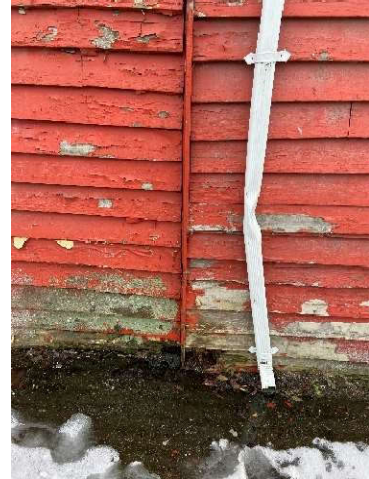
Photo 9: Cedar lap siding severely deteriorated within 48" of grade.

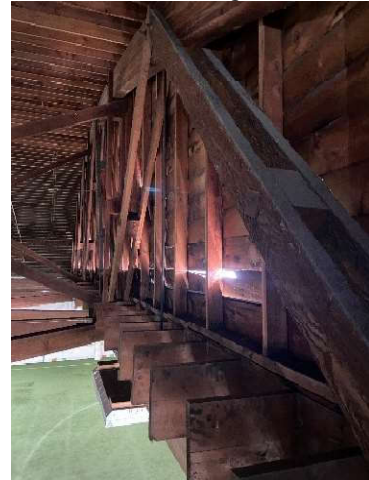
Photo 10: Light entering through cedar lap siding.

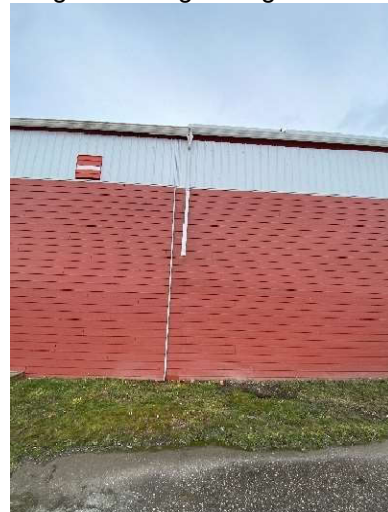
- The Hardi-plank lap siding is limited to the south wall of the arena and extends from grade to approximately within 5 feet of the eave. Photo 11.
- The siding is in fair condition throughout.
- The siding extends to grade along the east end of the arena. The manufacturer requires minimum 6-inch clearance from grade.
- The siding was installed over WRB and OSB sheathing.
- The bottom 6 inches of the OSB sheathing was saturated and has severe deterioration along the east half of the south wall.

Photo 11: Typical condition of Hardi-plank lap siding.

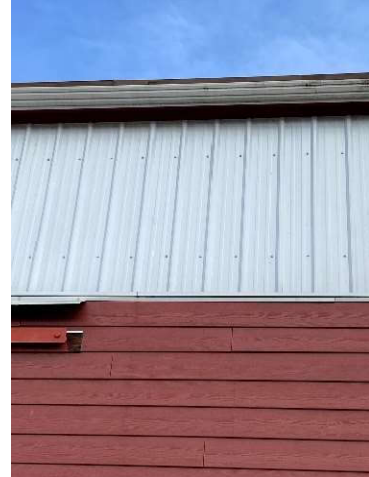
- The vertical metal cladding is limited to the upper 5 feet of the south wall of the arena.
- The metal cladding and associated trims and flashings are in good condition. Photo 12.
- The siding was installed over air barrier and OSB sheathing.

Photo 12: Vertical Metal Siding.

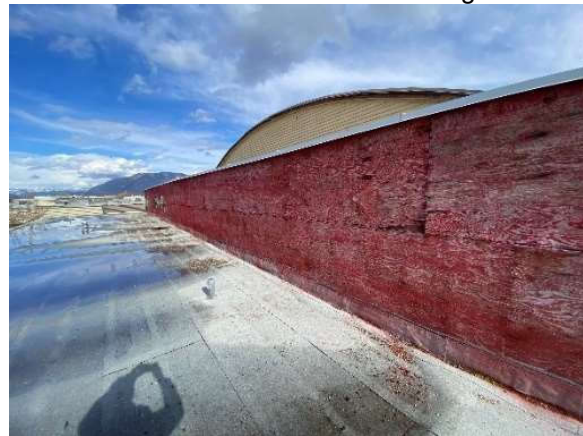
- The west gable of the west addition is finished with painted plywood.
- The plywood is deteriorated and in poor condition. Photo 13.
- The paint is peeling throughout.
- Cut outs in the plywood exposing structural timber and bolted connections were observed.

Photo 13: Typical condition of plywood sheathing.

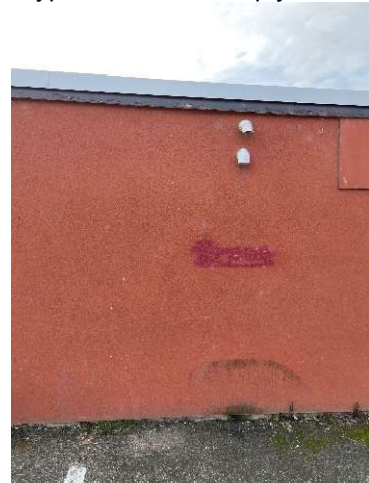
- The stucco siding is limited to the east addition of the building only.
- The stucco appears to be in fair condition with no significant cracking, delamination, or spalling. Photo 14.
- The stucco has a painted finish.

Photo 14: Typical condition of stucco siding.

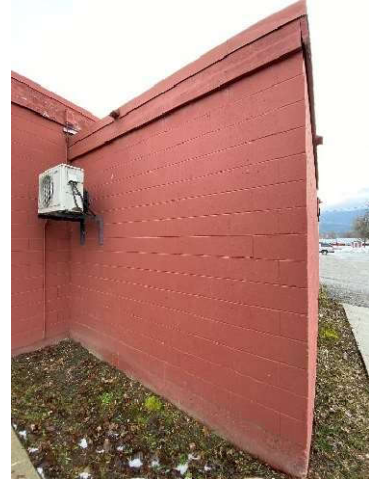
- The west addition is finished with painted CMU.
- The paint is in fair condition throughout. Photo 15.
- Minor impact defects noted in numerous locations.
- Peeling observed near grade.
- The condition of the CMU block is further discussed in the structural condition assessment later in this report.

Photo 15: Typical condition of painted CMU.

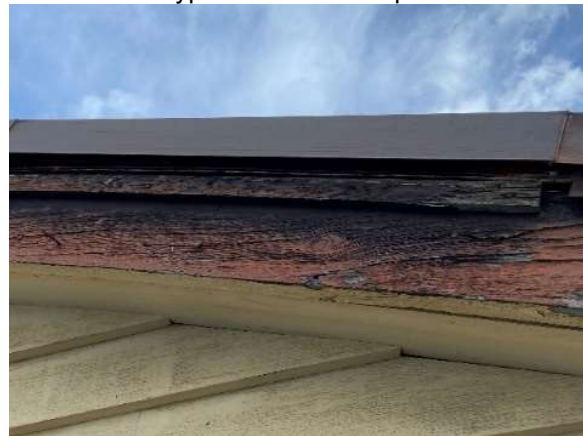
- The soffit and Facia along the gable end of the arena is painted wood.
- The paint is in failed condition and the wood is deteriorated. Photo 16.

Photo 16: Deterioration present on painted facia board.

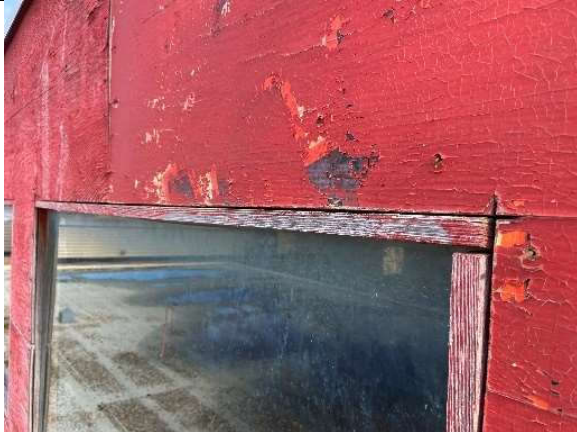
OBSERVATIONS	PHOTOS
<p>Wood Frames</p> <ul style="list-style-type: none">• The exterior windows throughout the arena and the east side of the east addition are wood framed.• The wood frames are deteriorated and in poor condition. Photo 17.• Water staining on the interior side of the window frames suggests water ingress.

<p>Photo 17: Typical wood window frame condition</p>

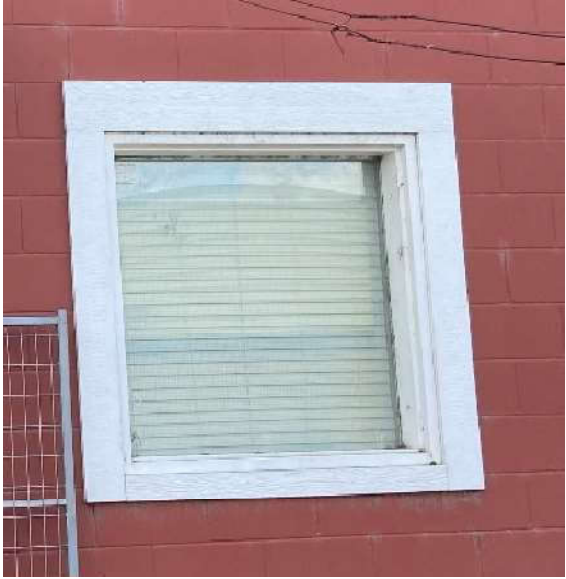
<p>PVC Frames</p> <ul style="list-style-type: none"> • The east and west addition windows are mainly PVC framed. Photo 18. • The frames are in fair condition with the exception of the south window in the east addition which is in poor condition. • The interior windows throughout the building are mainly PVC and are generally in fair condition. <p>Glazing</p> <ul style="list-style-type: none"> • The window glazing throughout the building are single pane and double pane sealed units. • The glazed units in PVC frames are generally in fair condition and well sealed. • The glazed units in wood frames are in poor condition and poorly sealed.

Photo 18: Typical PVC window frame condition

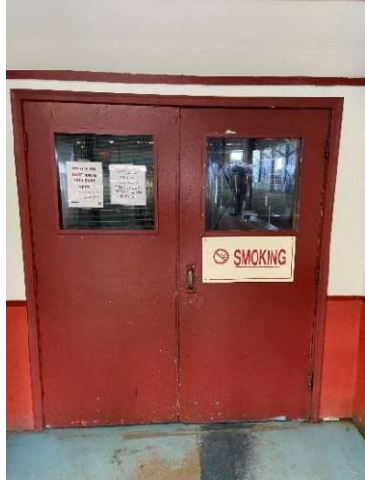
OBSERVATIONS	PHOTOS
<p>Solid Wood</p> <ul style="list-style-type: none"> • The solid wood doors are located sporadically throughout the building interior. The doors are generally in fair condition. Photo 19. • The southwest corner of the wood shop has a sliding wood door. The door is in poor condition and is difficult to operate. • The south wall of the arena has a large exterior barn style sliding door. The door is wood framed with a painted plywood exterior. The paint is peeling, and the wood is deteriorated. The door hardware appears to be in fair condition.

Photo 19: Solid wood door

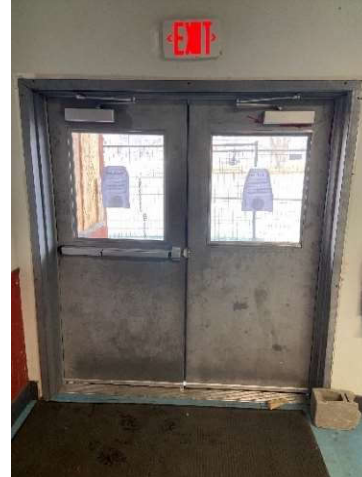
Photo 20: Insulated steel door

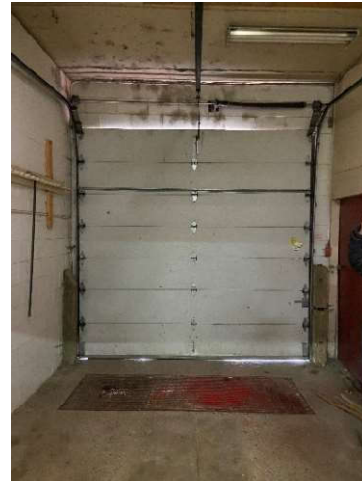
Photo 21: Overhead door

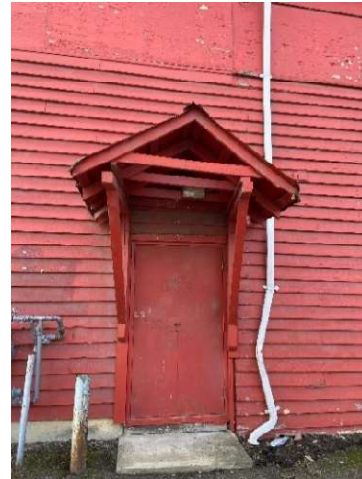
Photo 22: Hollow steel door

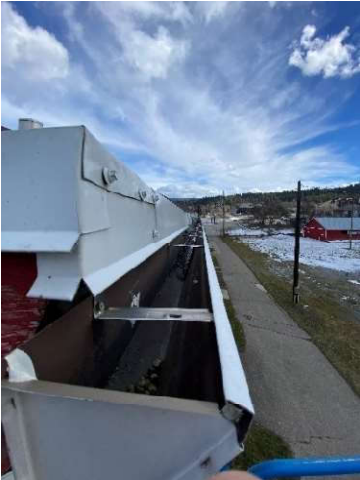
<p>Photo 24: Aluminium gutters and flashing along south arena wall.</p>

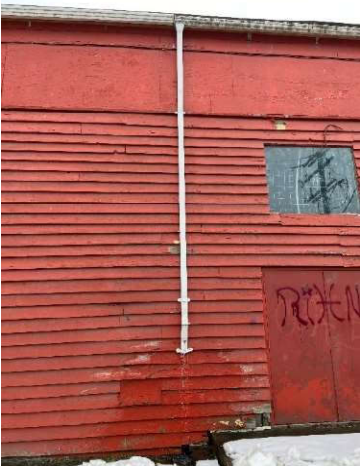
<p>Photo 25: Typical condition of gutter downspouts</p>

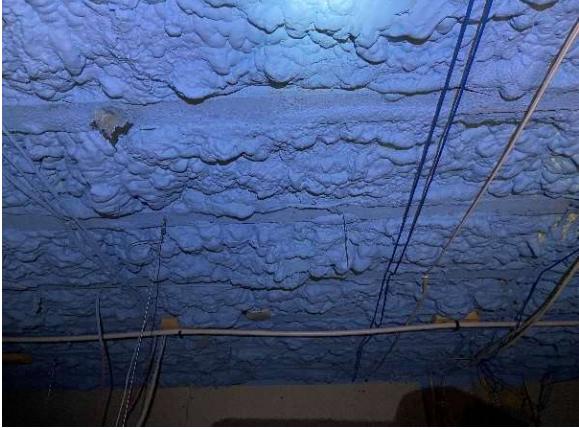
OBSERVATIONS	PHOTOS
<p>Vermiculite</p> <ul style="list-style-type: none"> Based on the background data reviewed the west addition CMU walls are filled with vermiculite insulation. The insulation could not be visually assessed. <p>Fibreglass Batt</p> <ul style="list-style-type: none"> Fibreglass insulation in the rafter bays of the west addition was confirmed, but its condition could not be assessed due to ceiling finishes. The east addition is assumed to have insulation between the roofing membrane and wood decking. Its condition could not be confirmed. The east addition exterior walls are assumed to be insulated with fibreglass batt insulation. Its condition could not be confirmed. <p>Polyurethane Spray Foam</p> <ul style="list-style-type: none"> The rafters above the offices at the northwest corner of the west addition are insulated with polyurethane spray foam insulation. The insulation is in good condition. Photo 26.

<p>Photo 26: Polyurethane spray foam and TJI joists</p>

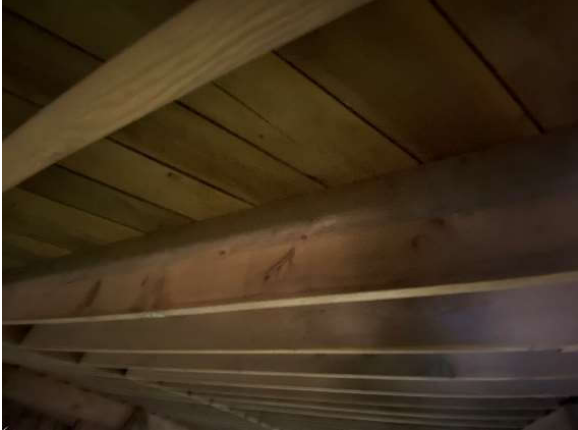
<p>Photo 27: Typical condition of arena roof planking</p>

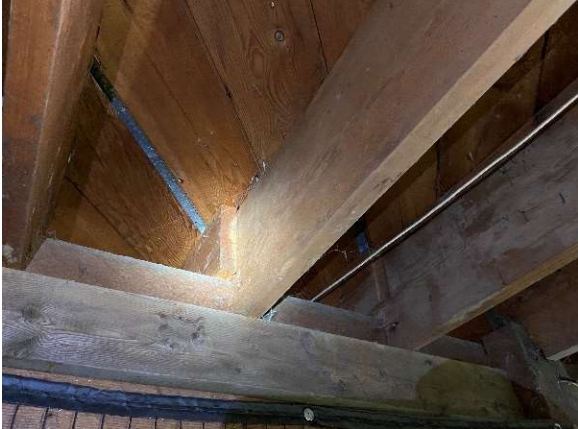
<p>Photo 28: Metal sheathing over gaps in planking.</p>

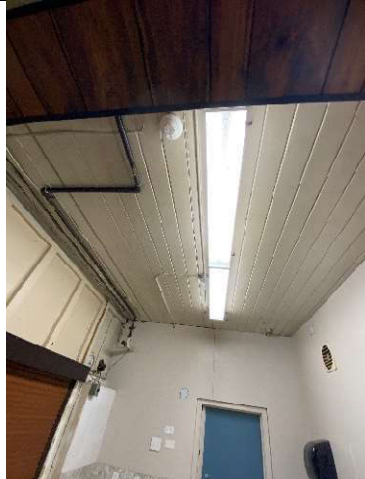
<ul style="list-style-type: none"> • East Addition <ul style="list-style-type: none"> ○ Planking is in fair condition. Photo 29. • West Addition <ul style="list-style-type: none"> ○ The roof decking was not assessed due to roof and ceiling coverings. <p>Plywood Sheathing</p> <ul style="list-style-type: none"> • Plywood sheathing was observed through numerous gaps in the arena roof planking. • The extent and condition of the sheathing could not be observed.

<p>Photo 29: T&G planking, east addition.</p>
---	--

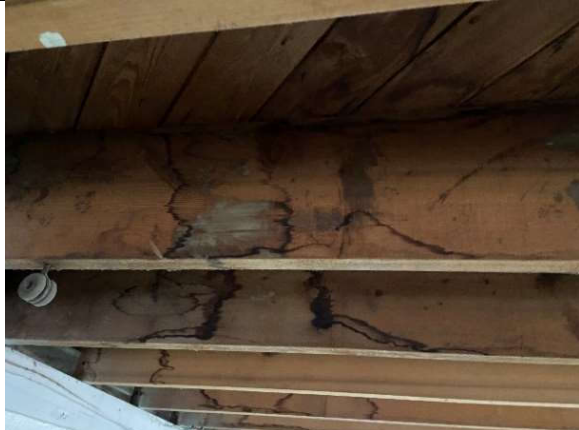
<p>Photo 30: Water staining observed on arena rafters.</p>

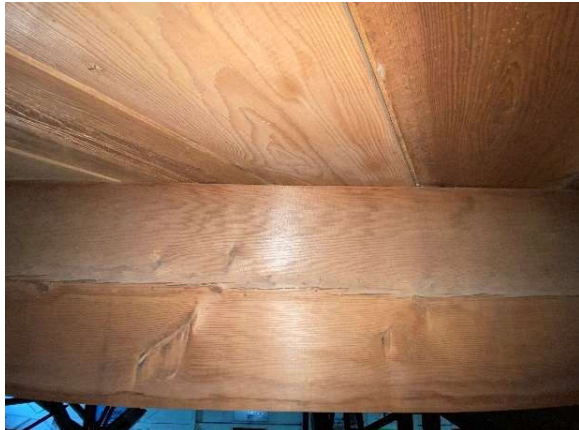
<p>Photo 31: Observed splitting in rafter</p>

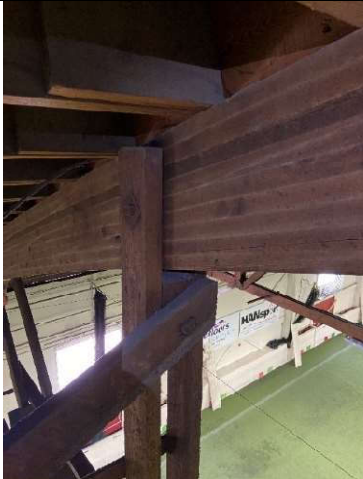
<p>Photo 32: Typical condition of top chord.</p>
<p>Bottom Chord</p> <ul style="list-style-type: none"> The bottom chord of the bowstring trusses are 6 ply 5"x9^{3/4"} glulam members. Photo 33. The bottom chords are generally in good condition. Water/moisture staining was observed throughout, but no signs of decay or rot were observed. Moisture content ranged from 8-10% throughout the arena. No crushing failures at rafter bearing locations were observed. Minor checking was observed on most of the truss bottom chords.

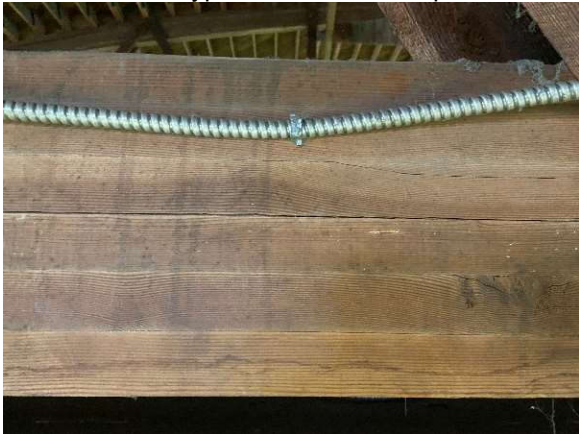
<p>Photo 33: Typical condition of bottom chord. Note minor checking in 3rd lamination.</p>

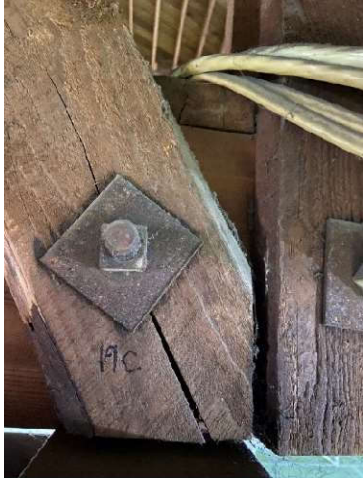
<p>Truss Webs</p> <ul style="list-style-type: none"> The truss webs are rough sawn D. Fir members. Web sizes include 2"x6" and 2"x8" members. Approximately 50% of the webs are in fair condition while the remaining 50% considered failed due to full depth splits at web to chord connections. Photo 34. The truss webs are nominally straight with limited lateral bowing. Approximately 25% of the web members have checking. Photo 35. Moisture content ranged from 8-10% throughout the arena.

<p>Photo 34: Typical splitting at web to chord connection.</p>

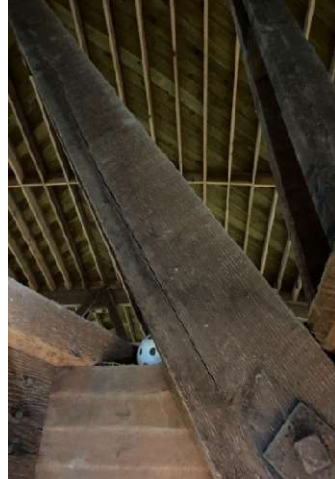
Photo 35: Web member with checking along entire length.

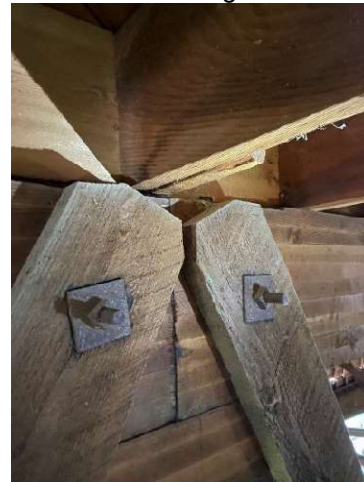
Photo 36: Typical top chord splice.

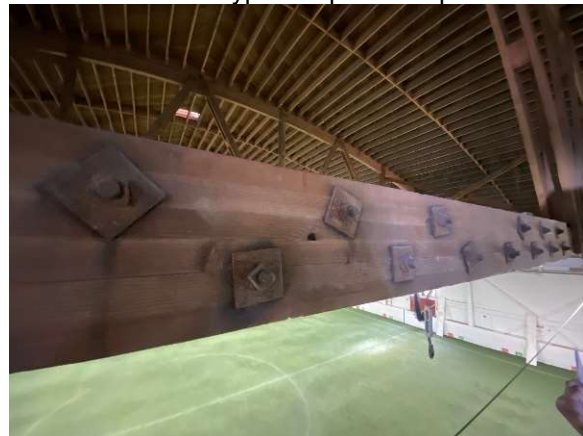
- The bottom chords are spliced at midspan with glulam splice blocks.
- The splice blocks are in good condition. Photo 37.
- Minor checking was observed throughout.

Photo 37: Typical bottom chord splice.

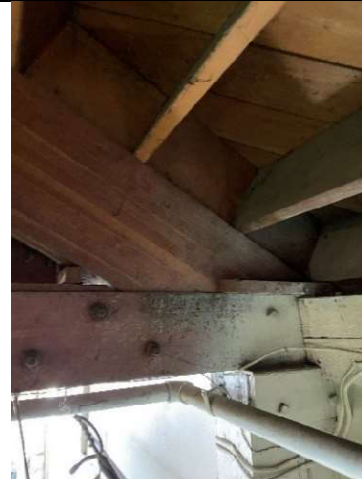
Photo 38.1: Truss bearing plate.

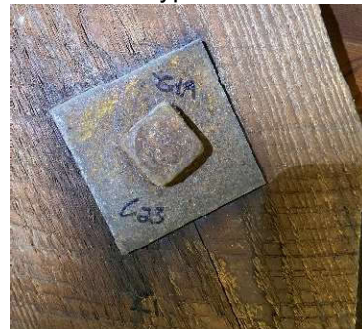
- Surface corrosion on the connection hardware was observed throughout. Photo 39.
- Random connection bolts were removed and assessed. The bolts reviewed are all in good condition. Photo 40.

Photo 39: Typical surface corrosion on connection hardware.

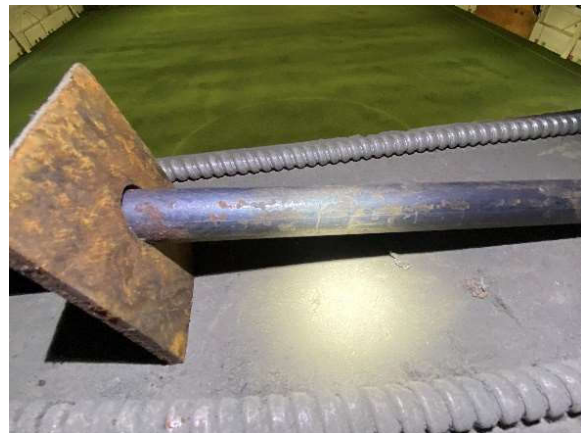
Photo 40: Typical bolt surface corrosion.

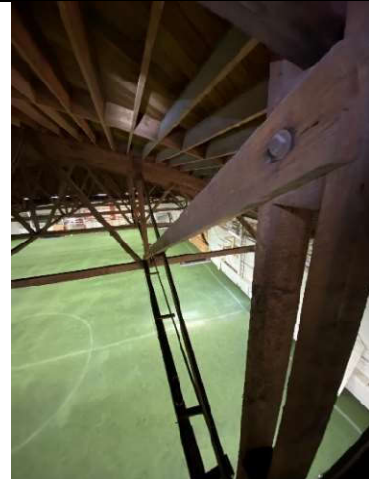
Photo 41: Typical sway bracing.

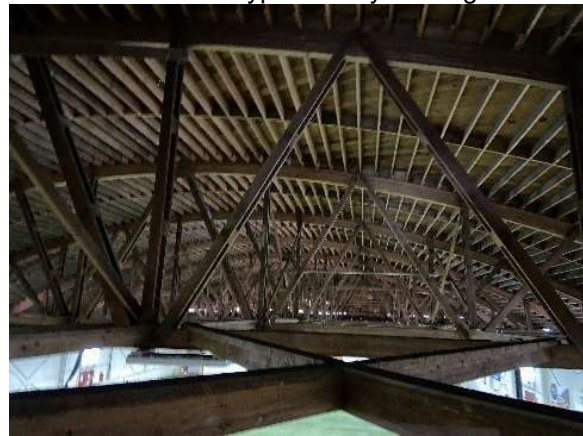
- The bottom chord bracing consists of cross-bracing in the east and west bays and strut braces in the remaining bays.
- The strut braces are in fair condition throughout.
- The cross-bracing in the end bays are in poor condition. Due to their long span, they have sagged 2-3 inches. Photo 42.
- Brace to truss connections are in fair condition with limited splitting.

Photo 42: Typical bottom chord cross bracing.

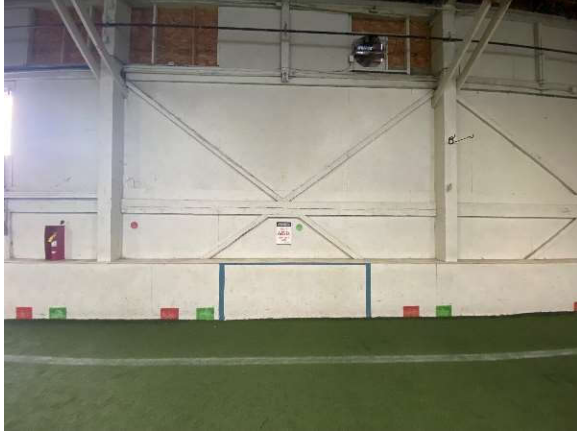
<p>Photo 43: Typical wall struts and bracing.</p>

- The walls of the arena have 4"x6" cross bracing. Photo 43.
- The braces are generally in fair condition.
- Checking was observed throughout.
- Several brace to column and brace to strut connections have failed due to building movement and member twisting and warping.

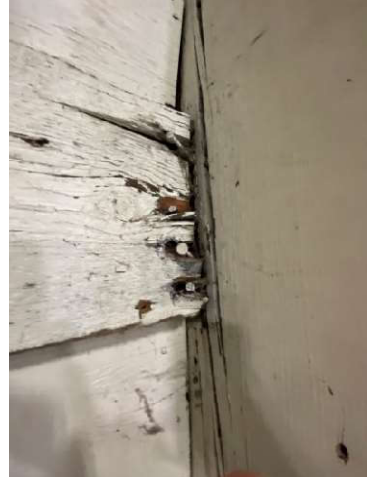
OBSERVATIONS	PHOTOS
<p>Struts</p> <ul style="list-style-type: none">• The struts span between the arena columns and are located at the bottom of the walls, approximately 6 feet above the arena floor, at the knee brace to column connection, and at the top of the walls. Photo 43.• The struts are generally in poor condition.• The struts located at the column bases on the east half of the arena are in failed condition due to severe decay.• Severe checking was observed throughout with checks measuring greater than 1/2" in width and 3" in depth.• Significant warping and twisting was observed throughout.• Strut to column connections have failed in many locations. The wood has split at

toenail locations and the members are disjointed from one another. Photo 44.

Photo 44: Strut to column connection.

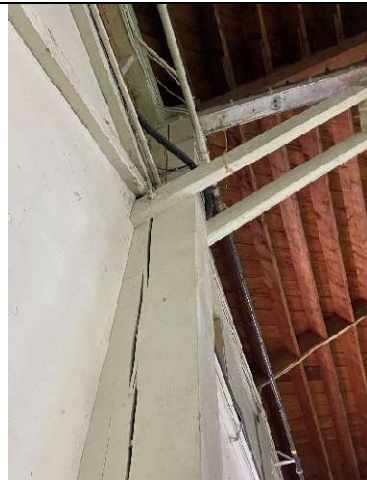
<p>Photo 45.1: Typical arena columns. Checking observed.</p>

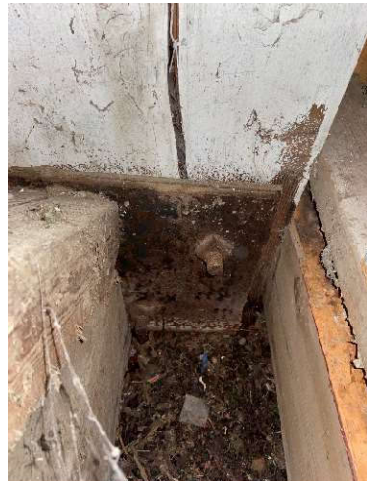
<p>Photo 45.2 Typical end split at base of column.</p>

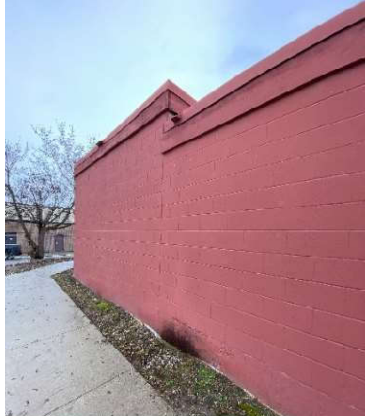
<p>Photo 47: Typical condition of exterior CMU walls.</p> </div> <div style="text-align: center;">

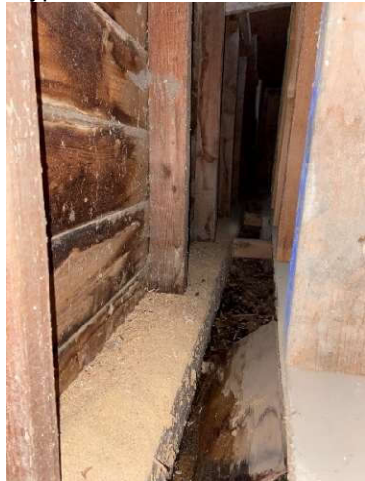
<p>Photo 48: Typical infill studwall framing seen on left, bearing on bottom strut, partially below grade. Studs clad with horizontal lap siding. No sill plate observed. Moisture staining throughout.</p> </div>

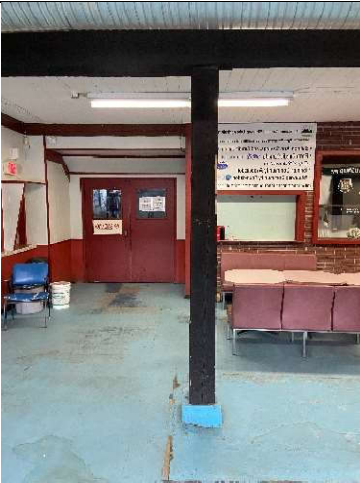
<p>Photo 49: East addition beam and column roof supports.</p>

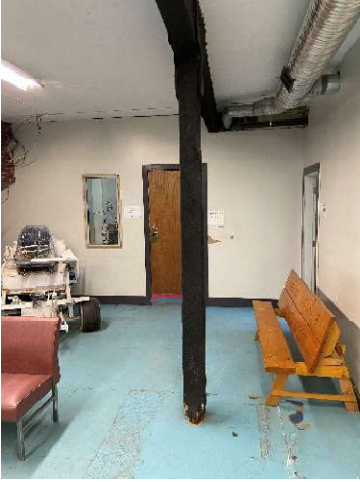
<p>Photo 50: East addition south column with mechanical damage at base.</p>

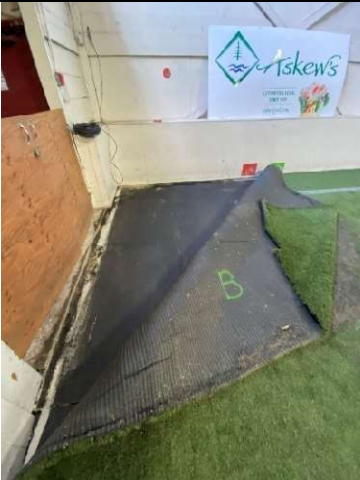
OBSERVATIONS	PHOTOS
<ul style="list-style-type: none"> • The floor slabs are generally in fair condition throughout the building. Photo 51. • Typical shrinkage and temperature cracking was observed throughout. • The concrete slab at the east end of the arena is in poor condition with cracking throughout and differential settlement. Photo 52. • The slabs throughout the east and west additions are nominally level. • The arena slab was surveyed. The slab elevation varies 1.5".

<p>Photo 51: Observed sample section of slab underneath turf.</p>

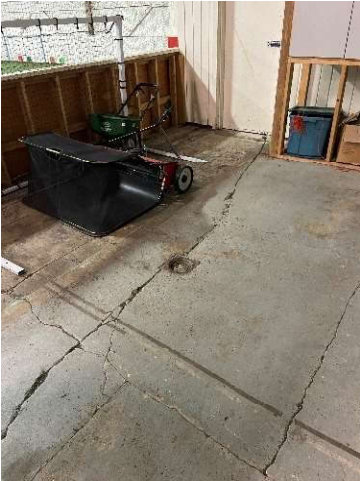
<p>Photo 52: East end of the arena typical slab cracking</p>

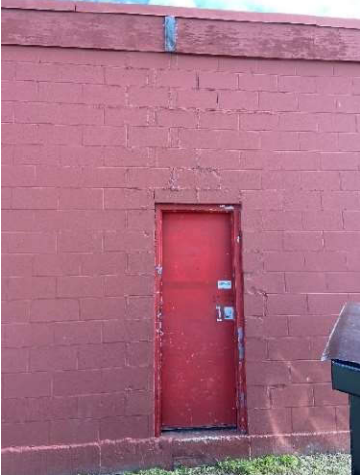
<p>Photo 53: Foundation wall observed at grade.</p>

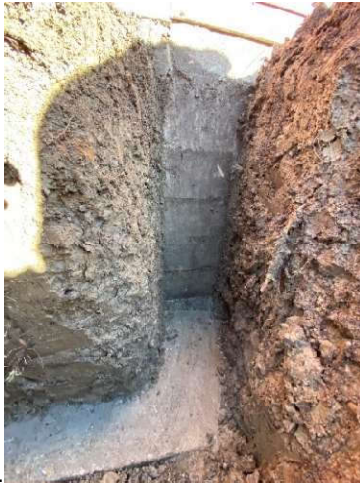
<p>Photo 54: Arena pilaster and pad footing.</p>

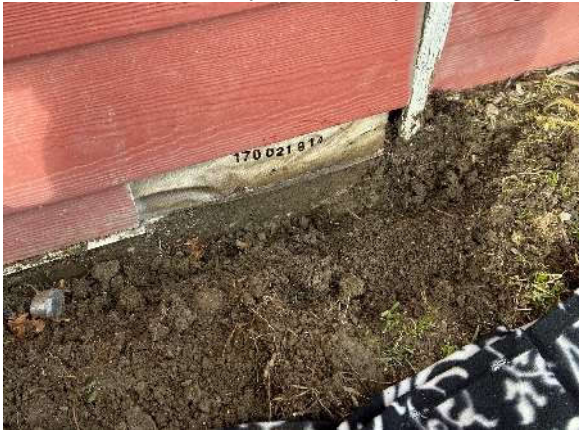
OBSERVATIONS	PHOTOS
<p>East and West Additions</p> <ul style="list-style-type: none">• The additions are assumed to be supported on concrete frost walls and continuous strip footings.• Only the portions of the foundation walls above grade could be observed.• The foundation walls appear to be in fair condition. Photo 53.• No significant signs of differential settlement or cracking were observed. <p>Arena</p> <ul style="list-style-type: none">• The arena foundations consist of concrete pilasters on spread pad footings.• Two pilasters and pads were partially excavated and confirmed to match the original design drawings. The pilaster and pads appeared to be in fair condition. No cracking or signs of instability were observed. Photo 54.• The top surface of the east half of the building pilasters are at or below grade. Photo 55.

<p>Photo 55: Top of pilaster roughly 4" below grade.</p>
