Salmon Arm Recreation Campus Redevelopment Feasibility Study

City of Salmon Arm

Issued: April 2019

Condition Assessment Report

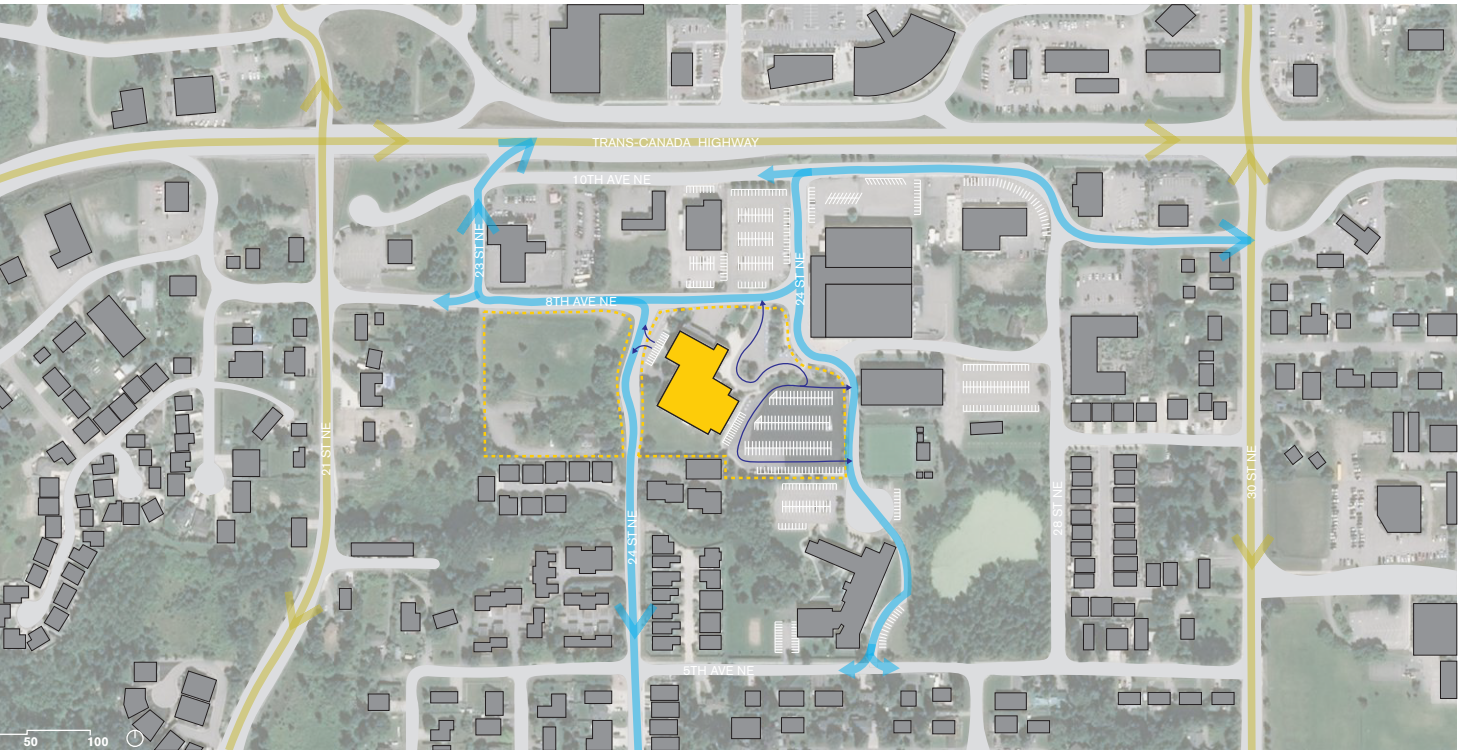
VEHICULAR ACCESS

- Major Arteries
- Site Access
- Parking Loops

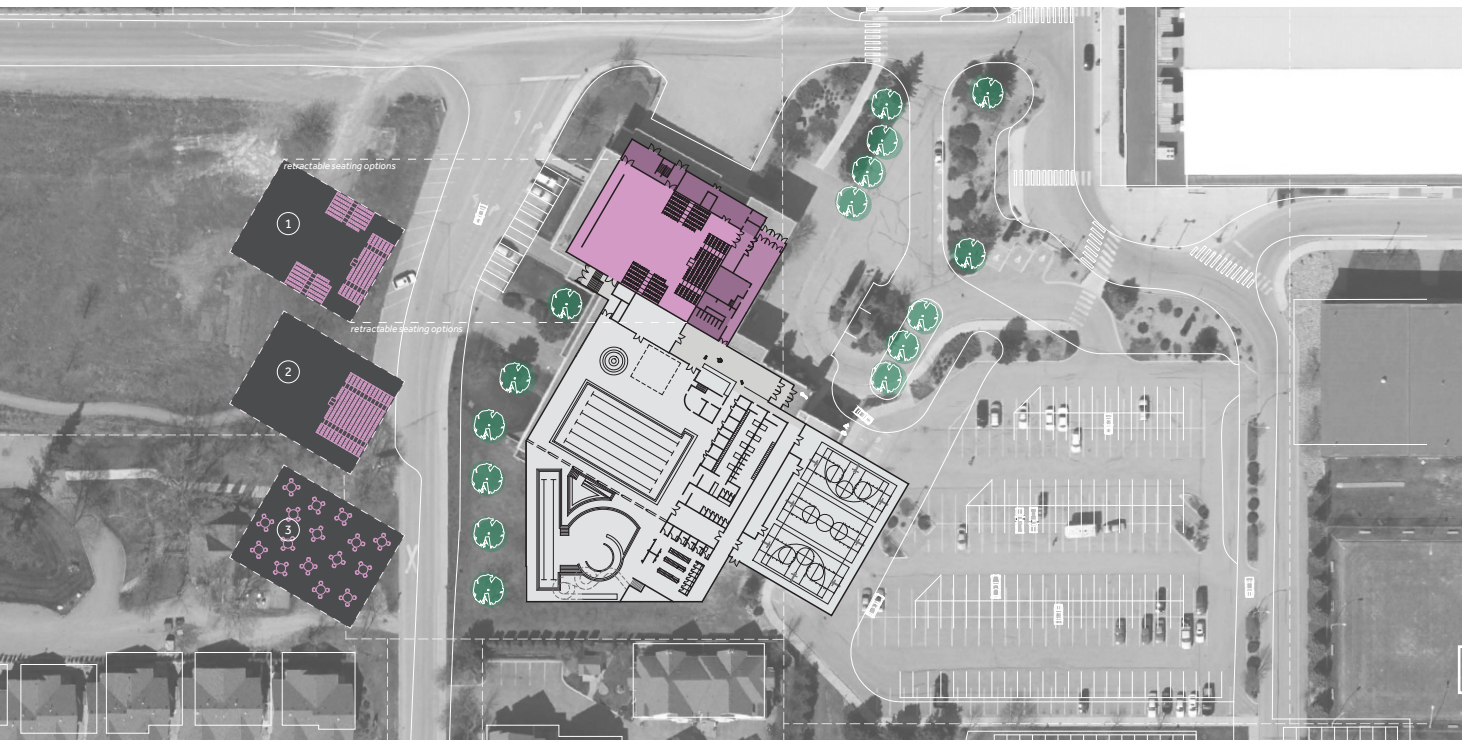
Level 1

- Retractable seating to accommodate 300 people
- Upgraded acoustics
- Theatre drapes
- Lighting grid
- Renovated dressing rooms
- Provide light and sound lock entrances
- Remove existing stage

1) Retractable seating arranged in proscenium configuration

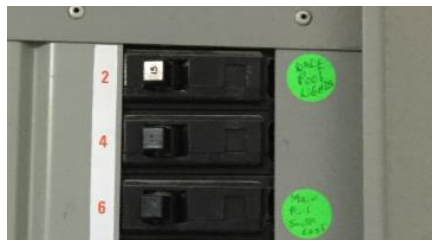
Figure 2: Sample pool lights, not GFCI

It was noted that Breakers for Pool lighting were not GFCI types:

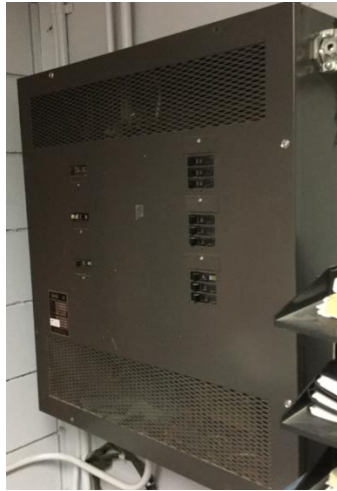
Figure 26: Existing Lighting control panel

There is also a defunct theater lighting control system beside the mezzanine. Interviews with staff revealed that these are no longer in use:

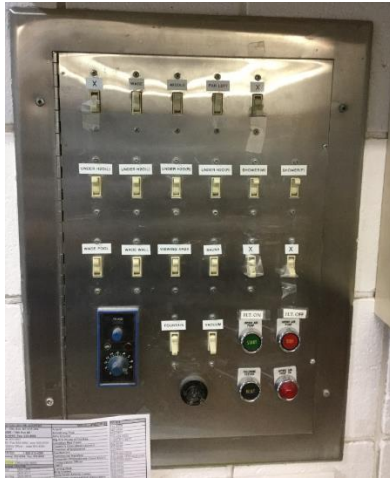
Figure 29: Manual control switch bank

For the pool facility, a manual control switch panel was present in the office:

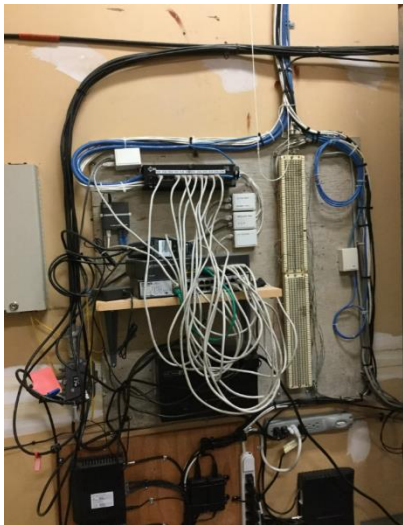
Figure 31: Communications backboard

The communications equipment is mounted on a mm fire rated plywood backboard in the Mezzanine Block B.

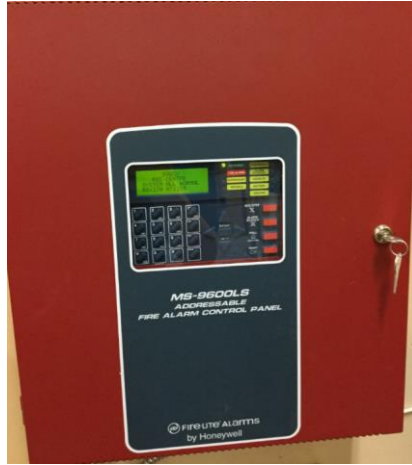
Figure 32: Existing FACP

The existing Fire Alarm Control Panel is a MS-9600LS addressable system by Fire-Lite and is located in Mezzanine Block B.

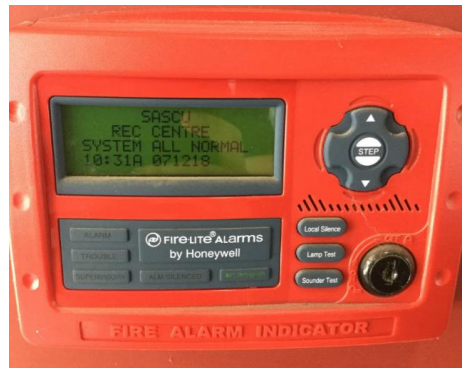
Figure 33: Existing FAAP

There are two Fire Alarm Annunciators located at the exits by the Pool Lobby and Auditorium Lobby.

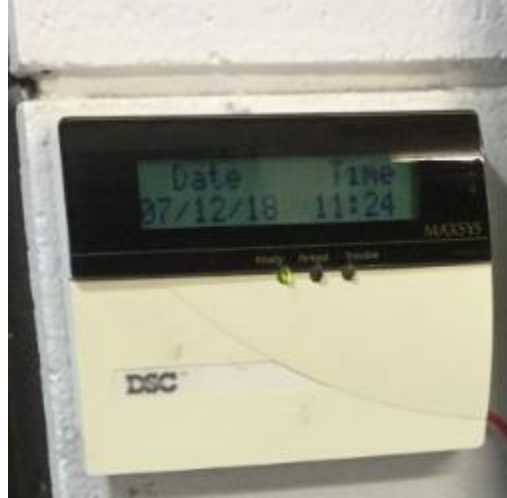
Figure 34: Existing security control panel

A security control panel was also observed in the main office:

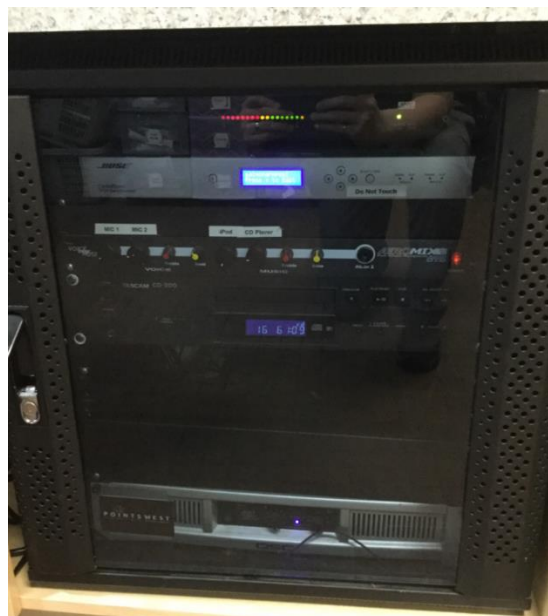
Figure 35: Pool area audio system

There is an existing audio system in both the auditorium and in the pool area:

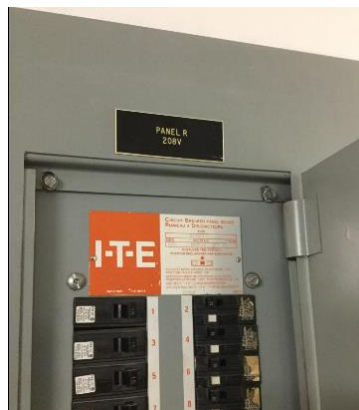
Figure 36: Sample existing panel

- A. Most of the existing panels are ITE panels that take 'BQ' type breakers. Note that the ITE brand has been phased out and is now represented by Siemens. Any breaker replacements should be coordinated for compatibility with Siemens.

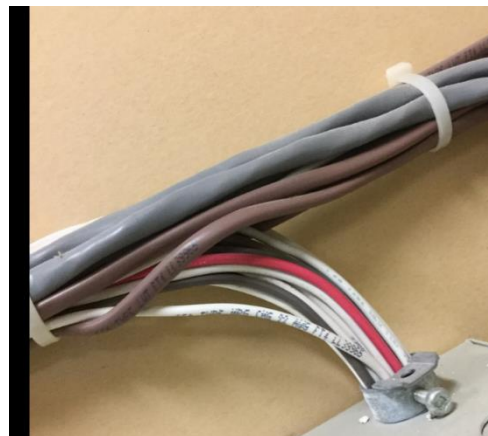
Figure 40: Sample Existing FT4 cable

The existing communications systems are in good condition. Many of the cables, however, were observed to be non-compliant with the BC Building Code's requirement for FT6 cable in plenum spaces.

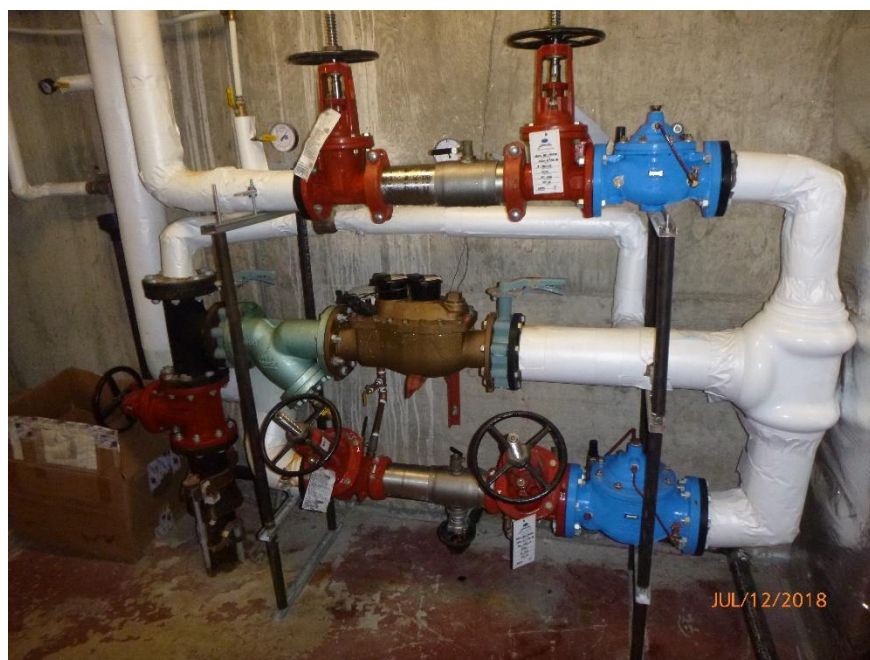
Figure 41 Water Entry Station

The domestic cold water (DCW) is supplied to the building by 100mm DCW main. The DCW main then split into 75mm DCW main and 100mm Pool Make Up. The DCW main is equipped with a supervised DCVA while the Pool Make Up is equipped with an RPBA. Each of the main lines is also equipped with a single PRV.

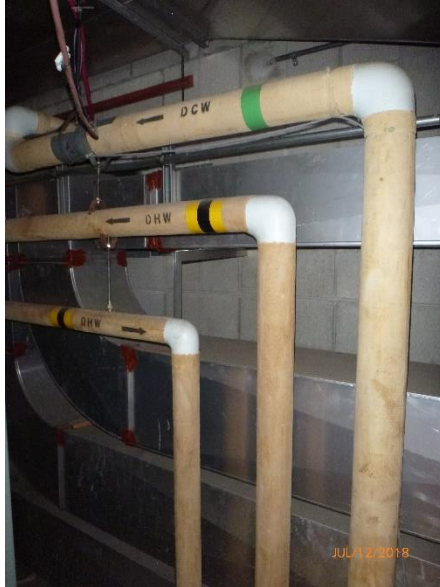
Figure 42 Domestic Water Pipework

The domestic water distribution pipework is made from copper and original to the building (1985). Domestic water copper pipework has a typical service life expectancy of 20 to 35 years.

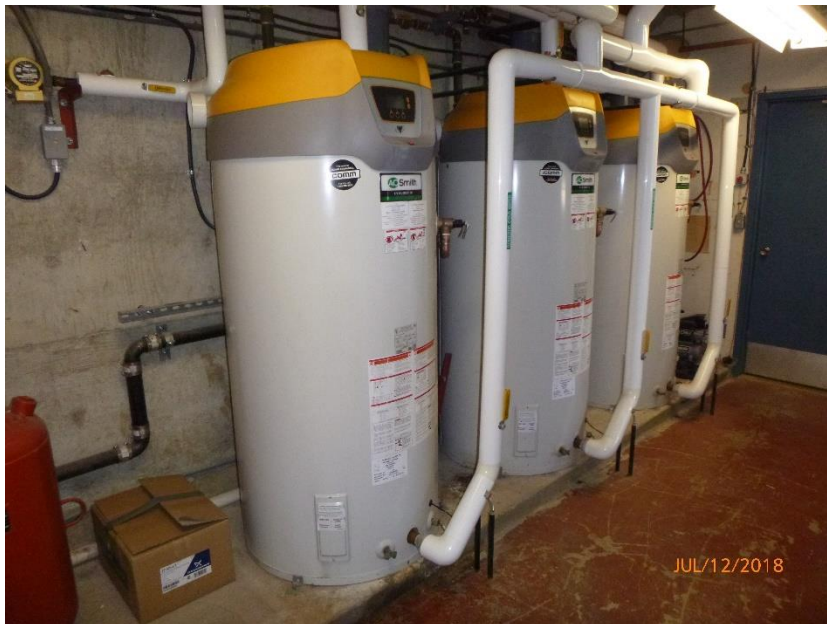
Figure 43 Domestic Hot Water Heaters

The domestic hot water for the building is generated by three AO Smith BTH-500-A (146 kW; 492 L each) gas-fired water heaters. The water heaters are in good condition and were installed in 2013. Gas fired water heaters have a 6 – 10 year service life expectancy.

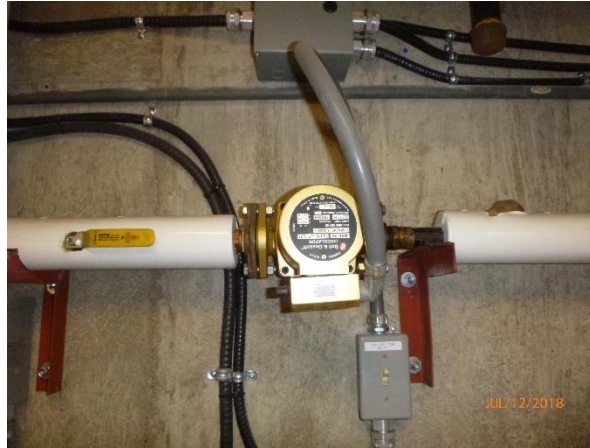
Figure 44 DHWR Pump

The system is also equipped with a Bell & Gosset B601T (0.19kW; 0.95 L/s; 45 kPa) domestic hot water recirculation pump which was installed in 2013. The typical service life of a small inline circulator pump is 10 years.

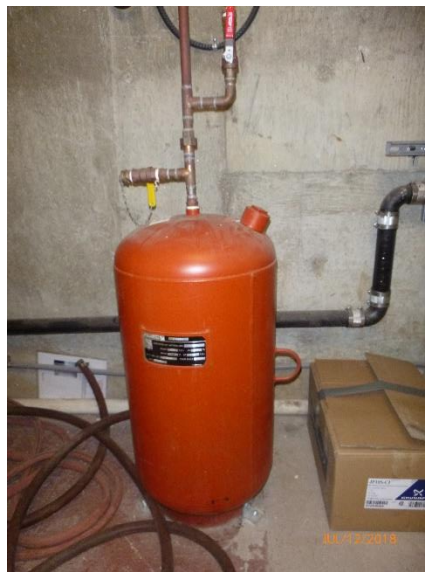
Figure 45 DHW expansion tank

A DHW expansion tank (Amtrol ST-60V-C) is located next to the Hot Water Heater. The tank was installed as part of the DHW system upgrade in 2013. The typical service life expectancy of an expansion tank is 20 years.

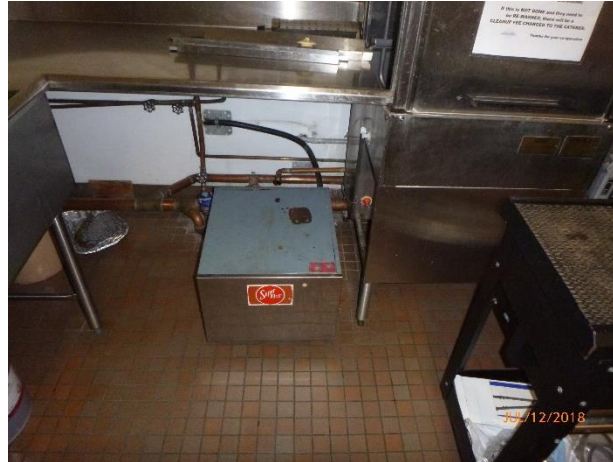
Figure 46 Super Hot 312B

The commercial dishwasher machine at the Auditorium Kitchen is equipped with a 12kW electric domestic hot water heater (Super-Hot 312B)

The typical service life of an electric domestic hot water heater is 10 to 15 years.

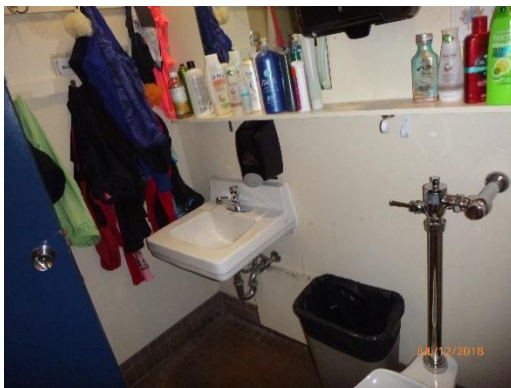
Figure 47 Sample of Existing Plumbing Fixtures

Most of the plumbing fixtures in the building are the original from 1985. They are operational but look dated and worn out.

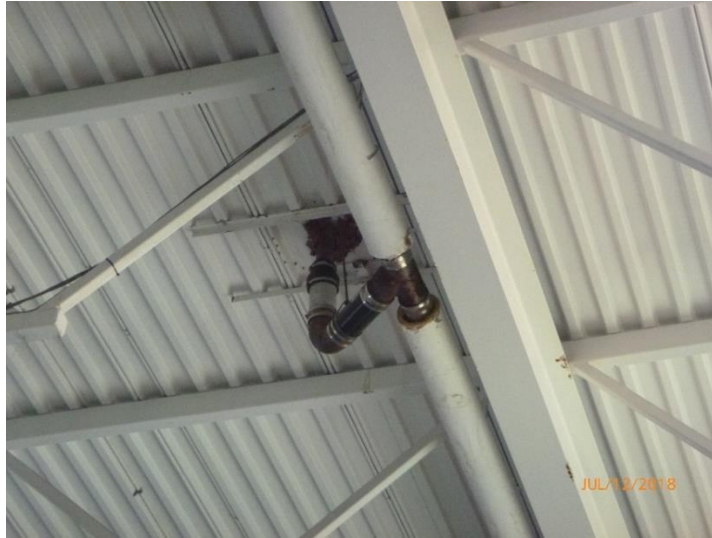
Figure 48 STW line

All the roof drains are collected by cast iron stormwater piping that runs from the roof down to below the grade. The storm water from the building is drained to the city main by gravity through a 250mm STW main. Cast iron STW piping typically lasts 40+ years. MH expect replacement of individual compression fittings will be needed as part of regular maintenance, as they age.

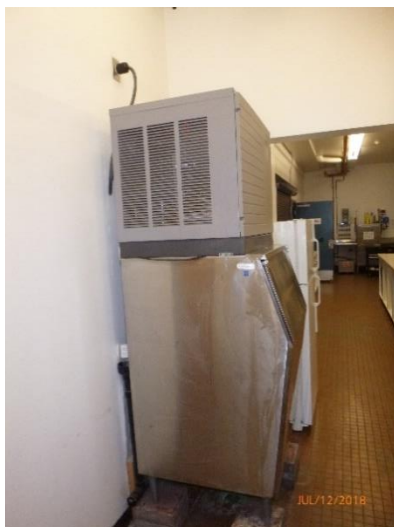
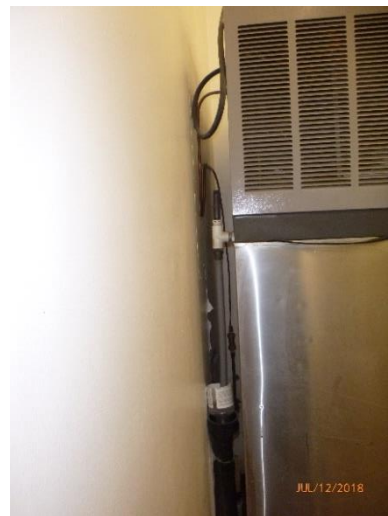
Figure 49 Ice Machine

The auditorium's kitchen is equipped with an ice machine. The water inlet of the ice machine is connected directly to the domestic cold water system. Based on CSA B64, an RPBA is required for ice machine installation.

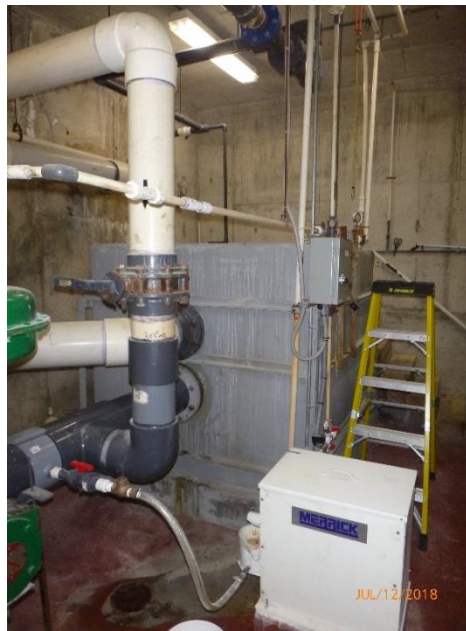
Figure 50 DE Tank and DE Feeder

1. Diatomaceous Earth (DE) Filter System
The diatomaceous earth filter system consists of DE feeder and DE tank. The main pool water filtration process happens in the DE tank. The tank is also equipped with filter rinse system.

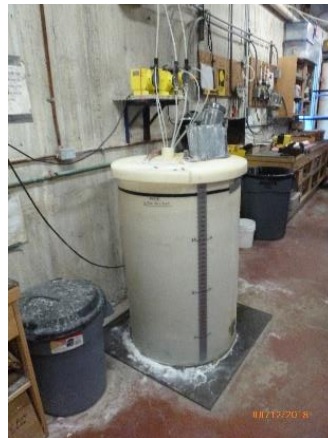
Figure 51 Soda Ash Container

2. Soda Ash/Hypochlorite Feeder & Container
Soda ash is being used to regulate the pH of the pool water. A feeder and container for soda ash services all three pool system.

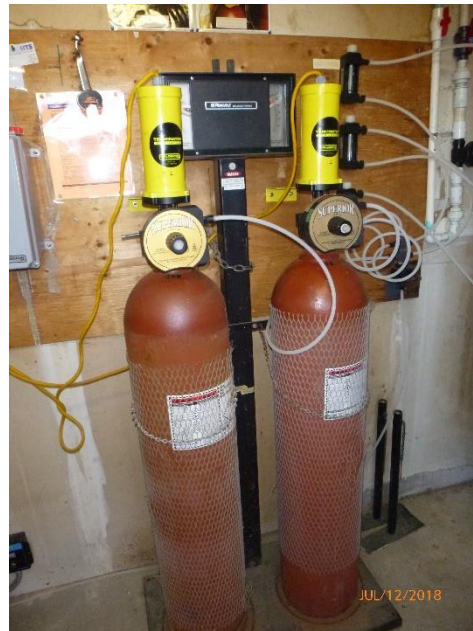
Figure 52 Chlorine Room

The chlorine gas is kept in a gas cylinder inside the chlorine room. The gas is piped to the 25 pool system at the chlorine injection points.

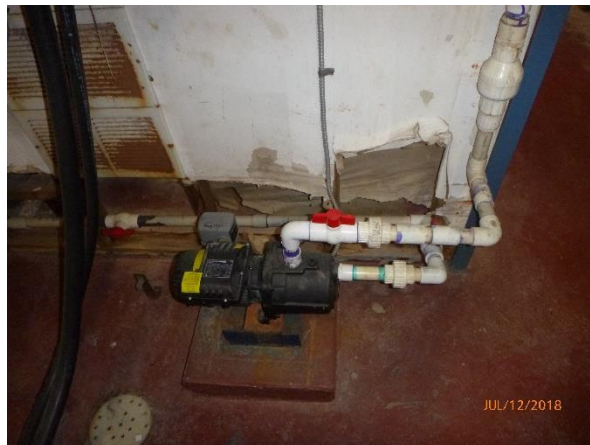
The system is also equipped with a chlorine booster pump (Grundfos JP series; $\frac{3}{4}$ HP). The pump was last replaced in 2017.

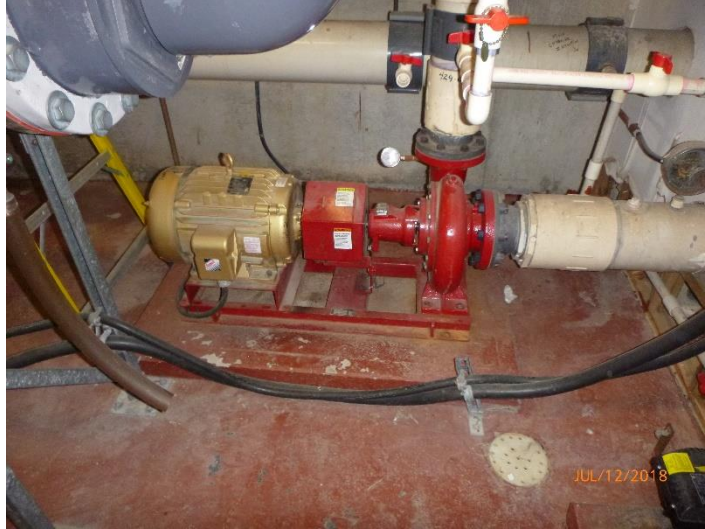
Figure 53 25m Pool's main Circulator Pump

The main circulator pump for the 25m pool is a 15 HP base mounted pump. The pump body is original (1985) but the pump motor has been replaced in 2013. Typical service life expectancy of a base mounted pump is 20 years.

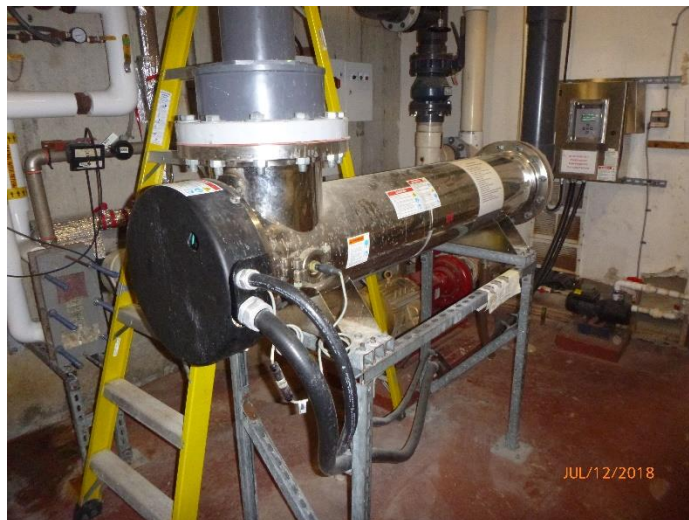
Figure 54 UV filter

A UV pool sanitizer (Aquafine UVLogic 06AL30) was added to the system in 2013. A UV filter system can remove up to 99.5% of pathogens found in the swimming pool water, reducing the required chlorine concentration.

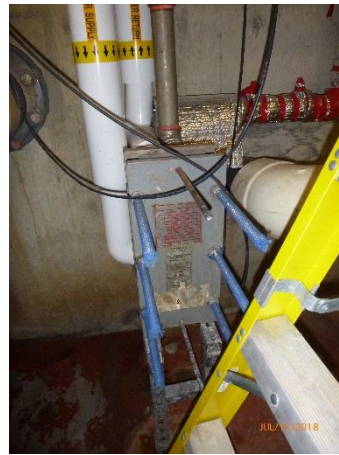
Figure 55 25m Pool Heat Exchanger

7. Heat Exchanger
The 25m pool's original heat exchanger has been replaced with new Bell and Gosset 73.3 kW plate and frame heat exchanger in 2013. The typical service life expectancy of a plate and frame heat exchanger is 15 to 20 years before needing to be rebuilt or replaced.

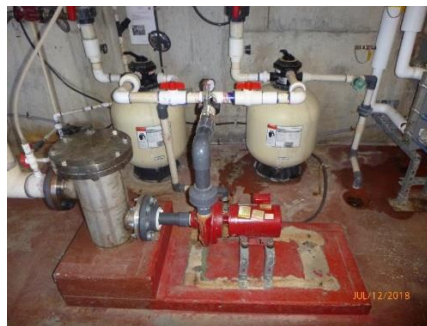
Figure 56 Wading Pool's Sand Filters

1. Sand filter
Two sand filters provide filtering for the wading pool. The sand filter container is original from 1985. The typical service life expectancy for the filter container is 25+years. The containers are typically replaced when they start to leak. The sand media is replaced once every 5 years as part of the maintenance program.

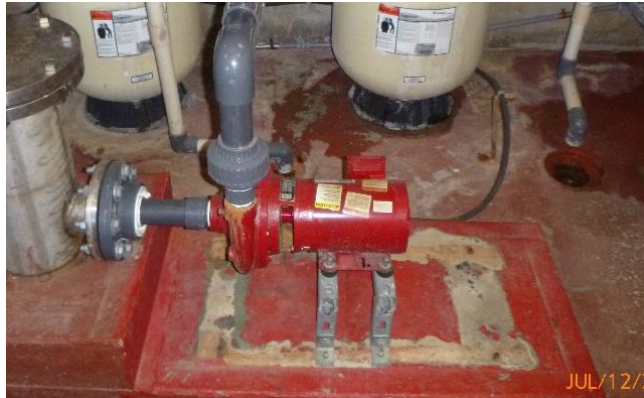
Figure 57 Main Circulator Pump

The main circulator pump for wading pool is a 2 HP close coupled base mounted pump. The pump was replaced in 2013. Typical service life expectancy of a base mounted pump is 20 years.

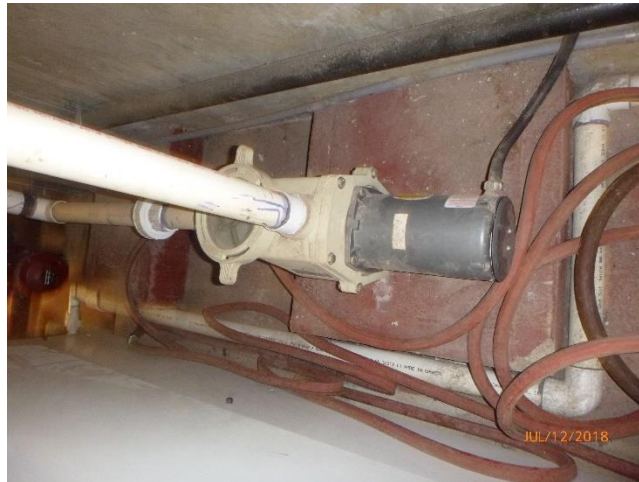
Figure 58 Fountain Re-circulation Pump

Water fountain recirculation was found behind Boiler B-2. The pump body is the original from 1985. The pump motor has been replaced more recently. Typical service life of a base mounted pump is 20 years.

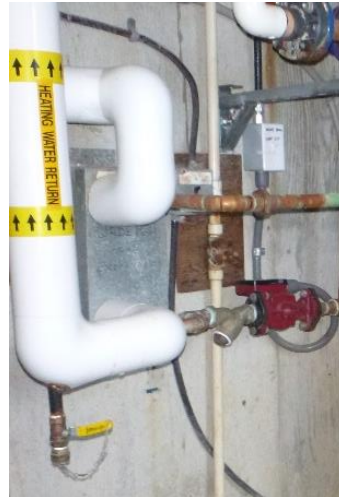
Figure 59 Wading Pool's Heat Exchanger

The wading pool's heat exchanger is the original from 1985. The typical service life expectancy of a plate and frame heat exchanger is 15 to 20 years.

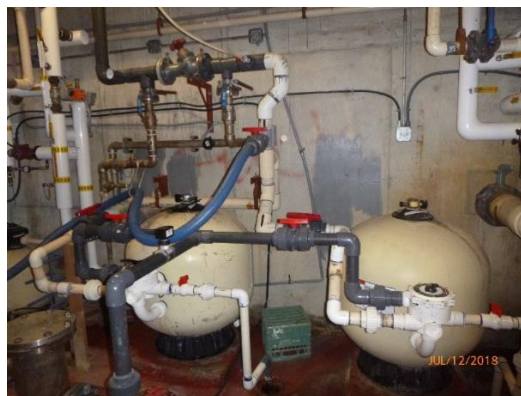
Figure 60 Wading Pool's Sand Filters

Two sand filters provide filtering for the whirlpool. The sand filter containers are original from 1985. The typical service life expectancy for the filter container is 25+years. The containers are replaced when they start to leak. The sand media has to be replaced once every 5 years as a part of the maintenance.

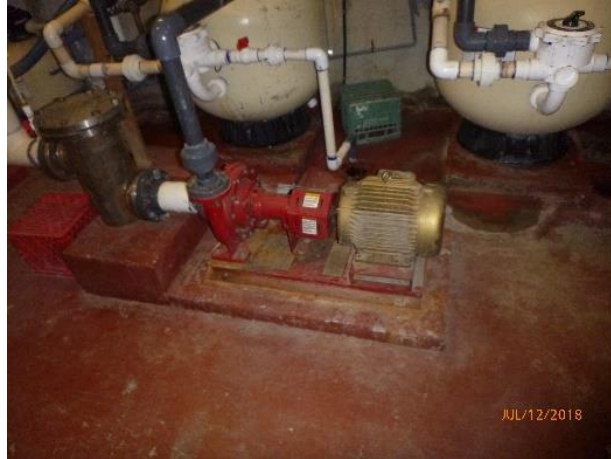
Figure 61 Main Circulator Pump

The main circulator pump for whirlpool is a 190 gpm Bell and Gosset base mounted pump. The pump motor has been replaced while the pump body remains to be original from 1985. Typical service life expectancy of a base mounted pump is 20 years.

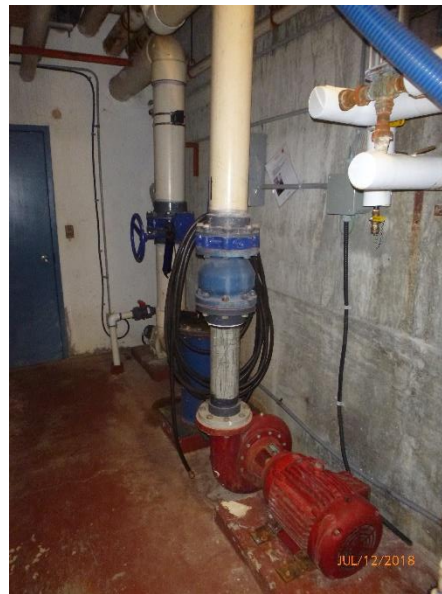
Figure 62 Hydro Air Pump

The hydro air pump is the original pump from 1985. Typical service life expectancy of a base mounted pump is 20 years.

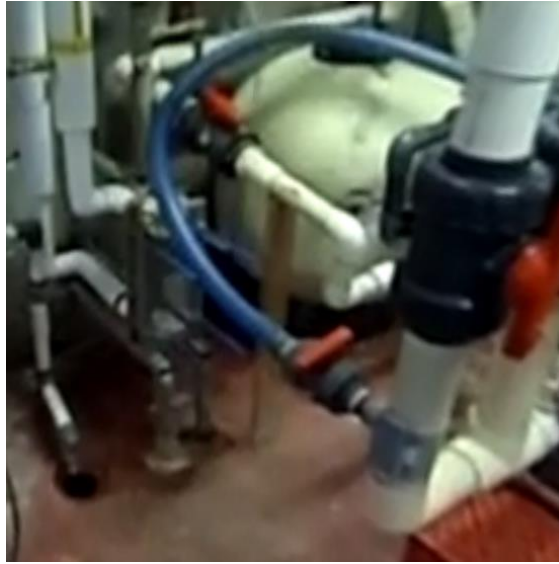
Figure 63 Wading Pool's Heat Exchanger

The whirl pool's heat exchanger was replaced in 2013. The typical service life expectancy of a plate and frame heat exchanger is 15 to 20 years.

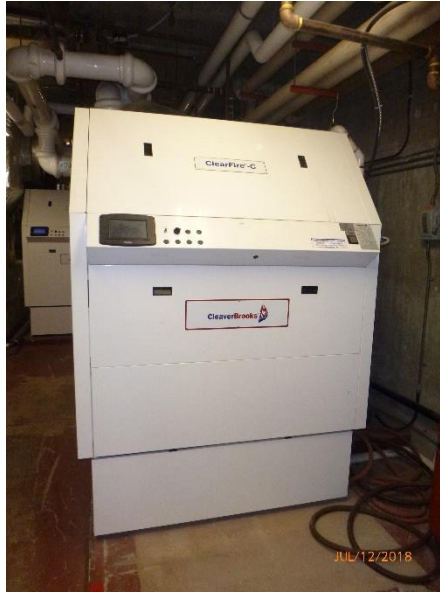
Figure 64 Existing Condensing Boilers

Typical service life expectancy for a condensing boiler is between 15 to 25 years.

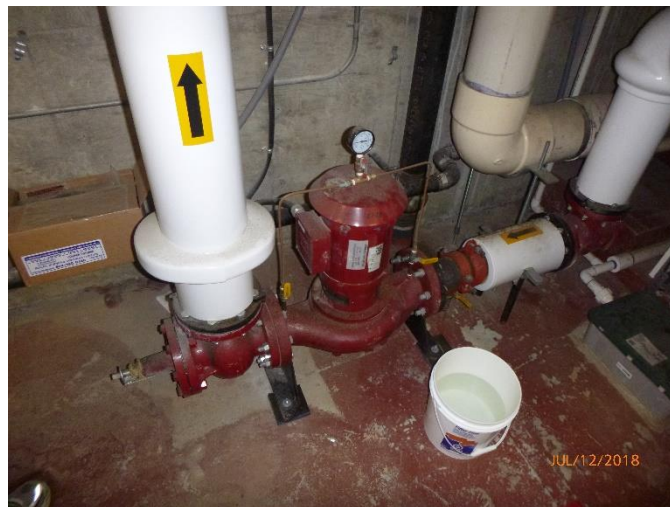
Figure 65 Boiler Pump

Each of the boilers is equipped with a dedicated 250gpm; 2.24 kW Bell & Gosset 80 4x4x7 circulator pump to maintain a constant flow rate across the boiler. The pumps were installed in 2013.

Typical service life expectancy for base mounted in-line pump is 20 years.

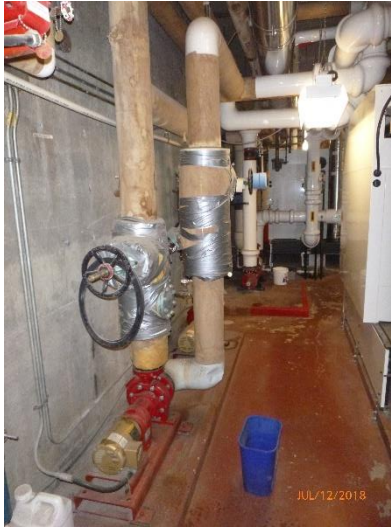
Figure 66 Main Circulator Pumps

found on these pumps. The main hydronic heating loop is currently designed to run at constant flow.

Typical service life expectancy for the base-mounted centrifugal pump is 20 years

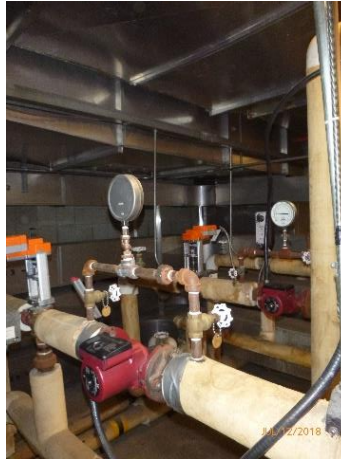
4.2.1.6.5 AHUs' heating coil pumps

In total there are 4 AHUs in the building. Except for AHU-3, each comes with a hydronic heating coil and a coil pump (Grundfos UPS series; fractional HP). The AHU-3 comes with two heating coils and two coil pumps. Based on the nameplate, the pumps were installed around 2013. The typical service life expectancy of in-line pipe mounted circulator pump is 10 to 15 years.

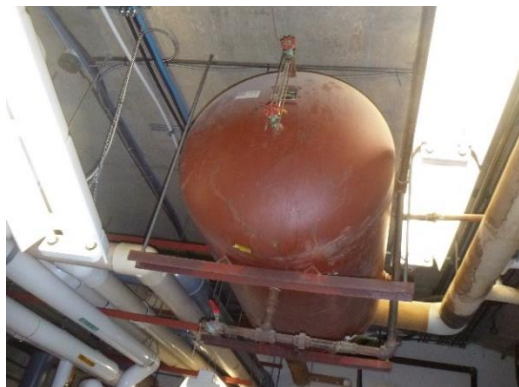
Figure 67 Ex. Expansion Tank

The hydronic heating system is equipped with a plain steel expansion tank. The tank is the original tank from 1985. With this type of tank, air will gradually transfer from the tank to the highest point in the system, due to air dissolving in the water, and then coming out of solution elsewhere in the system. This, in turn, required regular draining of the expansion tank, as well as regular bleeding of the system, to maintain its effectiveness.

14.	<p>Hydronic System</p> <p>Replace hydronic expansion tank with bladder type/diaphragm expansion tank.</p>

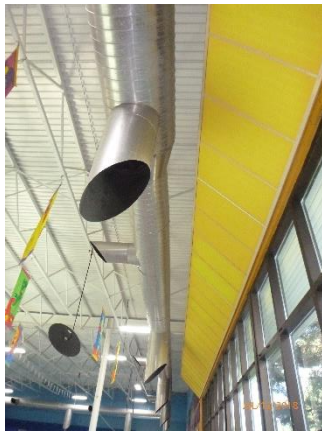
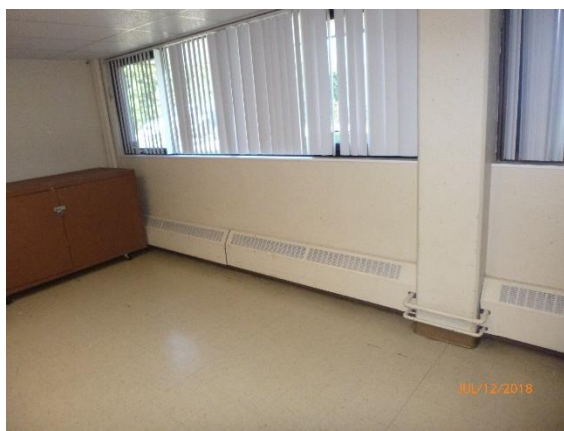
Figure 68 Radiant Panes and Hydronic Base Board Heaters

Except for the control valve, a hydronic baseboard heater and hydronic radiant panels typically last 50+ years. They typically are being replaced due to their outdated look. A control valve's typical service life expectancy is between 10 to 15 years.

MH believe the radiant panels and the hydronic baseboard heaters are designed based on high-temperature HWS. These design will prevent the condensing boilers from condensing when the outdoor air temperature is close to winter design, thus reducing the efficiency of the system.

1	\$ 7,000
15.	<p>Hydronic System - Optional</p> <p>Replace the existing hydronic baseboard heater with low-temperature perimeter hydronic heaters such as Jaga Strada (radiator) or Jaga Briza (wall mounted fan coil). This upgrade will allow the existing condensing boiler to condense and increase the heating system efficiency.</p>	4	60,000

16.	<p>Hydronic System - Optional</p> <p>Replace the existing radiant panel with a low-temperature radiant panel such as Giacomini GK60 Metal Radiant Panel. This upgrade will allow the existing condensing boiler to condense and increase the heating system efficiency.</p>

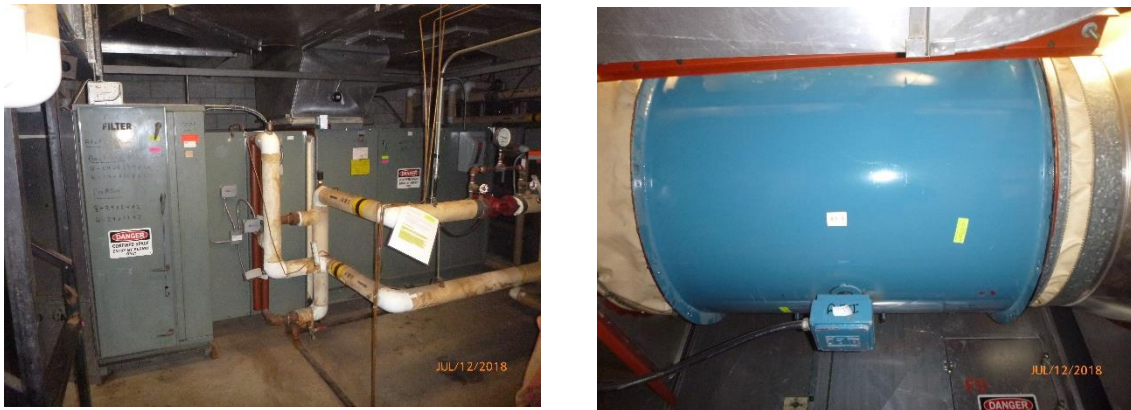
Figure 69 AHU-1 & RF-1

AHU-1 (Mark Hot) provides ventilation for the swimming pool area. The unit has a design flow rate of 14 000 L/s. The unit is equipped with an Alphaair 2000 A.P. (7.5 hp) return air fan (RF-1), a heating coil, and a mixing box. The AHU-1 is not equipped with a dehumidifier as commonly found in modern pool AHUs. The unit is the original unit from 1985. Typical service life expectancy of an indoor AHU is 35 years. None of the fans on AHU-1 are equipped with VFD, indicating that the system is running at constant flow.

The existing AHU-1 does not have a dedicated dehumidifier system. We believe the current system was designed to rely on OA as a method to dehumidify the pool room. This configuration has several drawbacks:

The lack of humidity control and dehumidification capacity of AHU-1 could be one of the reasons for all of the corrosion found in the building structures as mentioned in the mechanical section.

17.	<p>Air/Ventilation System – AHU-1</p> <p>Replace AHU-1 with new indoor swimming pool AHU, complete with a de-humidification module (e.g. PoolPak MPK series). The dehumidification module of the new AHU-1 will be able to recover the heat from the dehumidification process to pre-heat the swimming pool water thus reducing the heating energy consumption.</p> <p>The new unit will be installed either on the roof above the swimming pool or on the ground outside the swimming pool wall.</p> <p>The de-humidification process will reduce the corrosion problems faced by the building.</p>

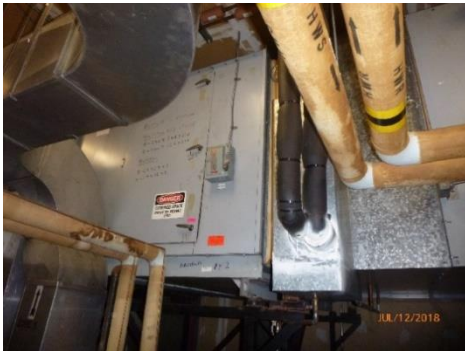
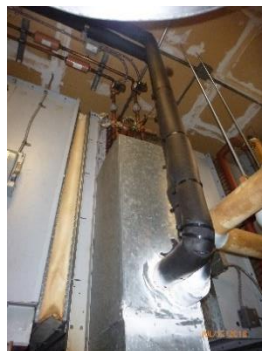
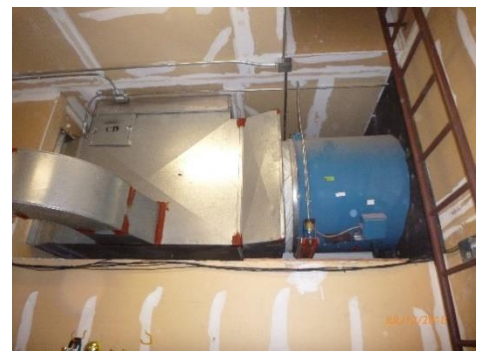
Figure 70 AHU-2 and RF-2

None of the fans of AHU-2 is equipped with VFD, indicating that the system is running at constant flow.

A DX cooling coil and condenser (on the roof) was added to the unit around 1997 (based on condenser manufacturing date) to provide cooling for the auditorium area.

18.	<p>Air/Ventilation System – AHU-2</p> <p>Replace AHU-2 with new variable flow AHU with energy recovery core. The new AHU will come with a hydronic heating coil and a DX coil for cooling. A roof-mounted DX condenser will be replacing the existing DX condenser.</p> <p>The unit will be a modular unit that will be assembled on site to take account the limited service access route to the fan/mechanical room.</p>	AHU:3; Condenser : 1	\$ 300,000

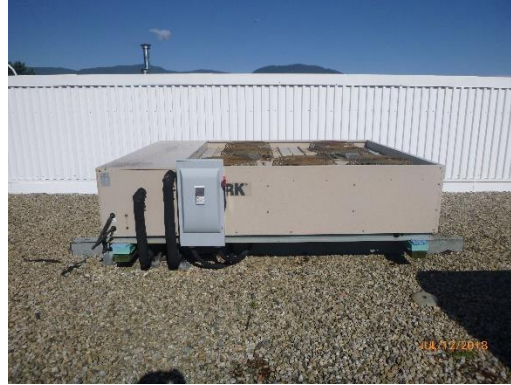
Figure 71 AHU - 2 Condenser

The typical service life expectancy of a DX condenser is 20 years which means it has reached its end of service life. One of the unit sub-module is currently no longer operational.

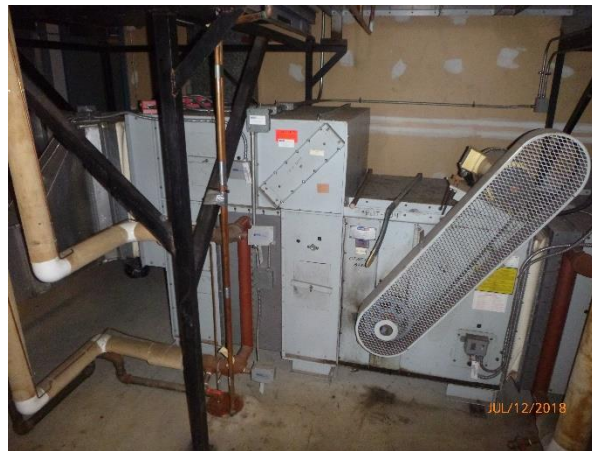
Figure 72 AHU-3

AHU-3 (Mark Hot) provides ventilation for auditorium lobby, upper floor office, women's change room, men's change room, and pool lobby. The unit has a design flow rate of 1850 L/s and come with a heating coil and a mixing box. No cooling system was found in the unit. No VFD was found in the unit, inferring that the unit run at constant flow. The unit is the original unit from 1985. Typical service life expectancy of an indoor AHU is 35 years.

19.	<p>Air/Ventilation System – AHU-3 – Option 1</p> <p>Replace AHU-3 with new variable flow AHU with energy recovery ventilator (ERV) core. The new AHU will come with a hydronic heating coil.</p> <p>The new unit can be specified with DX cooling coil and a roof-mounted DX condenser to provide cooling for the lobbies, change rooms, and the office area.</p> <p>With this configuration, EF-2 & EF-4 will no longer be needed and the heat from the washroom exhaust can be recovered to pre-heat the outdoor temperature during winter time.</p> <p>12 new VAV box will be installed to provide temperature control for various HVAC zones.</p> <p>The New AHU-3 will also provide HVAC service for Gym area.</p>	3	\$ 130,000

20.	<p>Air/Ventilation System – AHU-3 – Option 2 (Recommended)</p> <p>Replace AHU-3 with 3 medium size ERV units located inside the ceiling space (ventilation), combined with VRF DX Split Unit System (Heating and Cooling).</p> <p>Similar to the previous option 1, EF-2 & EF-4 will no longer be needed and the heat from the washroom exhaust can be recovered to pre-heat the outdoor temperature during winter time.</p> <p>During summer, the VRV split unit will provide cooling for the lobbies, change rooms, gym, and the office area.</p> <p>While during winter, the system can recover the heat from the internal zones to heat the perimeter zones.</p> <p>This configuration will not require any space inside the fan/mechanical room, freeing more space for AHU-2 installation.</p>	3	\$ 120,000

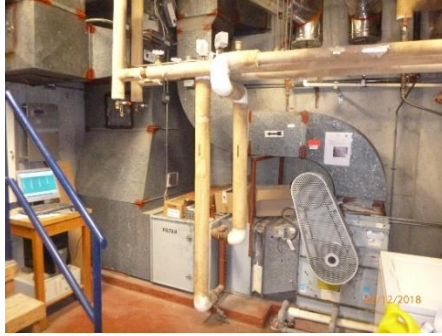
Figure 73 AHU-5

AHU-5 (Mark Hot) provides ventilation for multi-purpose rooms (Block B lower level). The unit has a design flow rate of 1870 L/s and come with a heating coil and a mixing box. No cooling system was found in the unit. No VFD was found in the unit, inferring that the unit run at constant flow. The unit is the original unit from 1985. Typical service life expectancy of an indoor AHU is 35 years.

21.	<p>Air/Ventilation System – AHU-5 – Option 1</p> <p>Replace AHU-5 with new variable flow AHU with energy recovery ventilator (ERV) core. The new AHU will come with a hydronic heating coil.</p>	3	\$ 130,000

22.	<p>Air/Ventilation System – AHU-5 – Option 2 (Recommended)</p> <p>Replace AHU-5 with an indoor ERV unit located in Block A mechanical Room (ventilation), combined with VRF DX Split Unit System (Heating and Cooling).</p> <p>EF-3 will no longer be needed and the heat from the washroom exhaust can be recovered to pre-heat the outdoor temperature during winter time.</p> <p>During the summer time, the VRV split unit will provide cooling. While during the winter, the system can recover the heat from the internal zones to heat the perimeter zones.</p>	3	\$ 120,000

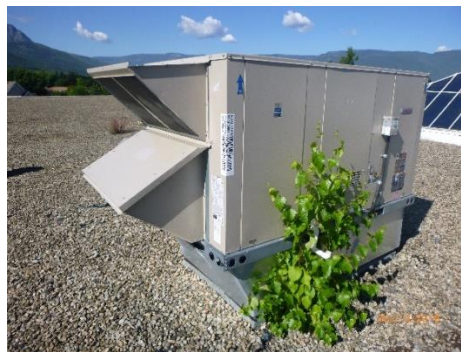
Figure 74 Pool Lobby RTU

A Lennox RTU (KGA072S4BH2J) has been added to provide cooling for the Pool Lobby area (AHU-3 does not have cooling). The unit has a heating capacity of 44 kW and Cooling capacity of 20.5 kW. The unit is 3 years old and in a good condition. An RTU has a typical service life expectancy between 15 to 20 years.

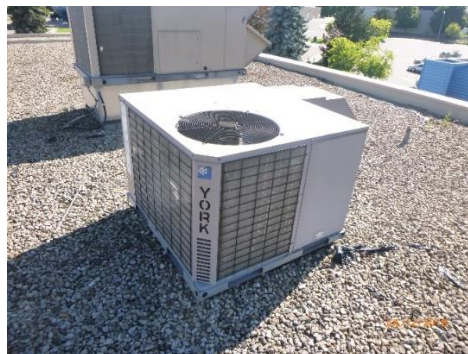
Figure 75 Lv.2 Office A/C

A 7kW York D1EM024A06A rooftop air conditioner has been added approximately 15 years ago to provide cooling for level 2 office area. The typical service life expectancy of a rooftop AC is between 20 to 25 years. The system seems to be in fair condition considering the age of the equipment.

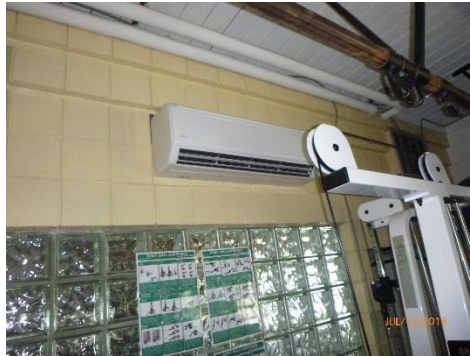
Figure 76 Gym's Split A/C unit

The Gym HVAC system is composed of a wall mounted split A/C with hydronic radiator/baseboard heater at the perimeter wall. The hydronic baseboard heater is original to the building while the Split A/C unit was installed to replace an existing fan coil unit due to service access issue. Typical service life expectancy of an A/C split units is 15 years.

Currently, there is no outdoor air ventilation provided for the Gym.

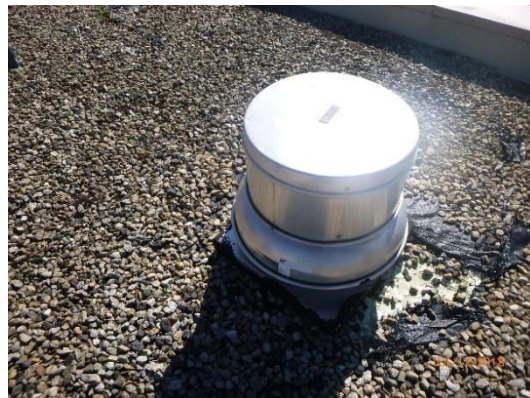
Figure 77 EF-2

1. EF-2
EF-2 (Green heck GB-9-4XQD) provide exhaust for the men's and woman's change room areas. Based on the mechanical drawing, the fan is supposed to have a design flowrate of 1248 L/s. Based on the fan manufacture specification, the fan will only have a flow rate of 1250 cfm (at 0.125 in.H₂O (31 Pa). This means that the exhaust flow rate at the change room area has been cut by half from the design flow rate.

The fan is the original fan from 1985.

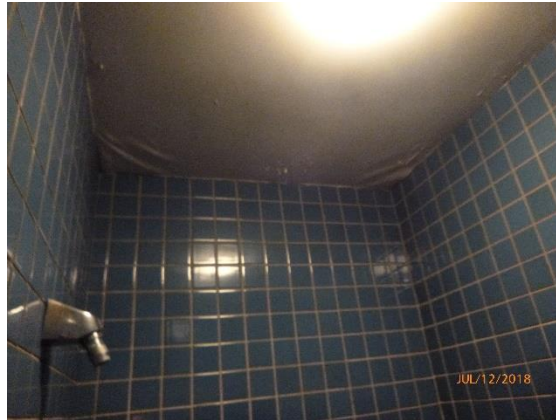
Figure 78 Level 1 Office Shower

4. Level 1 Guard & First Aid Area – Shower
A shower was located in the Level 1 Guard & First Aid Area. The shower room is not equipped with an exhaust which leads into a wet ceiling condition as shown in the picture below.

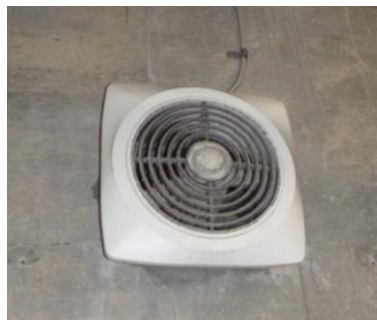
Figure 79 DE Filter Room Exhaust Fan

Currently, the DE filter room is equipped with a small wall-mounted exhaust fan. MH believes the fan does not have the capacity to meet the minimum exhaust flowrate that is specified by ASHRAE 62.1 (210 L/s)

24.	<p>DE Room Exhaust</p> <p>Provide and Install larger capacity exhaust fan for DE Room.</p>	0	\$ 750
25.	<p>Mechanical Control System</p> <p>Replace the outdated DDC control with the latest generation DDC control, c/w internet gateway to allow remote access for operational staff. Expand DDC control to include the swimming pool control system.</p>	3	\$ 150,000

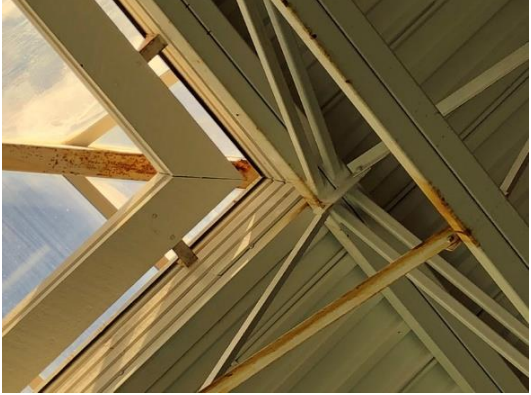
<p>There is corrosion visible in the structural steel framing for the skylight above the pool area. This is likely caused by condensation on the underside of the roof structure due to humidity from the pool.</p>

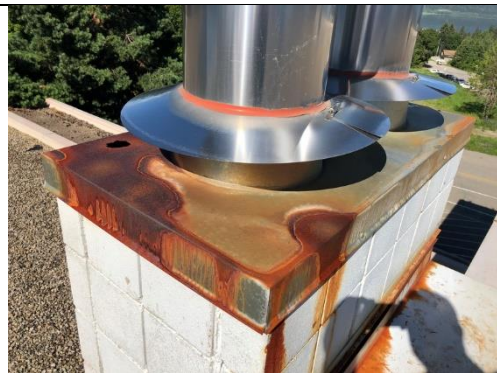
There was corrosion observed on one of the large metal roof vents.

- Repair sub-grade insulation and provide protective covering
- Locally repair damaged metal wall cladding
- Replace the damaged and corroded vents on the roof
- Repair flashing at boiler roof vent.
- Replace the metal door frames in the pool office area, after floor drainage has been improved
- Replace the ceiling in the pool office shower, after ventilation issues have been addressed
- Replace the ceiling tiles in the lobby area
- Perform thorough repairs to the swimming pool concrete surfaces, particularly at perimeter drains and at walls to lower level mechanical rooms
- Conduct a drainage study for the facility, considering observed issues with water ingress at perimeter walls and basement columns
- Replace hydronic expansion tank with bladder type / diaphragm expansion tank
