Salmon Run

WATER QUALITY
REPORT
2007

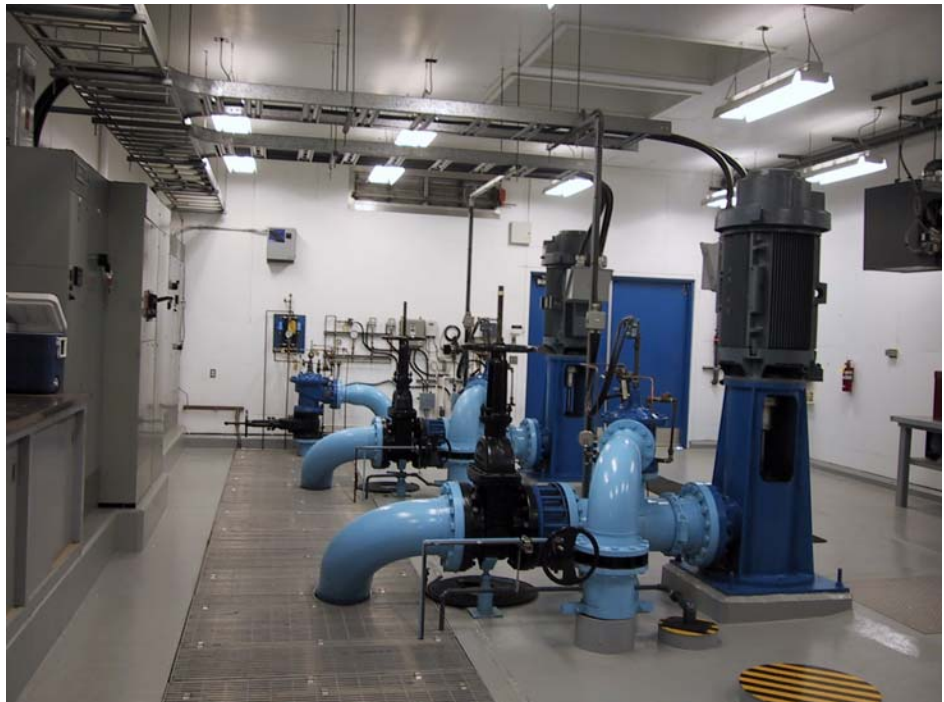
Figure 3 - Zone 1 Pumping Station at Canoe Beach

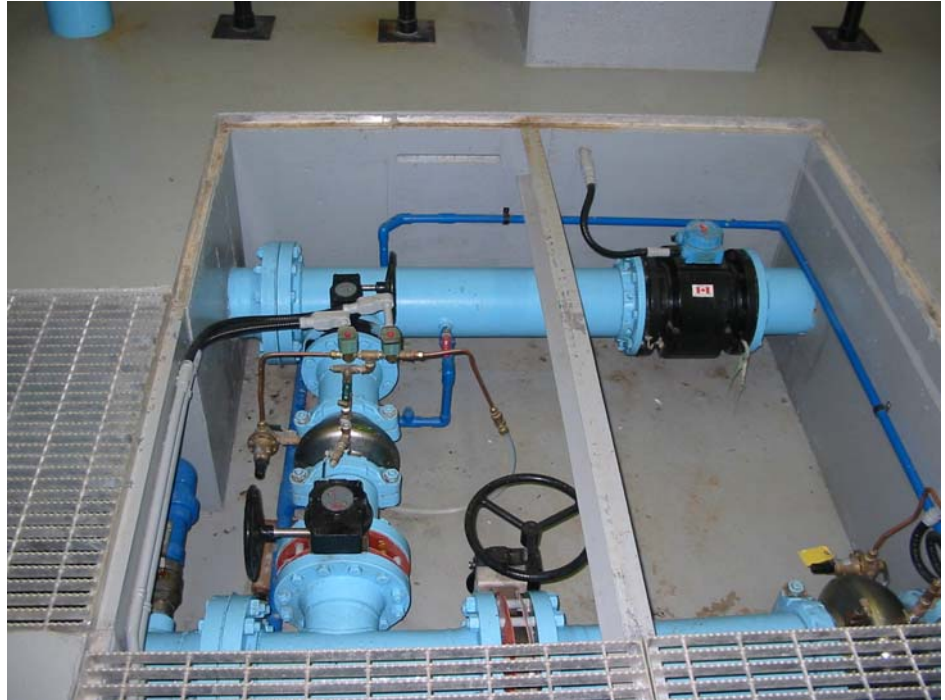
Figure 4 – Zone 4 Pump/Pressure Reducing Station on 30th Street NE

The maximum design water pressure for piping within the municipal water system is 1034 kPa (150 psi). We have five pressure reducing valve stations containing one Pressure-reducing valve (PRV) each. Pressure reducing valves are used to control the pressure in the water system by creating head losses that prevent pressures from exceeding the design maximum. The failure of a PRV could disrupt flows and mainline pressures to a large area of the community.

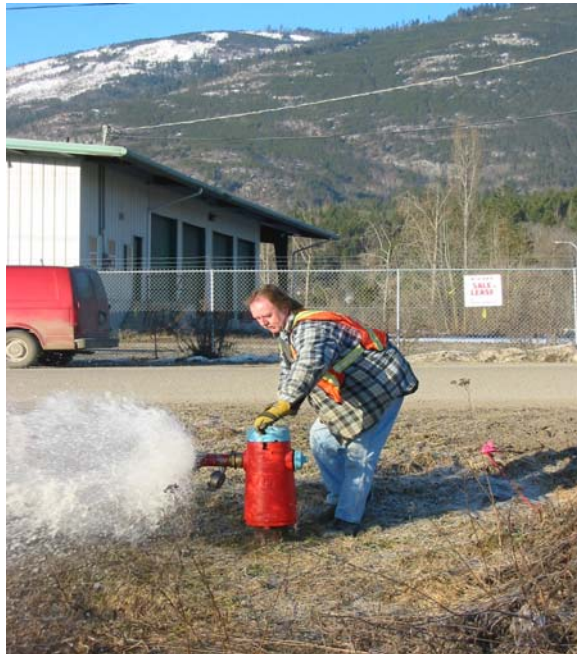
Figure 6 – Utilities Department operator flushing watermain as part of regular maintenance

As water travels from the watersheds, it collects organic particles and transports them to the water system. As these particles travel to areas of the water system with lower flow velocities they settle out. Accumulated debris and stagnant water inhibit flow through mains, cause dirty water and potentially create a favourable environment for bacterial growth. In response to these concerns, the Utilities Department initiated a watermain flushing program for identified problem areas. Each main is flushed annually during daytime hours. When flushing, a hydrant is opened and the water stream is used to expel the contents of the main. There are approximately 17 locations throughout the municipality referred to as "high maintenance areas" where water demand is low or where watermains terminate in a dead end. These areas are flushed as required, sometimes as often as every month during the summer.

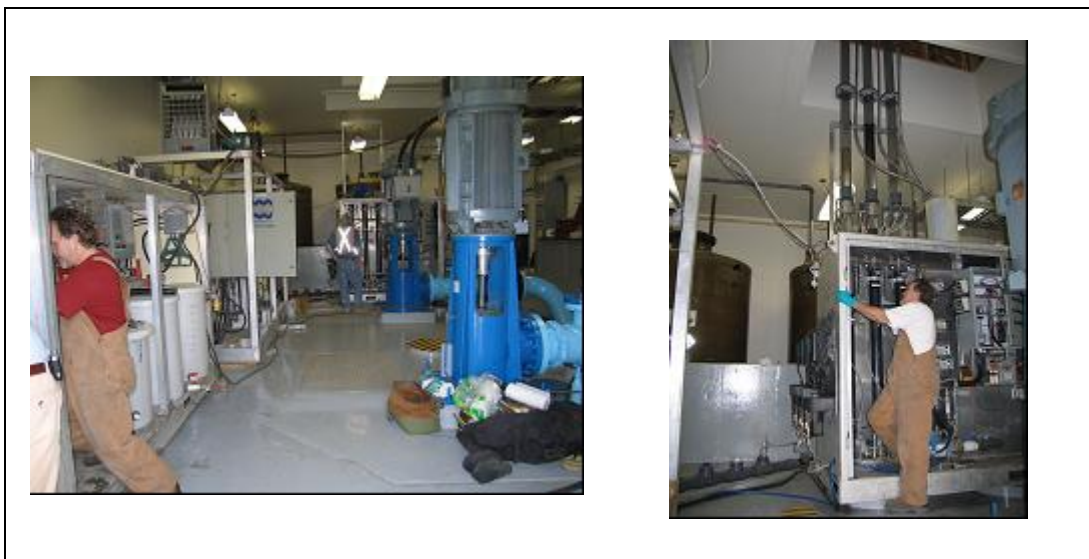
**Figure A.1
 Pilot-Scale Equipment at the Canoe Beach Pump Station**

Terasen Water was retained to install and commission all pilot-scale equipment. The equipment was located at the Canoe Beach Zone 1 Pump Station. **Figure A.1** shows photos of the pilot-scale testing location.

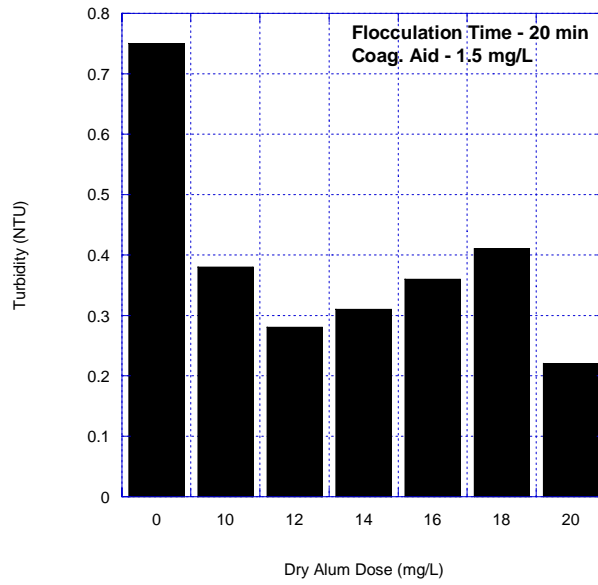
Figure A.2
Impact of Alum Dose on Turbidity

Because direct filtration relies on the formation of pinpoint flocs to ensure that the filters perform efficiently, doses were evaluated based on filtered turbidity, floc size and water filterability (measured through visual observation). For the tests run with PACl, no visible floc was observed with a concentration of 6 mg/L. Conversely, the flocs formed were too large when doses above 12 mg/L were used. These samples were not processed as the goal of the bench-scale effort was to identify chemical dose ranges to use at pilot-scale. Based on the results obtained, the following doses were used:

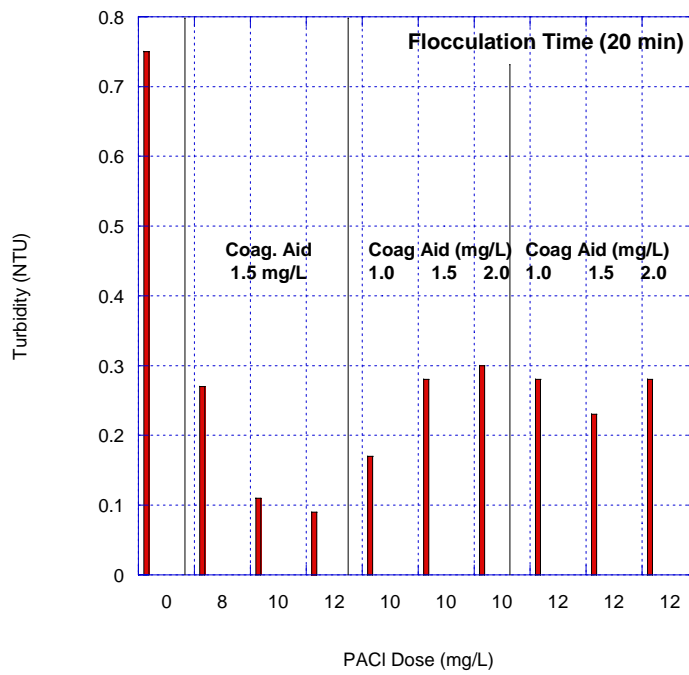
Figure A.3
Impact of PACI, and Coagulant Dose on Turbidity

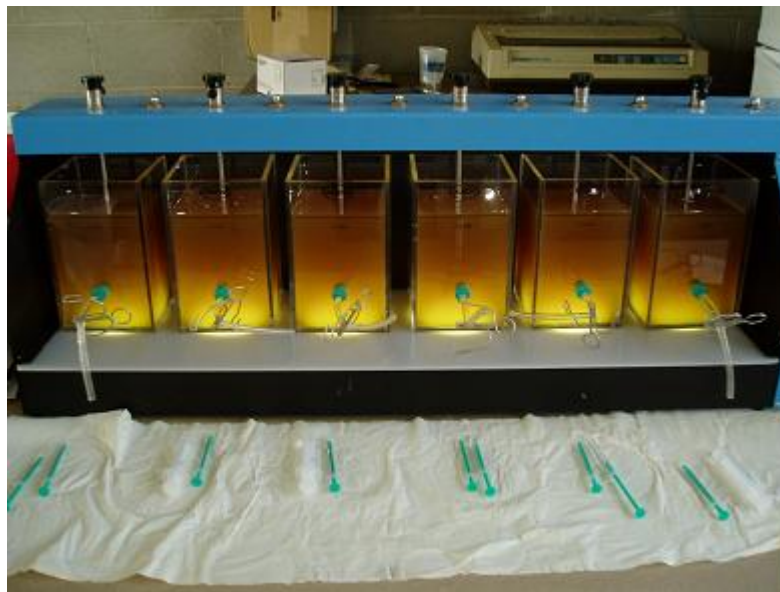
Figure A.9 – Backwash water samples at the start of the settleability tests.

Table A.13 shows the results obtained for the test number 3 (see **Table A.8**). Backwash water was allowed to settle with and without coagulant and coagulant aid addition. A dose of 25 mg/L of alum and 1.5 mg/L of Isofloc 222 were added to backwash water and compared to the sample without chemical addition. For each scenario, two samples were collected; the first in the beginning of the backwash cycle, and the second corresponding to a composite of samples collected throughout the backwash cycle. The first set of samples corresponded to the worst-case scenario, while the second intended to more accurately portray the effluent generated throughout the backwashing process.

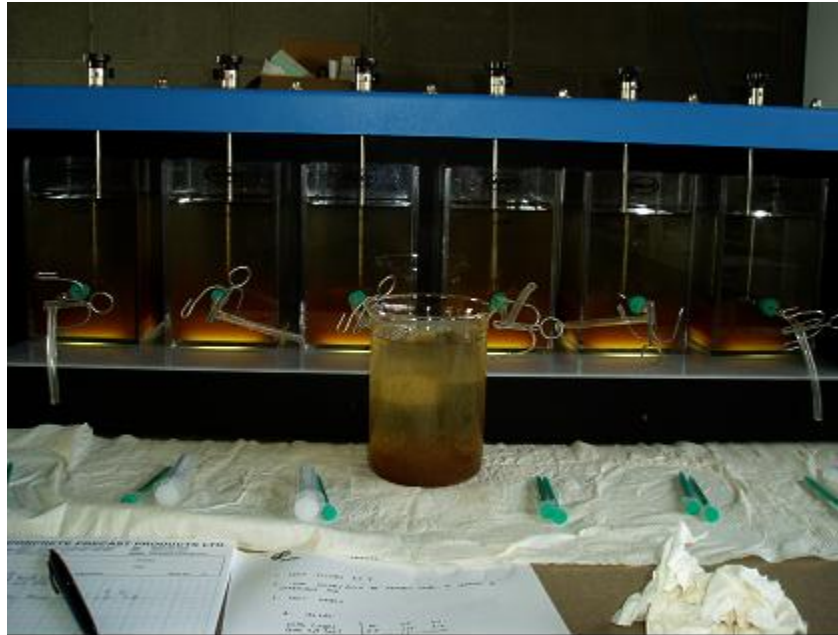
Figure A.10 – Backwash water samples after 15 minutes of settling time (From the left; PACl 10, 25 and 40 mg/L, and 0, 25 and 40 mg/L of alum). Control test (with no chemical addition) was performed in the beaker shown.

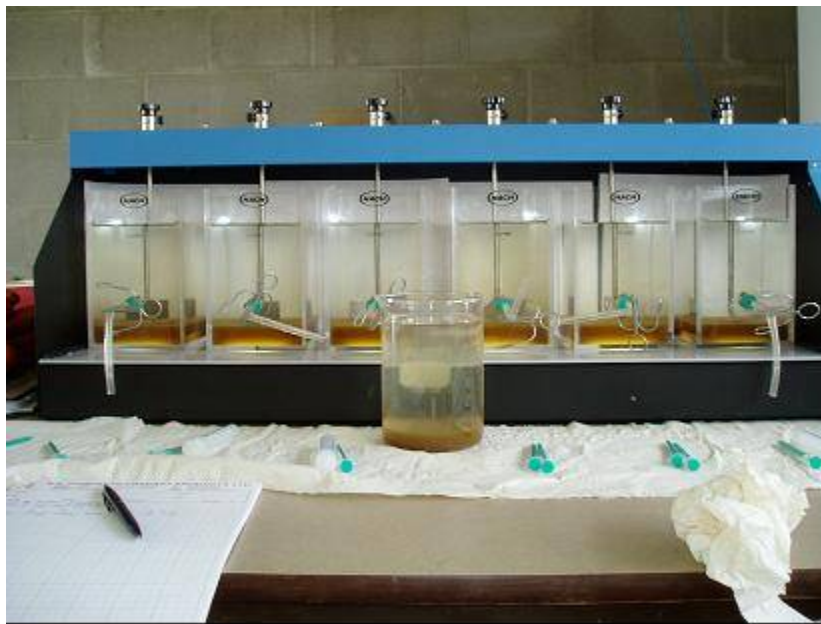
Figure A.11– Backwash water samples after 25 minutes of settling time (From the left; PACl 10, 25 and 40 mg/L, and 0, 25 and 40 mg/L of alum). Control test (with no chemical addition) was performed in the beaker shown.

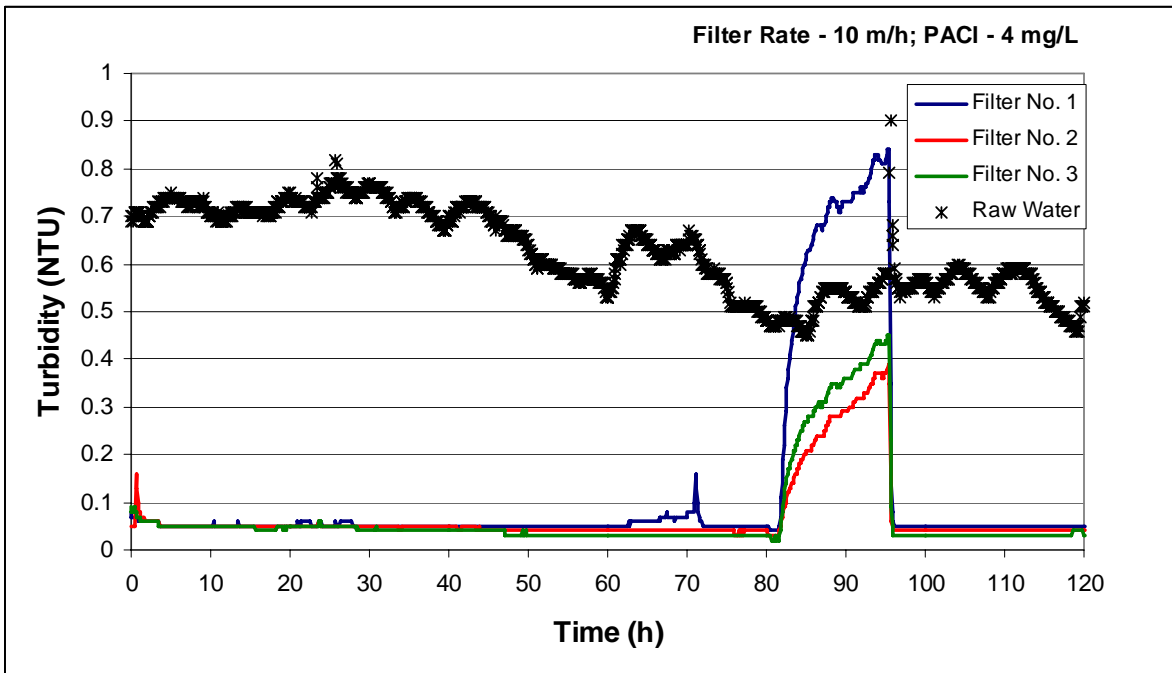
**Turbidity and pressure data measured at a filter rate of 10 m/h
 and a PACI dose of 4 mg/L (Flocculation time: 15 minutes).**
