**Attn: Darin Gerow**  
**Re: Structural Assessment & Life Cycle Assessment of the Memorial Arena – Final Report**  
**100 - 30th Street SE, Salmon Arm, BC**

# Structural Assessment and Lifecycle Analysis of the Memorial Arena

Final Report

Project No. 24VR-600400

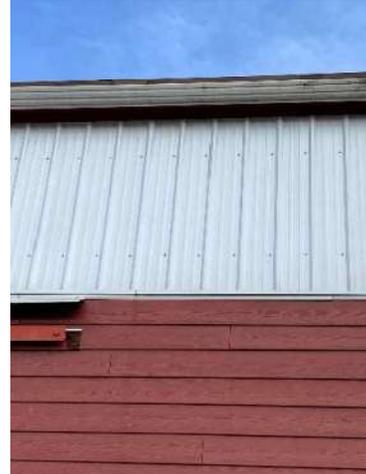
- The vertical metal cladding is limited to the upper 5 feet of the south wall of the arena.
- The metal cladding and associated trims and flashings are in good condition. Photo 12.
- The siding was installed over air barrier and OSB sheathing.

Photo 12: Vertical Metal Siding.

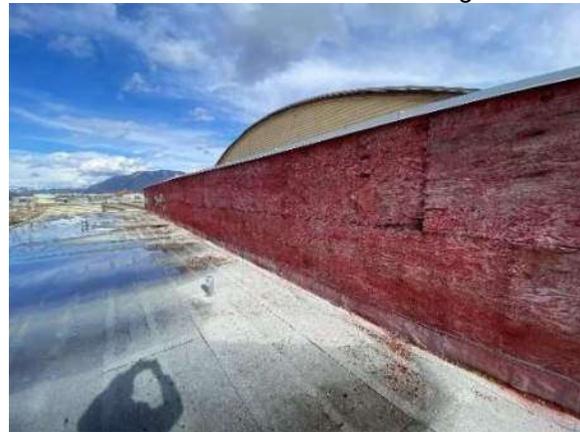
- The west gable of the west addition is finished with painted plywood.
- The plywood is deteriorated and in poor condition. Photo 13.
- The paint is peeling throughout.
- Cut outs in the plywood exposing structural timber and bolted connections were observed.

Photo 13: Typical condition of plywood sheathing.

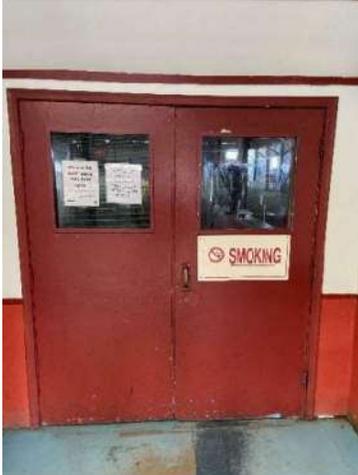
OBSERVATIONS	PHOTOS
<p><b>Solid Wood</b></p> <ul style="list-style-type: none"> <li>• The solid wood doors are located sporadically throughout the building interior. The doors are generally in fair condition. Photo 19.</li> <li>• The southwest corner of the wood shop has a sliding wood door. The door is in poor condition and is difficult to operate.</li> <li>• The south wall of the arena has a large exterior barn style sliding door. The door is wood framed with a painted plywood exterior. The paint is peeling, and the wood is deteriorated. The door hardware appears to be in fair condition.</li> </ul>

Photo 19: Solid wood door

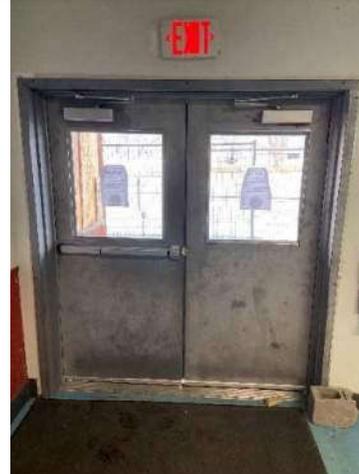
- The exterior doors in the east and west addition are insulated steel doors.
- The doors and frames are generally in fair condition. Photo 20.
- The door seals, weather stripping, and door hardware are in fair condition.

- The main entrance doors on the east wall of the east addition and the entrance door at the southeast corner of the east addition have glazing.
- The glazing is in fair condition. Photo 20.

Photo 20: Insulated steel door

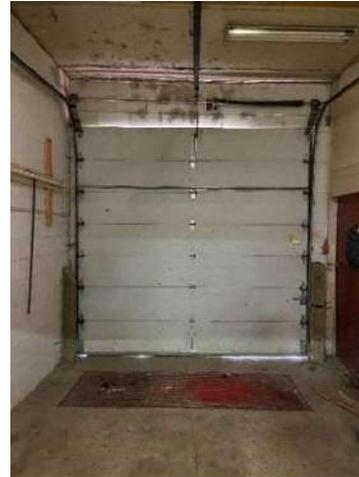
- The overhead door serving the vehicle bay in the west addition is in poor condition. Photo 21.
- The overhead door opener is not operational.
- The latch hardware for locking the overhead door is not operational.
- The door does not seal to the shop floor or door jamb.
- The door has mechanical damage from impact.

Photo 21: Overhead door

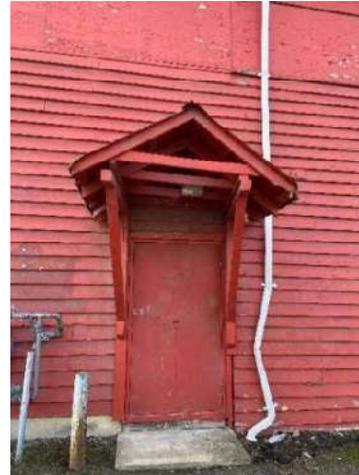
- The emergency exit doors serving the arena and the west addition are hollow steel doors. Photo 22.
- The doors are in failed condition.
- The doors seals and weather stripping are in failed condition and/or missing.
- Door hardware failure was observed throughout.

Photo 22: Hollow steel door

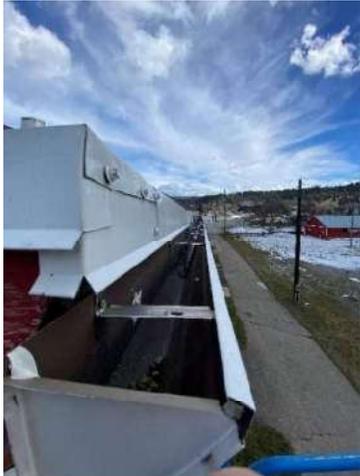
<p>Photo 24: Aluminium gutters and flashing along south arena wall.</p>

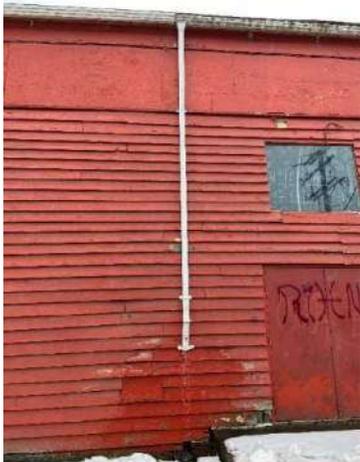
<p>Photo 25: Typical condition of gutter downspouts</p>

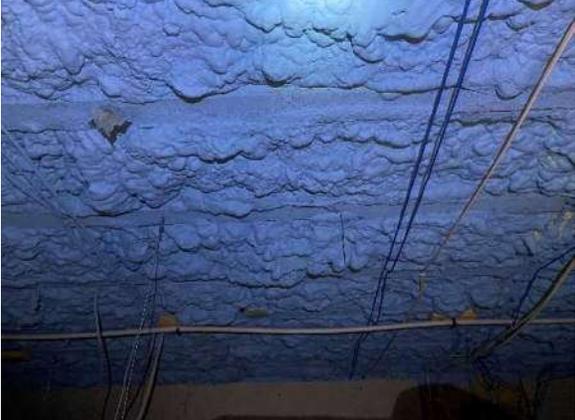
OBSERVATIONS	PHOTOS
<p><b>Vermiculite</b></p> <ul style="list-style-type: none"> <li>Based on the background data reviewed the west addition CMU walls are filled with vermiculite insulation.</li> <li>The insulation could not be visually assessed.</li> </ul> <p><b>Fibreglass Batt</b></p> <ul style="list-style-type: none"> <li>Fibreglass insulation in the rafter bays of the west addition was confirmed, but its condition could not be assessed due to ceiling finishes.</li> <li>The east addition is assumed to have insulation between the roofing membrane and wood decking. Its condition could not be confirmed.</li> <li>The east addition exterior walls are assumed to be insulated with fibreglass batt insulation. Its condition could not be confirmed.</li> </ul> <p><b>Polyurethane Spray Foam</b></p> <ul style="list-style-type: none"> <li>The rafters above the offices at the northwest corner of the west addition are insulated with polyurethane spray foam insulation.</li> <li>The insulation is in good condition. Photo 26.</li> </ul>

<p>Photo 26: Polyurethane spray foam and TJI joists</p>

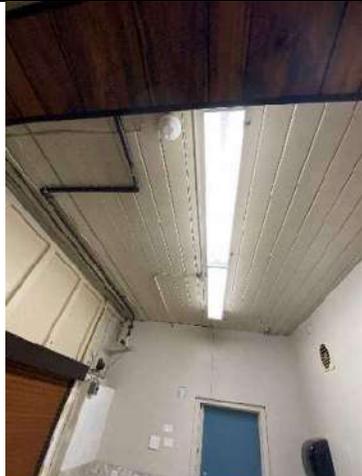
<ul style="list-style-type: none"> <li>• East Addition <ul style="list-style-type: none"> <li>○ Planking is in fair condition. Photo 29.</li> </ul> </li> <li>• West Addition <ul style="list-style-type: none"> <li>○ The roof decking was not assessed due to roof and ceiling coverings.</li> </ul> </li> </ul> <p><b>Plywood Sheathing</b></p> <ul style="list-style-type: none"> <li>• Plywood sheathing was observed through numerous gaps in the arena roof planking.</li> <li>• The extent and condition of the sheathing could not be observed.</li> </ul>

<p style="text-align: center;">Photo 29: T&amp;G planking, east addition.</p>
---	--

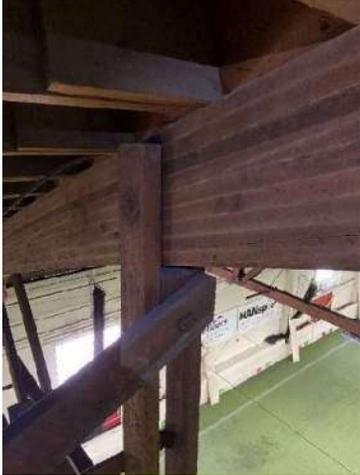
OBSERVATIONS	PHOTOS
<p><b>Top Chord</b></p> <ul style="list-style-type: none"> <li>The top chord of the bowstring trusses are 9-ply 5"x14<sup>5/8</sup>" glulam arched members with an approximate curvature radius of 54'-7<sup>3/16</sup>". Photo 32.</li> <li>The top chords are generally in good condition.</li> <li>Water/moisture staining was observed throughout, but no signs of decay or rot were observed.</li> <li>Moisture content ranged from 8-10% throughout the arena.</li> <li>No crushing failures at rafter bearing locations were observed.</li> <li>Minor checking was observed on most of the truss top chords.</li> </ul>

<p>Photo 32: Typical condition of top chord.</p>
<p><b>Bottom Chord</b></p> <ul style="list-style-type: none"> <li>The bottom chord of the bowstring trusses are 6 ply 5"x9<sup>3/4</sup>" glulam members. Photo 33.</li> <li>The bottom chords are generally in good condition.</li> <li>Water/moisture staining was observed throughout, but no signs of decay or rot were observed.</li> <li>Moisture content ranged from 8-10% throughout the arena.</li> <li>No crushing failures at rafter bearing locations were observed.</li> <li>Minor checking was observed on most of the truss bottom chords.</li> </ul>

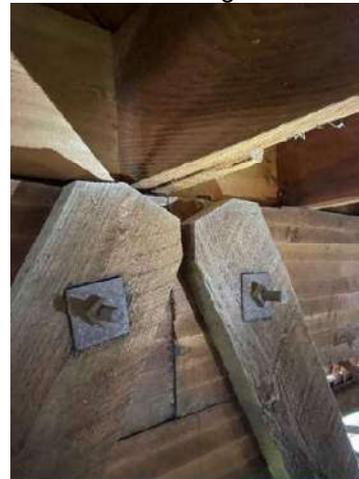
- The top chord is spliced at the peak of the arched roof.
- The splice connections are in good condition with no signs of stress related failures or deterioration. Photo 36.

Photo 36: Typical top chord splice.

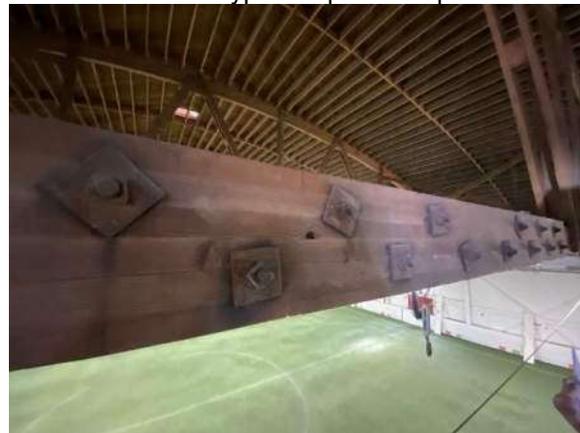
- The bottom chords are spliced at midspan with glulam splice blocks.
- The splice blocks are in good condition. Photo 37.
- Minor checking was observed throughout.

Photo 37: Typical bottom chord splice.

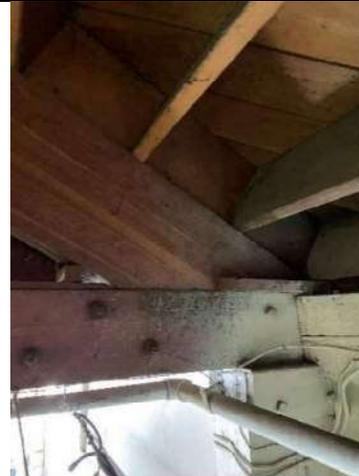
- The truss bearing locations appear to be in good condition with no signs of deterioration. Due to the nature of the steel saddle connection at the truss bearing locations the actual condition of the timber within the saddle could not be reviewed in detail. Photo 38.1.

- The steel splice plates are in good condition. Photo 38.1.
- The bottom chords within the splice plate connection could not be observed and end splitting could not be confirmed.
- Gaps between the top chord and bottom chord at the splice location ranged from  $\frac{1}{4}$ " to  $\frac{1}{2}$ ". This may have caused some end splits in the bottom chord which could not be confirmed.

Photo 38.1: Truss bearing plate.

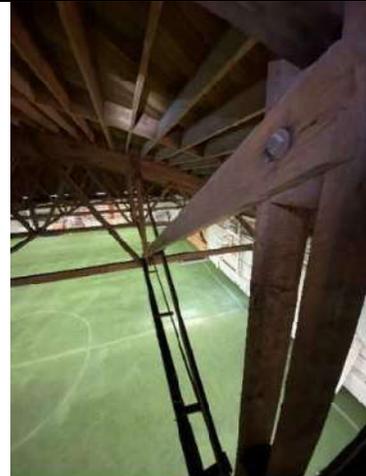
Photo 41: Typical sway bracing.

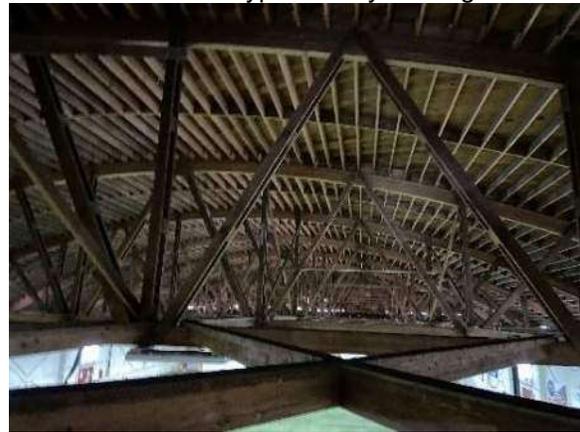
- The bottom chord bracing consists of cross-bracing in the east and west bays and strut braces in the remaining bays.
- The strut braces are in fair condition throughout.
- The cross-bracing in the end bays are in poor condition. Due to their long span, they have sagged 2-3 inches. Photo 42.
- Brace to truss connections are in fair condition with limited splitting.

Photo 42: Typical bottom chord cross bracing.

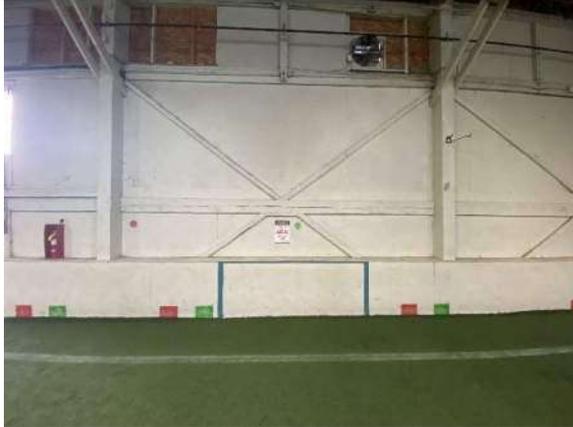
OBSERVATIONS	PHOTOS
<p><b>Struts</b></p> <ul style="list-style-type: none"><li>• The struts span between the arena columns and are located at the bottom of the walls, approximately 6 feet above the arena floor, at the knee brace to column connection, and at the top of the walls. Photo 43.</li><li>• The struts are generally in poor condition.</li><li>• The struts located at the column bases on the east half of the arena are in failed condition due to severe decay.</li><li>• Severe checking was observed throughout with checks measuring greater than 1/2" in width and 3" in depth.</li><li>• Significant warping and twisting was observed throughout.</li><li>• Strut to column connections have failed in many locations. The wood has split at</li></ul>

<p>Photo 43: Typical wall struts and bracing.</p>

- The walls of the arena have 4"x6" cross bracing. Photo 43.
- The braces are generally in fair condition.
- Checking was observed throughout.
- Several brace to column and brace to strut connections have failed due to building movement and member twisting and warping.

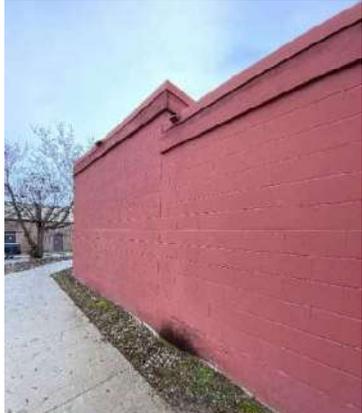
OBSERVATIONS	PHOTOS
<p><b>Concrete Masonry Unit (CMU) Walls</b></p> <ul style="list-style-type: none"> <li>• The west addition CMU walls are generally in fair condition.</li> <li>• Minor step cracking was observed above the exit door at the southwest corner of the west addition.</li> <li>• Minor step cracking was observed on the west wall of the wood shop.</li> <li>• The CMU walls are straight and plumb.</li> </ul> <p><b>Wood Framing</b></p> <ul style="list-style-type: none"> <li>• East Addition               <ul style="list-style-type: none"> <li>○ The exterior walls are generally in fair condition.</li> <li>○ The exterior wall framing could not be visually assessed due to wall finishes.</li> <li>○ Based on the background data reviewed and the site conditions, it is expected that the exterior walls are framed using conventional wood framing.</li> <li>○ The walls are straight and plumb.</li> <li>○ No concerning defects were observed.</li> </ul> </li> <li>• Arena               <ul style="list-style-type: none"> <li>○ The infill framing between the columns, struts, and bracing is 2"x4" D. Fir studs spaced at 16" on center with plywood sheathing on the interior face.</li> <li>○ The infill framing is generally in poor condition. Photo 48.</li> </ul> </li> </ul>	<div style="text-align: center;">

<p>Photo 47: Typical condition of exterior CMU walls.</p> </div> <div style="text-align: center;">

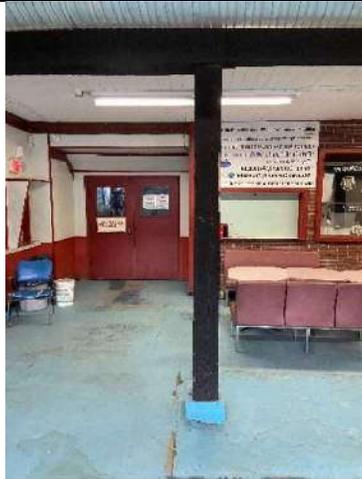
<p>Photo 49: East addition beam and column roof supports.</p>

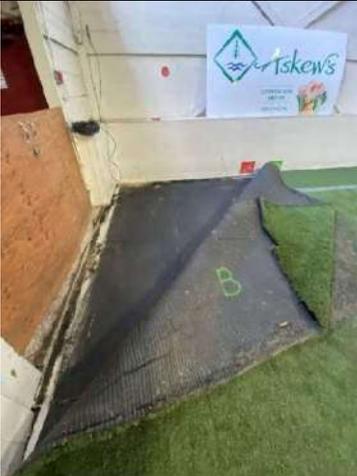
<b>OBSERVATIONS</b>	<b>PHOTOS</b>
<ul style="list-style-type: none"> <li>• The floor slabs are generally in fair condition throughout the building. Photo 51.</li> <li>• Typical shrinkage and temperature cracking was observed throughout.</li> <li>• The concrete slab at the east end of the arena is in poor condition with cracking throughout and differential settlement. Photo 52.</li> <li>• The slabs throughout the east and west additions are nominally level.</li> <li>• The arena slab was surveyed. The slab elevation varies 1.5".</li> </ul>

<p>Photo 51: Observed sample section of slab underneath turf.</p>

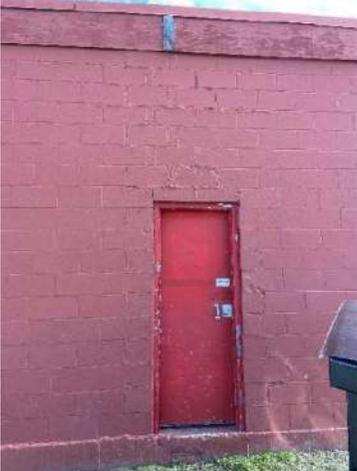
OBSERVATIONS	PHOTOS
<p><b>East and West Additions</b></p> <ul style="list-style-type: none"><li>• The additions are assumed to be supported on concrete frost walls and continuous strip footings.</li><li>• Only the portions of the foundation walls above grade could be observed.</li><li>• The foundation walls appear to be in fair condition. Photo 53.</li><li>• No significant signs of differential settlement or cracking were observed.</li></ul> <p><b>Arena</b></p> <ul style="list-style-type: none"><li>• The arena foundations consist of concrete pilasters on spread pad footings.</li><li>• Two pilasters and pads were partially excavated and confirmed to match the original design drawings. The pilaster and pads appeared to be in fair condition. No cracking or signs of instability were observed. Photo 54.</li><li>• The top surface of the east half of the building pilasters are at or below grade. Photo 55.</li></ul>

<p>Photo 53: Foundation wall observed at grade.</p>

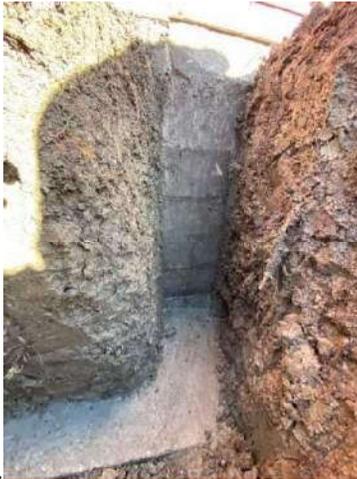
<p>Photo 54: Arena pilaster and pad footing.</p>
