Attn: Darin Gerow
Re: Structural Assessment & Life Cycle Assessment of the Memorial Arena – Interim Report
100 - 30th Street SE, Salmon Arm, BC

Structural Assessment and Lifecycle Analysis of the Memorial Arena

Interim Report

Project No. 24VR-600400

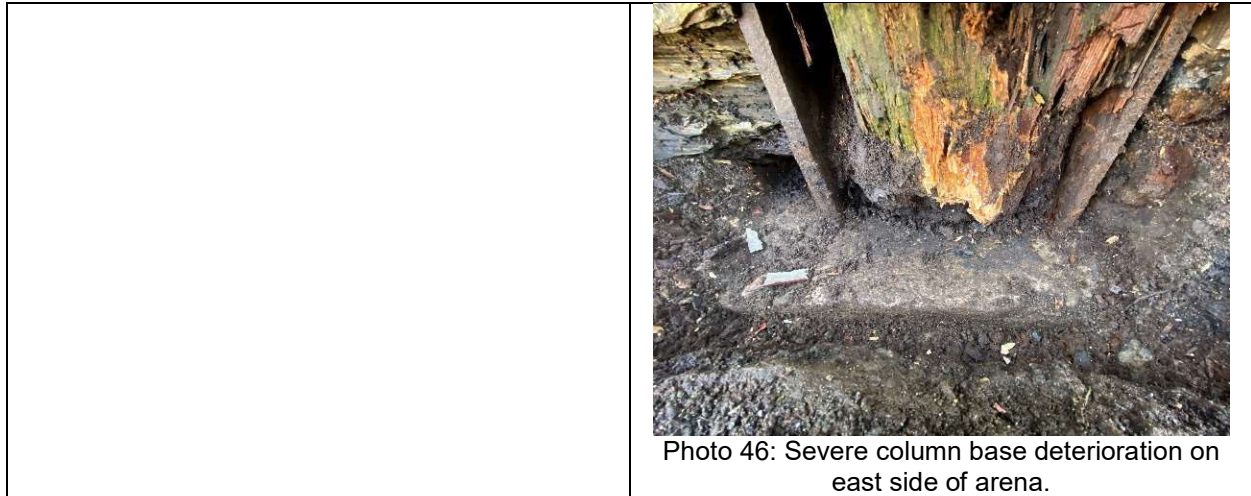
OBSERVATIONS	PHOTOS
<p>Arena Sidewall Columns</p> <ul style="list-style-type: none">• The columns are 10" x 16" D. Fir and extend from the foundation to the underside of the roof trusses.• The columns are generally in very poor condition.• Severe checking was observed throughout. Checks measured as large as ¾" in width and 3" in depth. Photo 45.• Some columns have end splitting at the base connection.• Moisture staining was observed throughout. Photo 45.2/• The base of the columns on the east half of the arena are at/below grade and exposed to moisture. These columns have varying degrees of decay. The base steel brackets at these columns are corroded. Photo 46.

<p>Photo 45.2 Typical end split at base of column.</p>
