2022 Wastewater Collection and Treatment Report

CITY OF
SALMON ARM

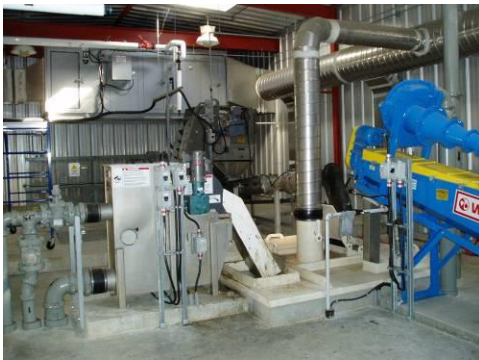
Initially the wastewater is pumped into the plant from a sewage lift station (Wharf Street) located at Marine Park Drive. The influent then passes through several mechanical devices to remove large particles including rocks, rags, plastics and grit. This is done in the headworks of the facility and prevents damage to downstream equipment.

Headworks

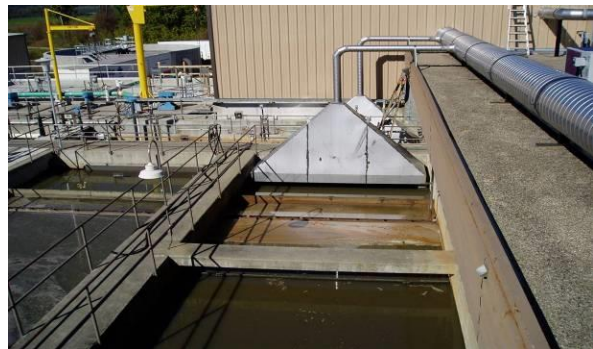
Primary Sedimentation Tanks

The flow then enters one of two Primary Sedimentation Tanks where heavier organic and inorganic solids are settled out of the liquid stream. These particles are then pumped to the ATAD for stabilization. The liquid, on the other hand, then enters the tertiary BNR and SGR-FGR part of the facility for further treatment.

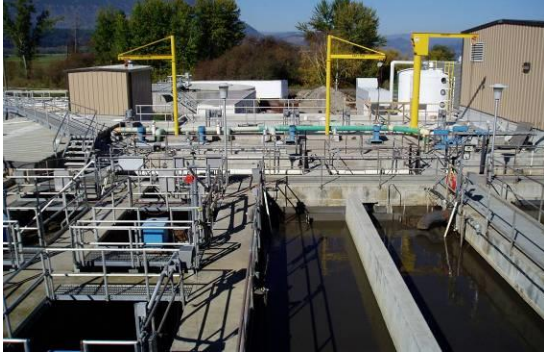
SGR's

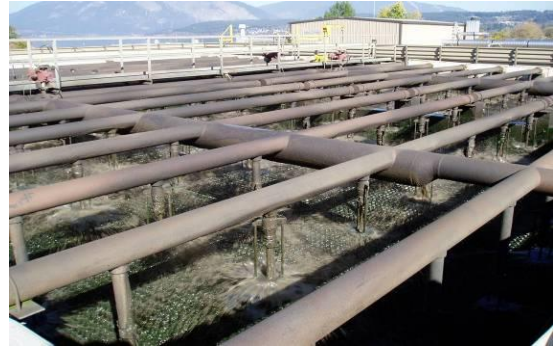
FGR

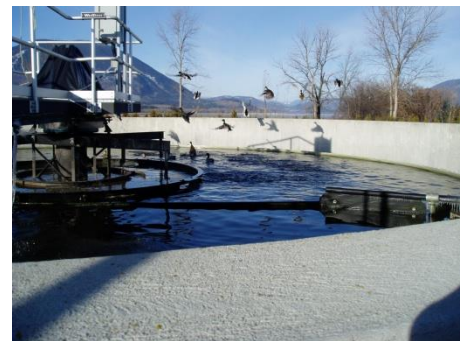
The tertiary treatment involves the use of bacteria to convert degradable organic matter into bacterial cells. These cells are then separated from the liquid in the secondary clarifiers.

Secondary Clarifiers

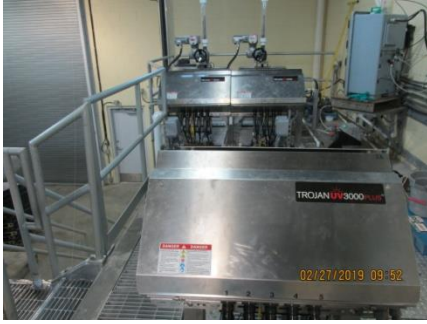
The secondary effluent then passes through the Aqua Aerobics disk filtration system which provides 10 micron filtration. The effluent is then disinfected using a TrojanUV3000Plus™ Ultra Violet Light (UV) disinfection system prior to it being discharged into the Salmon Arm Bay in the Shuswap Lake.

UV Treatment System

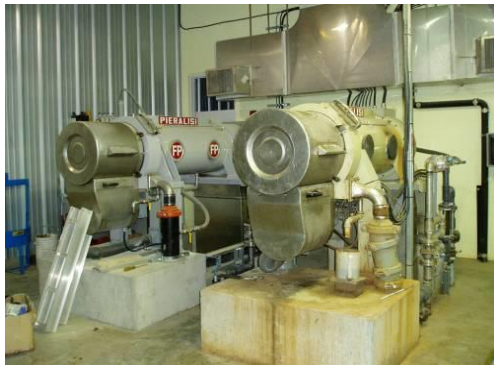
The primary solids and waste biological solids are digested (broken down) in the ATAD cells. This process uses high temperature bacteria (60 to 70 degrees Celsius) to stabilize and pasteurize the biosolids. Following processing, the biosolids are thickened with the use of high speed centrifuges and then hauled to landfill for potential site reclamation.

Centrifuge

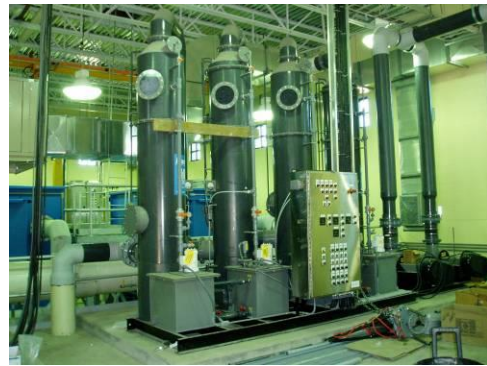
Train B Odour Scrubber

Odour control is another major component of the plant operation. The odour control has been separated into two trains based on the concentration of odour generating compounds. One train deals with a large air volume of low odour concentration while the second train deals with a low air volume with a high concentration of odour compounds. The latter system uses a multi treatment system – biofilter, ozone contact, four (4) stage chemical scrubber and dilution while the other train uses a single stage chemical scrubber to oxidize the odour producing compounds.

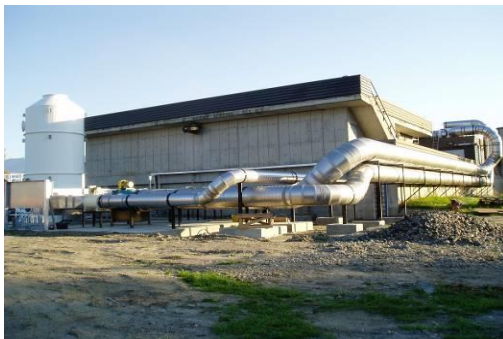
Single Stage Chemical Scrubber

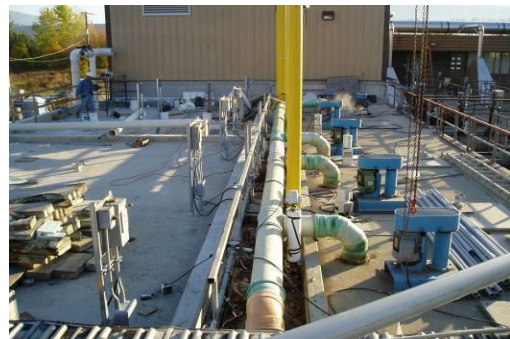
ATAD & Piping

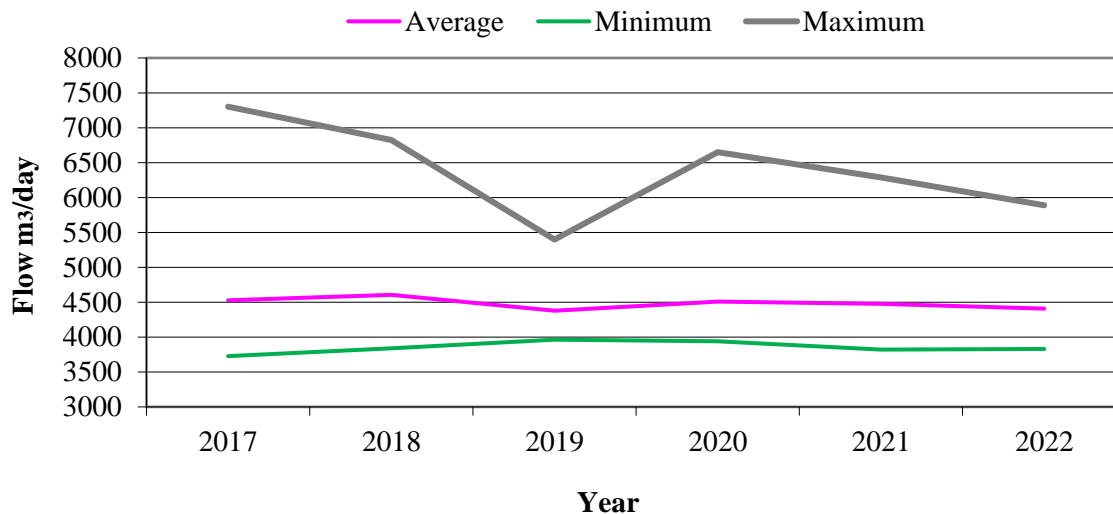
Figure 2: Minimum, Maximum and Average Daily Flows

Plant flows decreased by 1.5% in 2022 from 2021. The average daily flow was 4,410 m³/d while in 2021 it was 4,479 m³/d. The highest flow of 5,890 m³/d was recorded on December 27, 2022 when rain combined with warmer temperatures advanced the snow melt increasing the inflow and infiltration into the collection system.
