Attn: Darin Gerow
Re: Structural Assessment & Life Cycle Assessment of the Memorial Arena – Interim Report
100 - 30th Street SE, Salmon Arm, BC

Structural Assessment and Lifecycle Analysis of the Memorial Arena

Interim Report

Project No. 24VR-600400

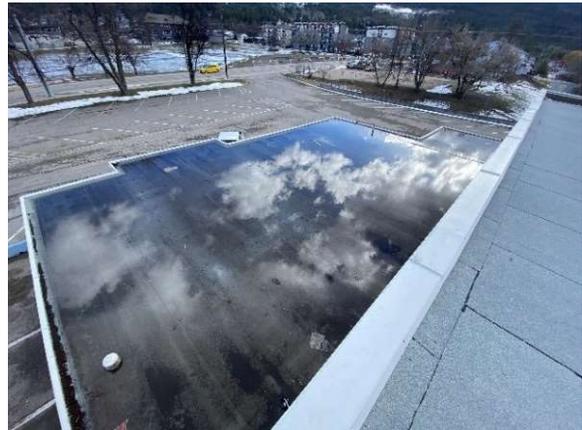
- Roofing is in fair condition.
- Entire lower roof area was flooded at time of review. No leaks apparent within building interior suggesting roofing is watertight. Photo 5.
- Significant staining observed throughout.
- Poor drainage.

Photo 5: East addition lower roof flooded.

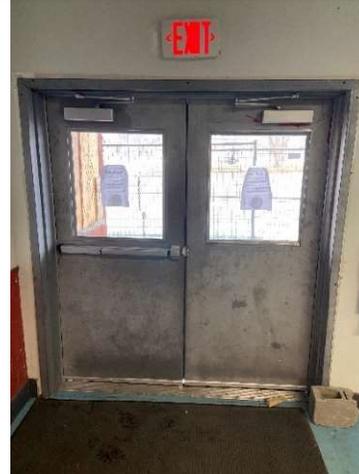
- The exterior doors in the east and west addition are insulated steel doors.
- The doors and frames are generally in fair condition. Photo 20.
- The door seals, weather stripping, and door hardware are in fair condition.

- The main entrance doors on the east wall of the east addition and the entrance door at the southeast corner of the east addition have glazing.
- The glazing is in fair condition. Photo 20.

Photo 20: Insulated steel door

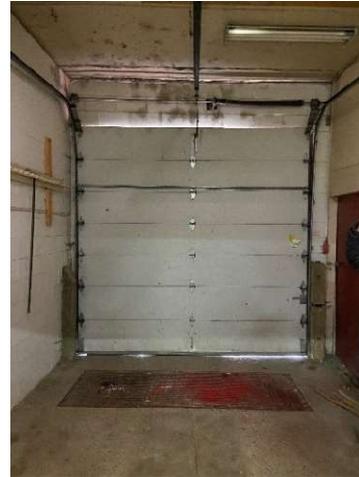
- The overhead door serving the vehicle bay in the west addition is in poor condition. Photo 21.
- The overhead door opener is not operational.
- The latch hardware for locking the overhead door is not operational.
- The door does not seal to the shop floor or door jamb.
- The door has mechanical damage from impact.

Photo 21: Overhead door

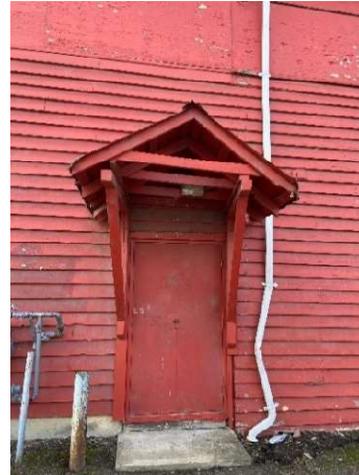
- The emergency exit doors serving the arena and the west addition are hollow steel doors. Photo 22.
- The doors are in failed condition.
- The doors seals and weather stripping are in failed condition and/or missing.
- Door hardware failure was observed throughout.

Photo 22: Hollow steel door

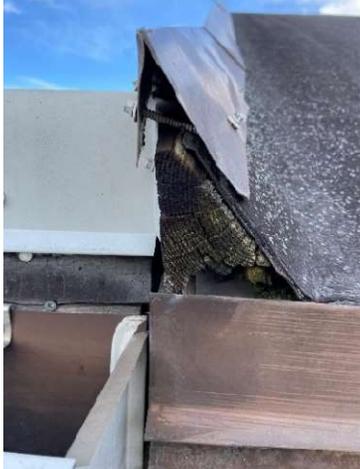
OBSERVATIONS	PHOTOS
<p>Flashing</p> <ul style="list-style-type: none"> • Aluminum flashing exists along the eaves and gable ends of the roofs. • The flashings are generally in poor condition. Photo 23. • Flashing fasteners missing in some locations. • Gable flashing at southwest corner of arena roof does not fully cover wood. Wood has deteriorated and flashing fasteners no longer engaged into substrate materials. Photo 23. • No head and sill flashing observed at windows and doors with the exception of the south wall of the arena. • Flashing at material transitions don't adequately protect against water ingress. • The metal flashings along the south wall of the arena, where the exterior siding has been replaced with metal cladding, are in fair condition. Photo 24. <p>Aluminum Gutters & Downspouts</p> <ul style="list-style-type: none"> • The arena is fitted with aluminum gutters along the eaves with 4 downspouts evenly spaced along each eave. Photo 24. • The gutters are generally in poor condition. • The gutters have 2-3 inches of debris accumulation. Much of the debris includes the aggregate surface of the SBS roofing system. Drain holes at downspouts were mostly clogged. • The downspouts are in failed condition. Downspouts missing or damaged in numerous locations. (Photo 25). • Downspouts no longer drain into designated stormwater piping. <p>Silicone, Bitumen, and Polyurethane sealers</p> <ul style="list-style-type: none"> • Majority of the exterior wall penetrations have not been sealed or flashed. • The caulking of the Hardi-plank siding on the south side of the Arena is in fair condition.

<p>Photo 23: Gable flashing with deteriorated substrate materials</p>

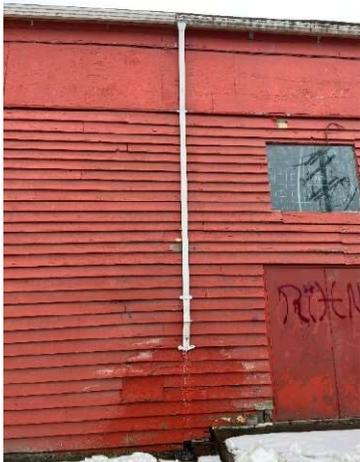
<p>Photo 25: Typical condition of gutter downspouts</p>

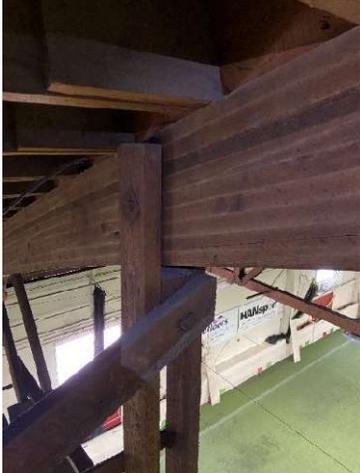
OBSERVATIONS	PHOTOS
<p>Top Chord</p> <ul style="list-style-type: none"> The top chord of the bowstring trusses are 9-ply 5"x14^{5/8}" glulam arched members with an approximate curvature radius of 54'-7^{3/16}". Photo 32. The top chords are generally in good condition. Water/moisture staining was observed throughout, but no signs of decay or rot were observed. Moisture content ranged from 8-10% throughout the arena. No crushing failures at rafter bearing locations were observed. Minor checking was observed on most of the truss top chords. <p>Bottom Chord</p> <ul style="list-style-type: none"> The bottom chord of the bowstring trusses are 6 ply 5"x9^{3/4}" glulam members. Photo 33. The bottom chords are generally in good condition. Water/moisture staining was observed throughout, but no signs of decay or rot were observed. Moisture content ranged from 8-10% throughout the arena. No crushing failures at rafter bearing locations were observed. Minor checking was observed on most of the truss bottom chords. <p>Truss Webs</p> <ul style="list-style-type: none"> The truss webs are rough sawn D. Fir members. Web sizes include 2"x6" and 2"x8" members. Approximately 50% of the webs are in fair condition while the remaining 50% considered failed due to full depth splits at web to chord connections. Photo 34. The truss webs are nominally straight with limited lateral bowing. Approximately 25% of the web members have checking. Photo 35. Moisture content ranged from 8-10% throughout the arena.

<p>Photo 32: Typical condition of top chord.</p>

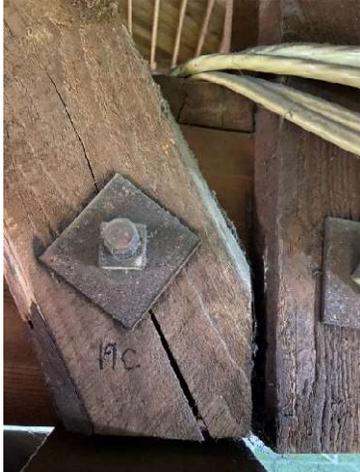
<p>Photo 34: Typical splitting at web to chord connection.</p>

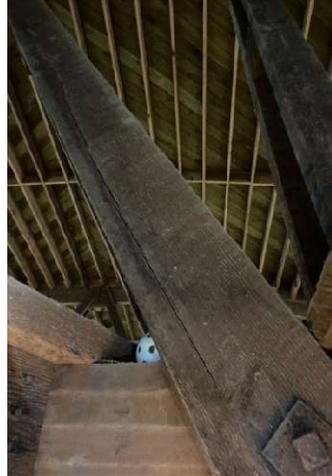
Photo 35: Web member with checking along entire length.

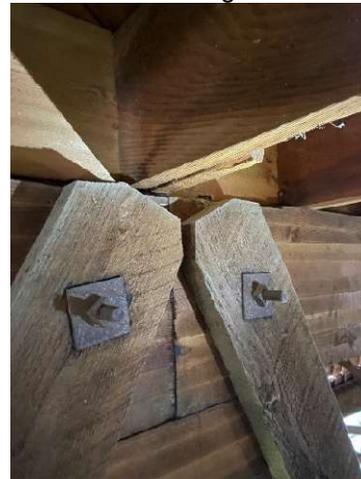
- The top chord is spliced at the peak of the arched roof.
- The splice connections are in good condition with no signs of stress related failures or deterioration. Photo 36.

Photo 36: Typical top chord splice.

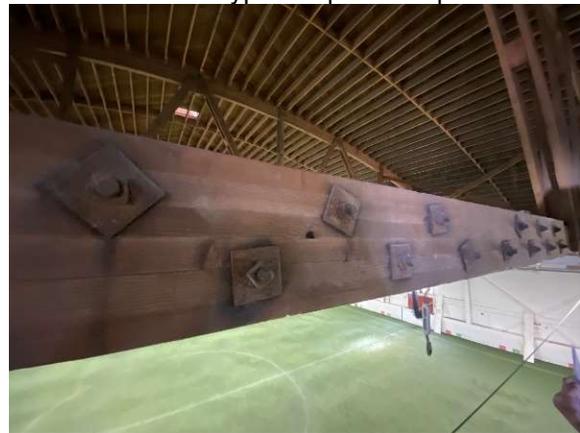
- The bottom chords are spliced at midspan with glulam splice blocks.
- The splice blocks are in good condition. Photo 37.
- Minor checking was observed throughout.

Photo 37: Typical bottom chord splice.

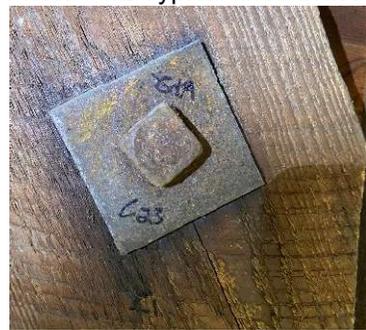
- Surface corrosion on the connection hardware was observed throughout. Photo 39.
- Random connection bolts were removed and assessed. The bolts reviewed are all in good condition. Photo 40.

Photo 39: Typical surface corrosion on connection hardware.

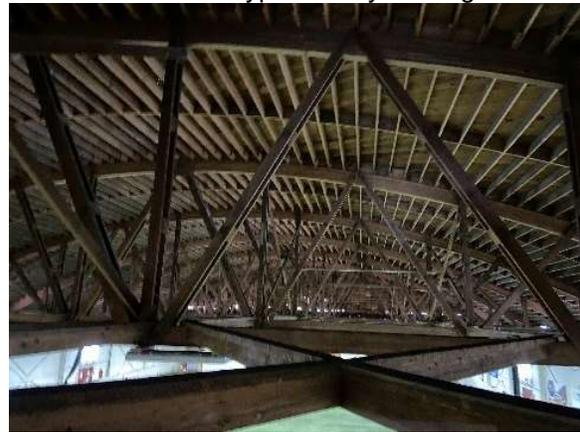
- The bottom chord bracing consists of cross-bracing in the east and west bays and strut braces in the remaining bays.
- The strut braces are in fair condition throughout.
- The cross-bracing in the end bays are in poor condition. Due to their long span, they have sagged 2-3 inches. Photo 42.
- Brace to truss connections are in fair condition with limited splitting.

Photo 42: Typical bottom chord cross bracing.

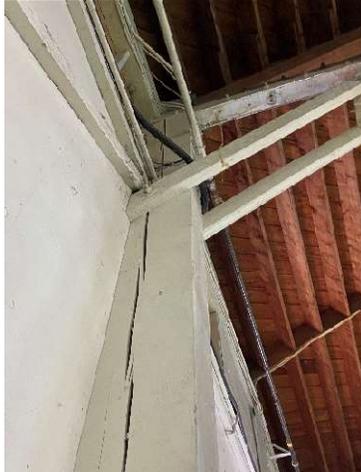
OBSERVATIONS	PHOTOS
<p>Arena Sidewall Columns</p> <ul style="list-style-type: none">• The columns are 10" x 16" D. Fir and extend from the foundation to the underside of the roof trusses.• The columns are generally in very poor condition.• Severe checking was observed throughout. Checks measured as large as ¾" in width and 3" in depth. Photo 45.• Some columns have end splitting at the base connection.• Moisture staining was observed throughout. Photo 45.2/• The base of the columns on the east half of the arena are at/below grade and exposed to moisture. These columns have varying degrees of decay. The base steel brackets at these columns are corroded. Photo 46.

<p>Photo 45.1: Typical arena columns. Checking observed.</p>

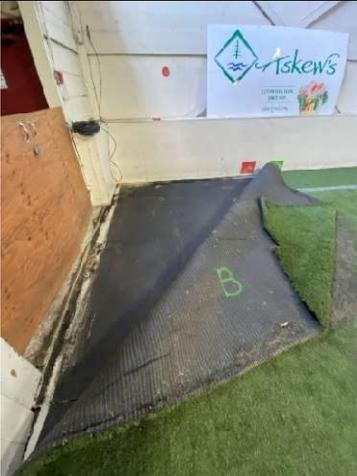
OBSERVATIONS	PHOTOS
<ul style="list-style-type: none"> • The floor slabs are generally in fair condition throughout the building. Photo 51. • Typical shrinkage and temperature cracking was observed throughout. • The concrete slab at the east end of the arena is in poor condition with cracking throughout and differential settlement. Photo 52. • The slabs throughout the east and west additions are nominally level. • The arena slab was surveyed. The slab elevation varies 1.5".

<p>Photo 51: Observed sample section of slab underneath turf.</p>

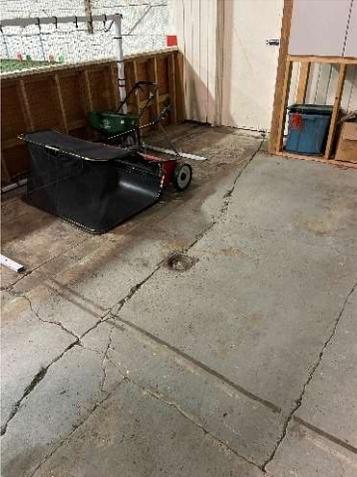
<p>Photo 52: East end of the arena typical slab cracking</p>

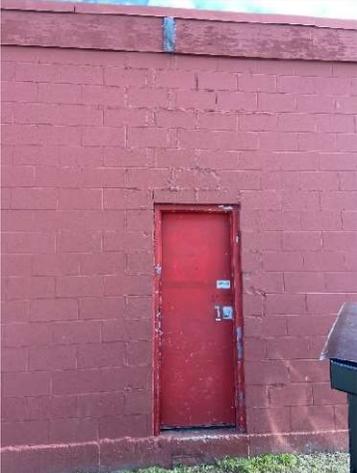
OBSERVATIONS	PHOTOS
<p>East and West Additions</p> <ul style="list-style-type: none"> The additions are assumed to be supported on concrete frost walls and continuous strip footings. Only the portions of the foundation walls above grade could be observed. The foundation walls appear to be in fair condition. Photo 53. No significant signs of differential settlement or cracking were observed. <p>Arena</p> <ul style="list-style-type: none"> The arena foundations consist of concrete pilasters on spread pad footings. Two pilasters and pads were partially excavated and confirmed to match the original design drawings. The pilaster and pads appeared to be in fair condition. No cracking or signs of instability were observed. Photo 54. The top surface of the east half of the building pilasters are at or below grade. Photo 55.

<p>Photo 53: Foundation wall observed at grade.</p>

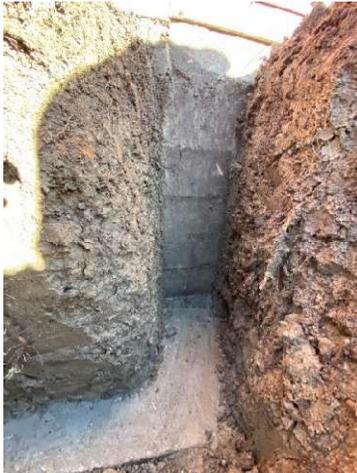
<p>Photo 54: Arena pilaster and pad footing.</p>

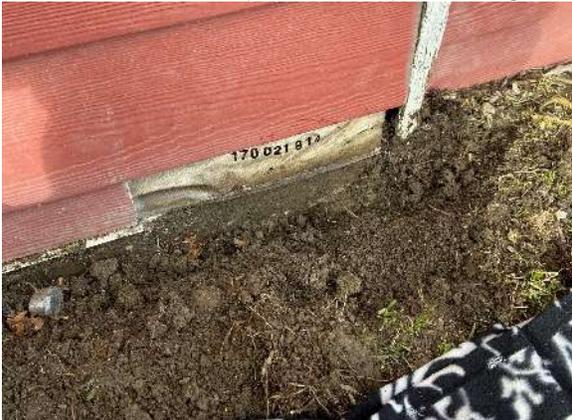
<p>Photo 55: Top of pilaster roughly 4" below grade.</p>

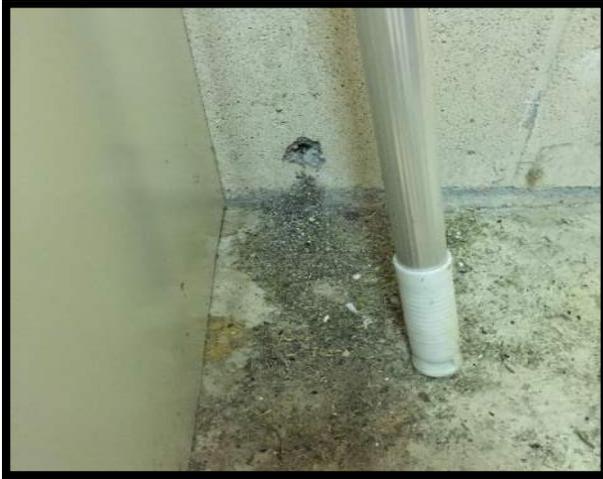
Asbestos-containing vermiculite insulation present as debris in the Back Storage (Loc. 17)

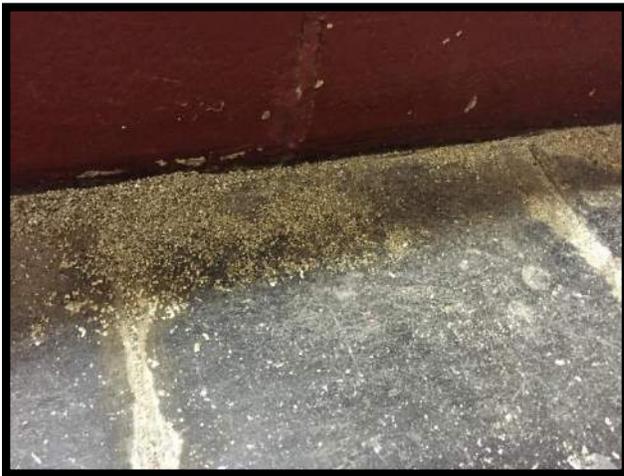
Asbestos-containing vermiculite insulation present as debris in the Back Hallway (Loc. 15)

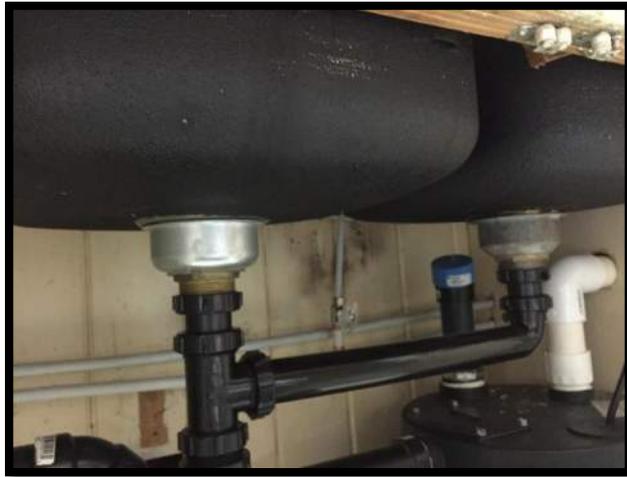
Black sink mastic in the kitchen (Loc.7) is asbestos-containing.

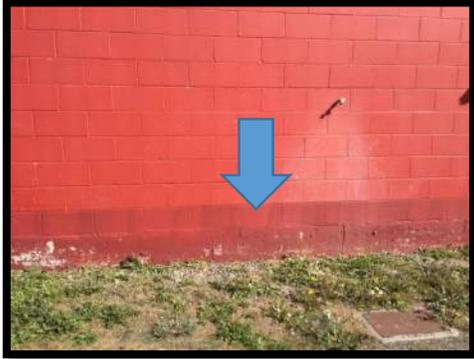
Dark red paint applied to exterior block wall contains 1.8% lead.

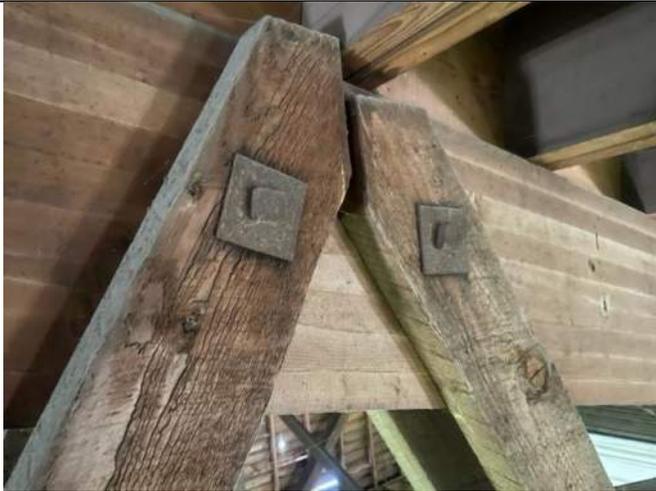
Table A1: Observations	
<p><i>Photo 1</i> Typical through-bolt connection for main roof structure.</p>

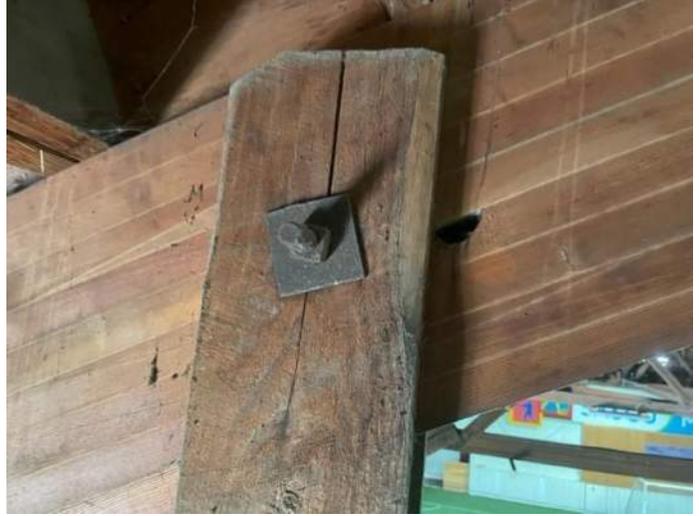
Photo 4

A split in a vertical truss member was identified which should be reviewed for repairs as soon as possible.

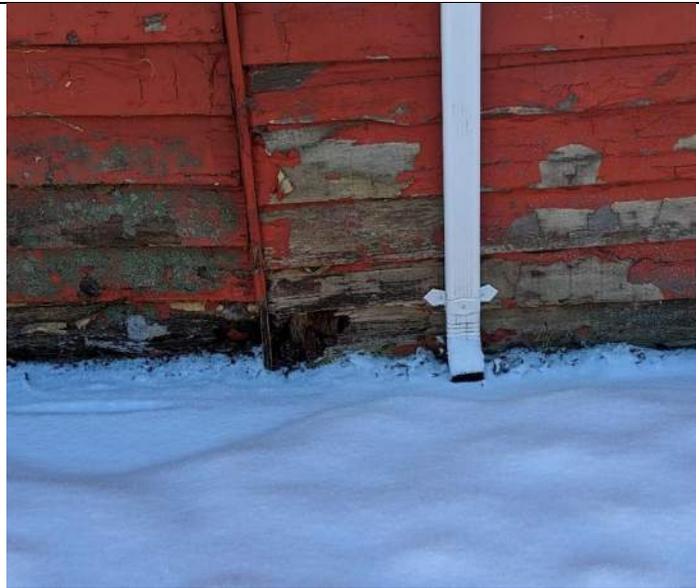
Photo 5

The exterior stud walls and heavy timber columns are supported at grade on a foundation with unknown configuration. In review of the perimeter of the building, it appears that the exterior grading of the finishes around the building are flush with the interior of the building which has resulted in moisture entrance into the building. In the northeast corner of the building, there is one column location which shows significant signs of rot and deterioration, which is shown in photograph 5. This rot resulted in the column to deform vertically and out of plane, which has also caused the structure to deform globally in this location. Due to the extent of the deformation of the structure, this column should be reviewed by a structural engineer as soon as possible such that a repair can be provided.

Exterior of building at location in which a column shows signs of significant deterioration. The exterior finish of the building also shows indications of excessive moisture and deterioration.

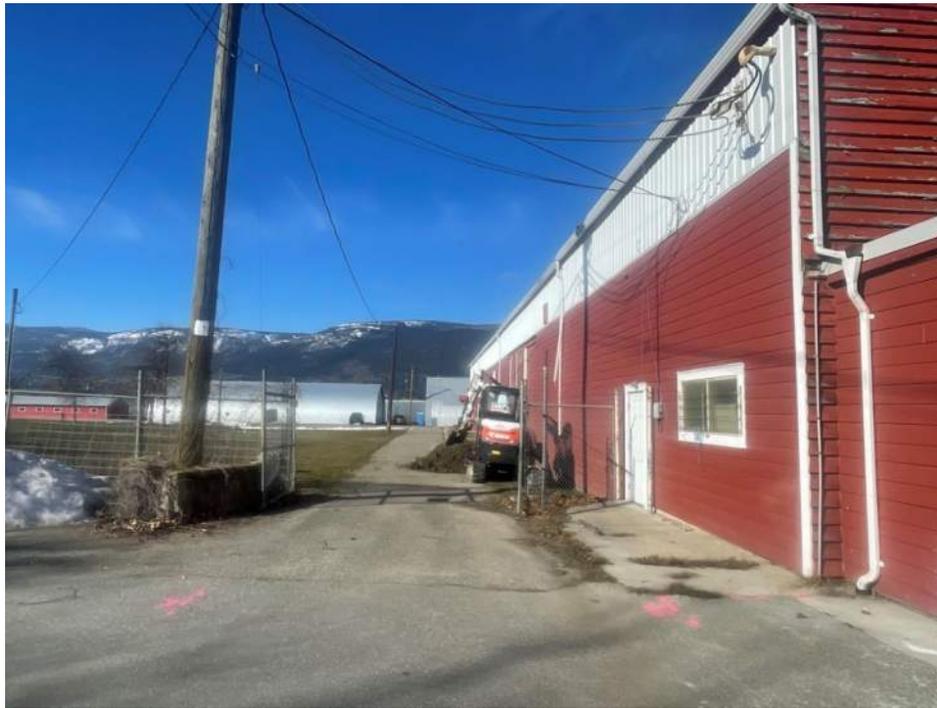
Photograph 1 – TP1 Location, south wall, looking West.

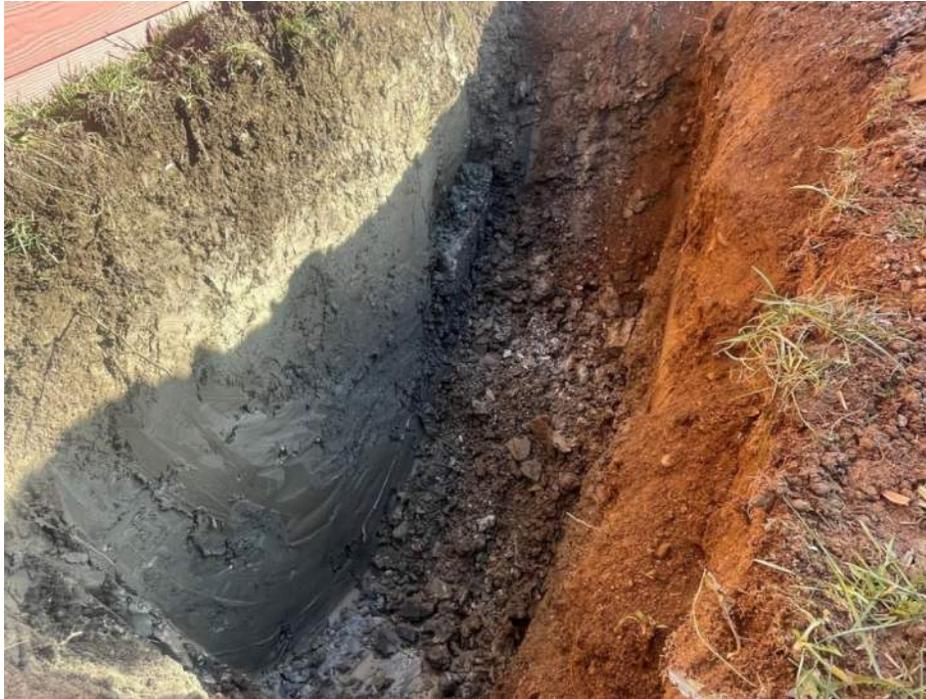
Photograph 3 – TP1 Excavated profile.

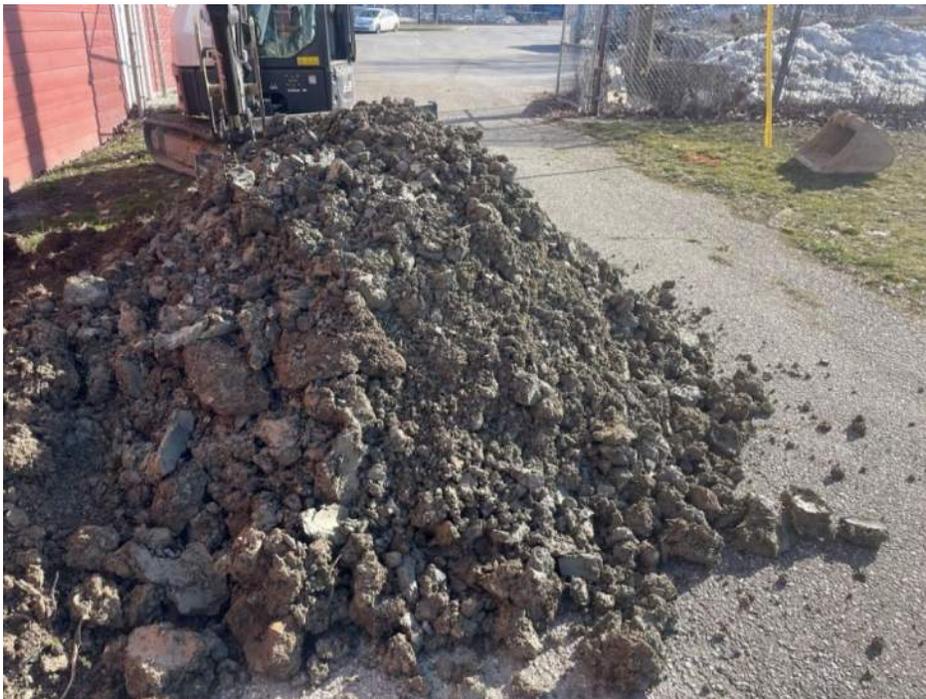
Photograph 4 – TP1 Excavated material.

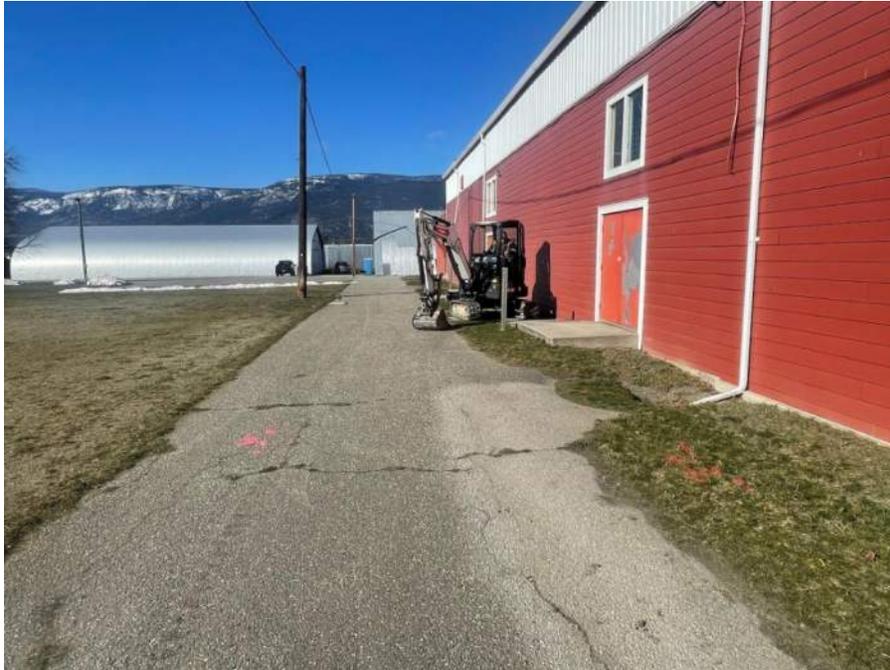
Photograph 5 – TP2 Location, south wall, looking West.

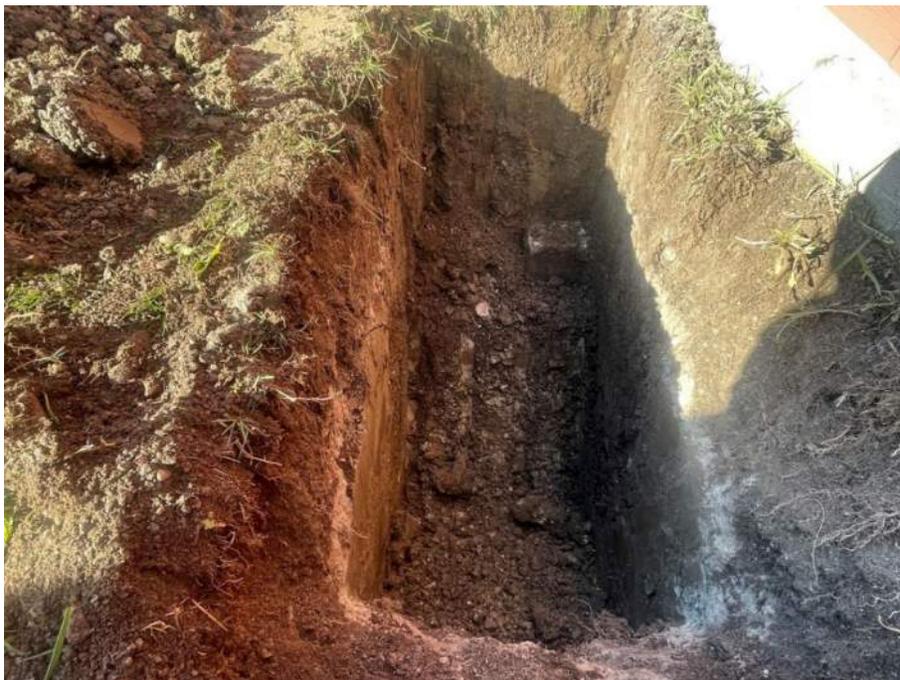
Photograph 6 – TP2 Exposed the edge of existing footing.

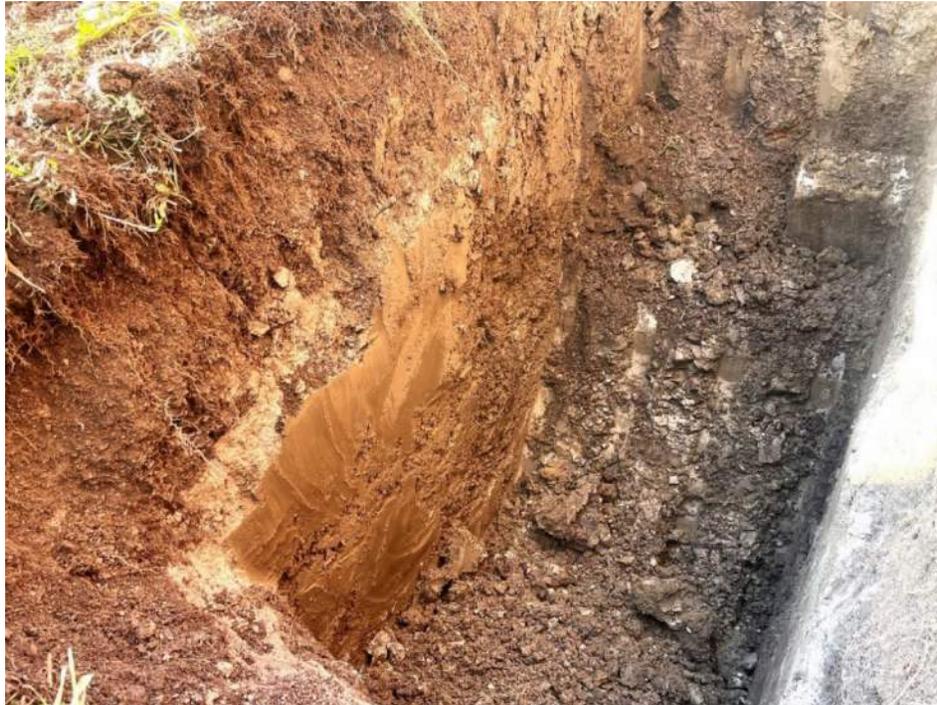
Photograph 7 – TP2 Excavated profile.

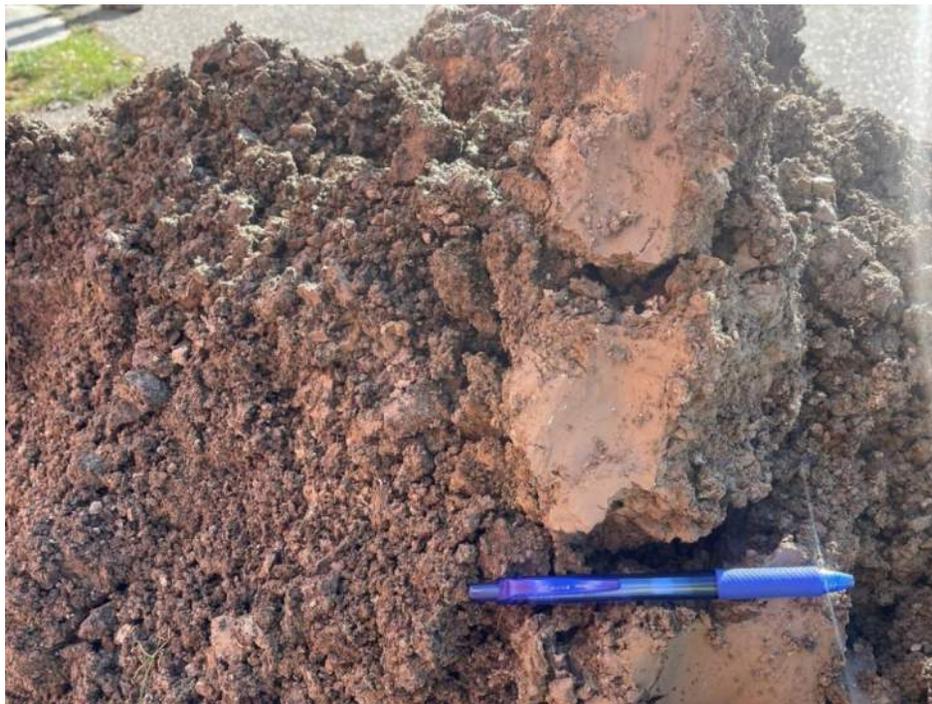
Photograph 8 – TP2 Excavated material, closeup.
